1981 Mariner 28 “Crusader”

Purpose of Inspection: Pre Purchase

Survey ID: 151119DB

Date of Inspection: 15th November 2019

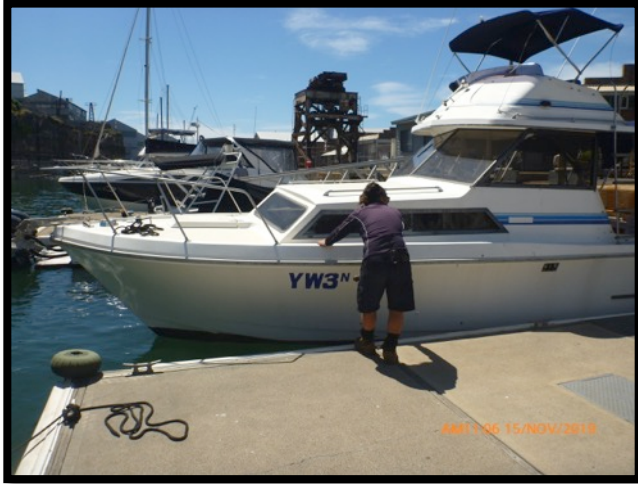
Deck

The GRP deck areas are well constructed and include non-skid surfaces. The foredeck area is accessed via walkways either side of the main saloon. The handrails are solid and well positioned.

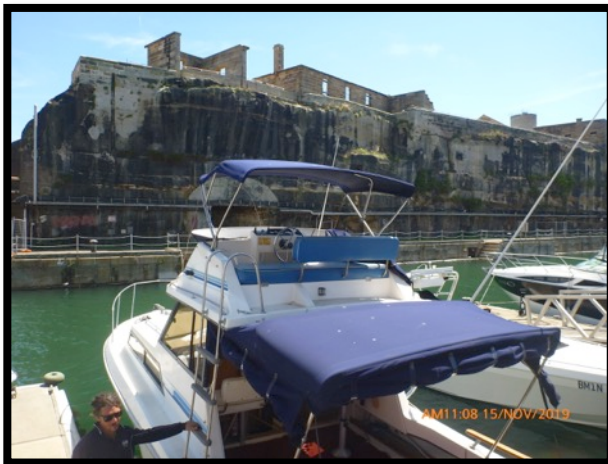
Flybridge

Is accessed via a ladder on the port aft side deck, it was originally located in the cockpit.

There is a mirrored set of engine controls and a helm bench seat

There is no storage under the bench seat and the entire area is covered and enclosed by a canvas Bimini.

Vision from the helm station is very good, both forward and aft.

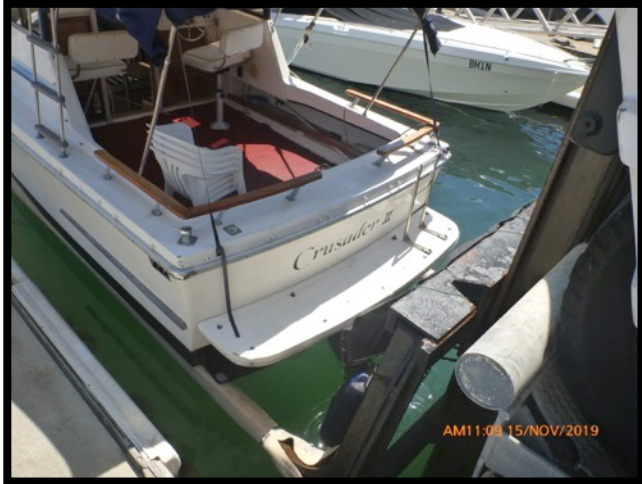
Aft Cockpit

The aft cockpit is very roomy and provides good access to the side decks and transom area. The side deck height is low enough to allow access from a floating marina arm.

There are fairleads and cleats for mooring lines and the floor panels lift away which gives easy access to the engine, fuel and water tanks, trim tab motor, bilge pumps and also the steering gear.

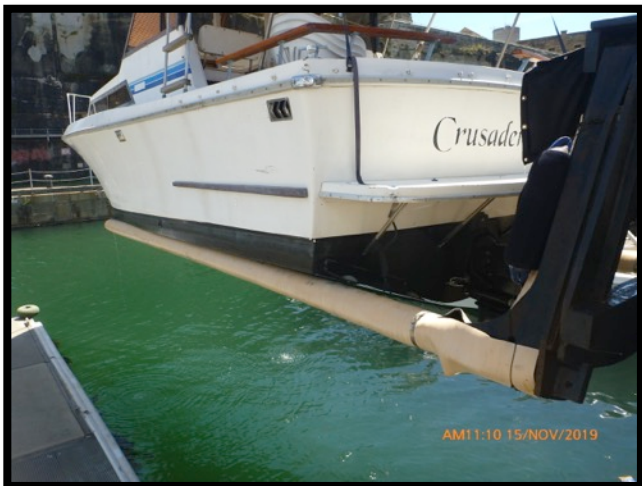
Hull

The hull appeared to be very solid and well constructed in GRP. The Gelcoat, although needing polish and some docking impact repairs in some areas, appeared to be free of any major repairs and is protected by a full length, alloy rubbing strip.

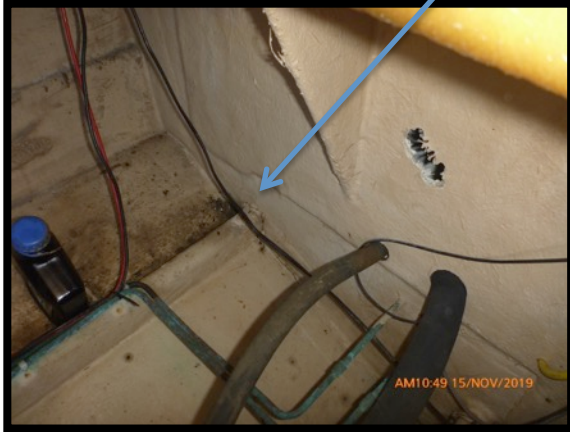
Bulkheads/frames etc.

All frames, stringers and frames that were accessible appeared to be very solid and in good condition. There is one small crack in the bonding of the bulkhead and stringer on the port side, which is not major.

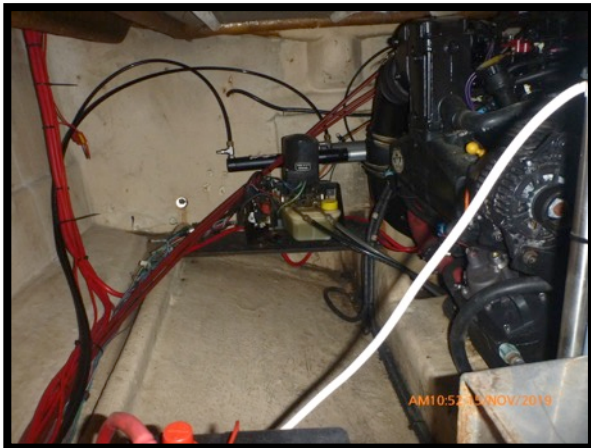
Engine bearers

The engines bearers were part of longitudinal stringers system and appeared solid.

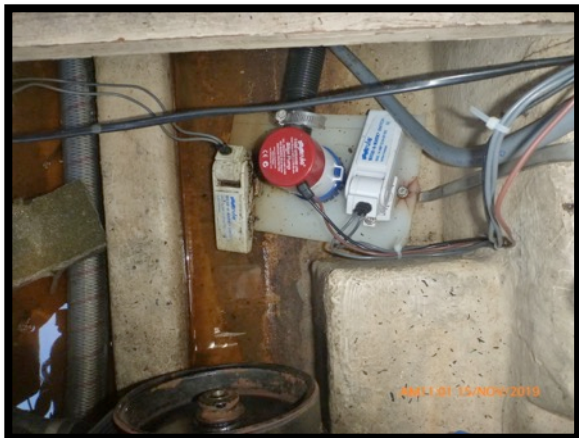
Bilges

All bilge areas that were accessible appeared to be clear and sumps were provided in the various compartments for bilge pumping.

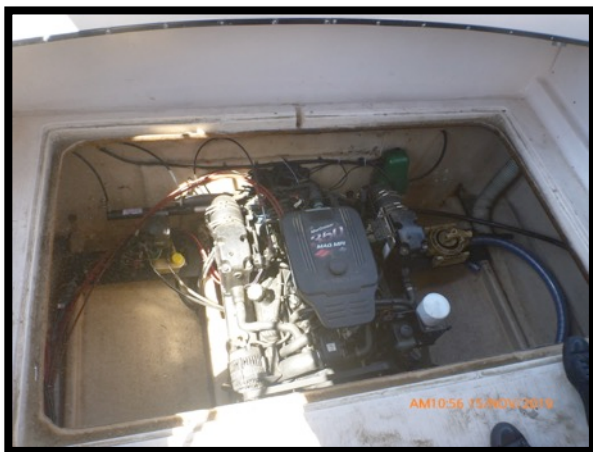
Under cockpit space

The engine and other equipment is accessed through removable floor hatches in the cockpit floor providing very good access. The area contains the following equipment

- Main engine
- Fuel tank
- Water tank
- Battery bank
- Freshwater pump
- Hot water system
- Engine room blower (not working)
- Manual & electric bilge pumps

- Mechanical – adjust throttle control so it stays in place
- Mechanical – fix engine room blower
- Electrical – horn not working
- Electrical – check all navigation lights are working
- Safety – check all safety gear is onboard to minimum standard

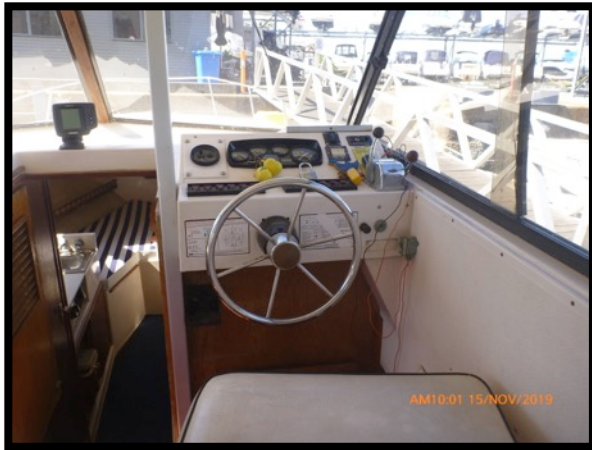
Lower helm

Located at the forward end of the cockpit on the STBD side is the main helm station with all controls and a basic GPS plotter. A VHF radio is mounted above the helm. The windscreen windows are fixed but the side windows slide open to provide ventilation. There is a single passenger seat opposite the helm seat.

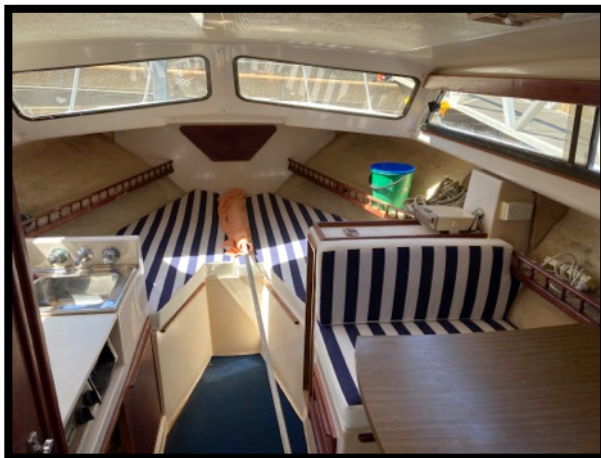
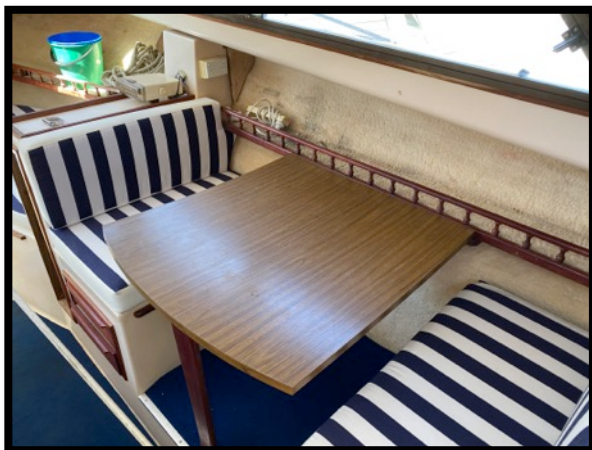
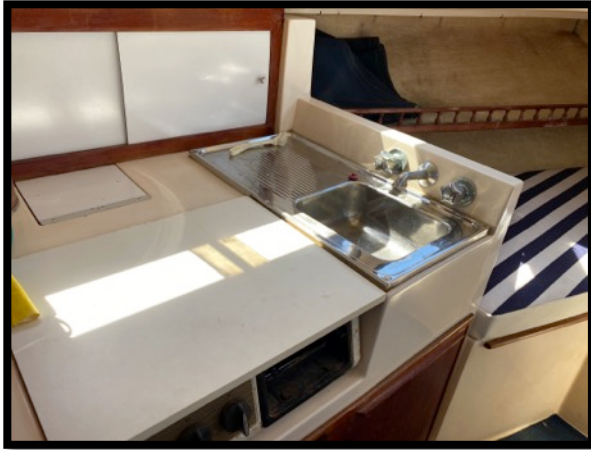
Saloon

Down a couple of stairs from the lower helm area is the saloon area with a separate bathroom, double berth, dining area and small galley.

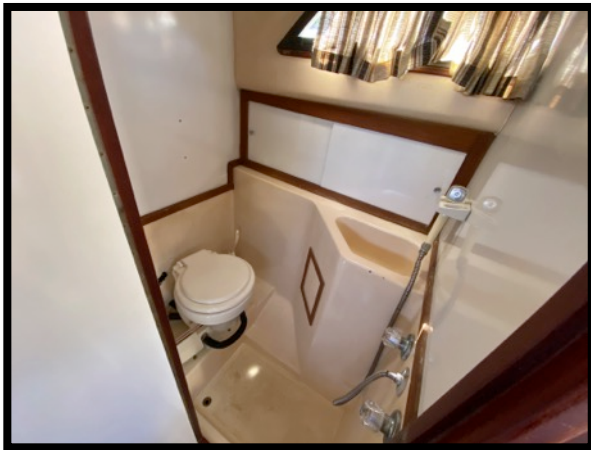
Bathroom

The enclosed bathroom is fitted with an electric toilet.

There are controls for the flushing and black water management. There is a sink with a showerhead and shelves with sliding doors.

All the fittings, mirror, finishes are in reasonable condition.

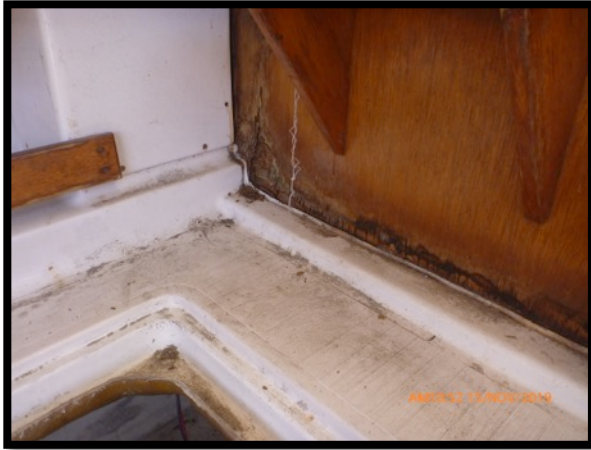
Windows, hatches etc.

Throughout the vessel there are opening windows, hatches and portholes. These are all original and some will need refitting or upgrading in the future. The side windows have leaked over the years causing some damage to the plywood panelling in the saloon particularly. As discussed these water damaged panels will be relatively easy to replace/repair

It may be the case that the sliding window drains are blocked or insufficient to handle heavy rain.

- Safety – possible swap anchors – spare maybe in better condition
- Safety – fit a compass
- Electrical – fit solar charging system
- Timberwork – replace/repair any water damaged timberwork
- Anchor winch – consider fitting foot button at bow
- Tankage – confirm capacity of water & fuel tanks
- Flybridge ladder – consider location options
- Gas supply – consider moving gas bottle out of saloon
- Antifouling - look at full soda blast and strip of old layers
- Galley – finish removing old fridge timberwork – perhaps fit a small fridge
- Hot water – clean up tank and check corrosion – repair or replace

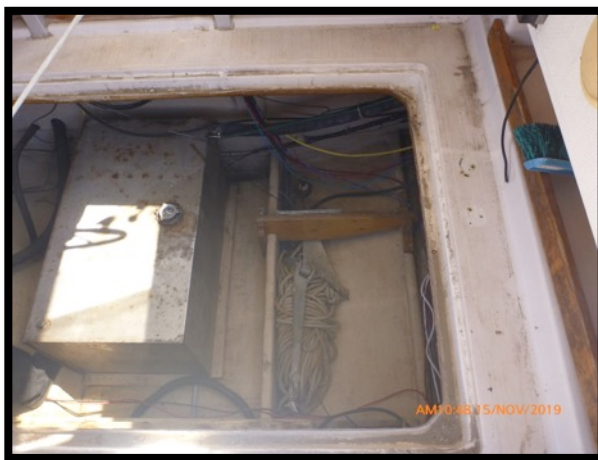
Thru hull fittings

All fittings appear to have been replaced in recent years and seem to be in good order.

In some cases the hoses have been fitted directly to the hull fitting without a stopper valve, which should be fitted for safety. Also any hoses under the water line should have 2 x hose clamps. Also the electric bilge pump is not marine grade and should be replaced at some stage.

- General – fill any unused holes to protect GRP – incl. hole in bathroom wall
- General - Thru hull valves – look at fitting valves to through hulls

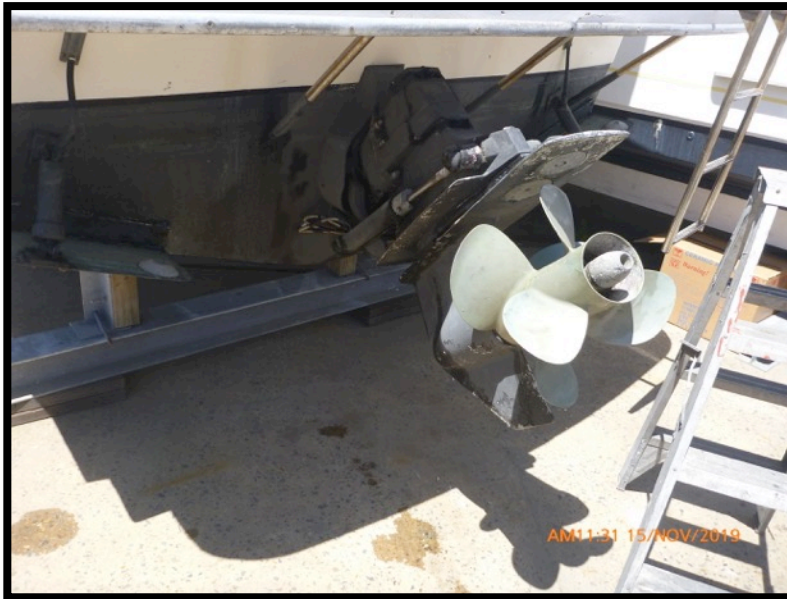
Haul out

Keelson, strakes etc.	appear undamaged
Antifouling	reasonable condition – some worn areas
Topsides	GRP needs polishing and gelcoat repairs
Blistering/osmosis	generally appeared free of blistering or damage
Sterndrive	appeared OK
Trim Tabs	OK
Prop/s	Mercruiser duo prop – good condition
Anodes	all anodes were approx. 75% intact
Skin fittings – intakes etc.	Appeared to be clear of debris

- Maintenance – redo antifouling especially bare spots
- Maintenance – empty all lockers/bilges and remove all old mould and dirt
- Maintenance – fix settee table mounting
- Electrical – check and clearly label all electrical switches and breakers
- Electrical – tie down both batteries
- Electrical – remove any old or redundant systems
- Electrical – tidy up wiring where possible
- General – monitor side windows and hatches for leaks – repair as needed
- General - topsides and gloss areas need to be maintained and polished annually
- General – replace any broken clips for canvas covers
- General – tighten any loose deck fittings, aerals etc. and forward handrails

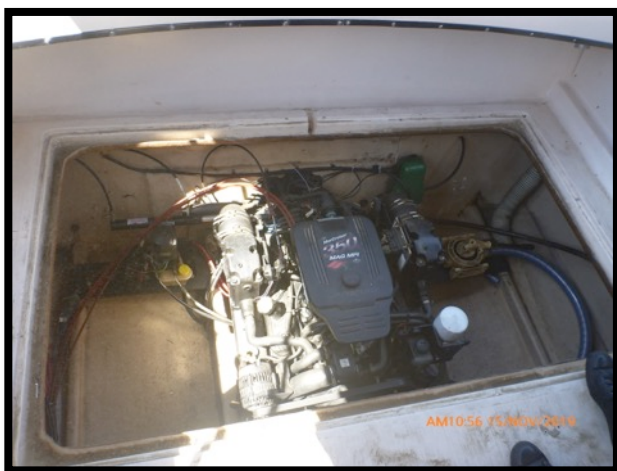
Engine/s

Make	MerCruiser
Serial number	tba
Capacity	5.7/L 300hp
Fuel type	Unleaded
Engine hours	tbc
Service history	tbc
Drive system	Sterndrive
Exhaust systems	appeared OK
Fuel filters	appeared OK
Throttle control/s	needs adjustment
Engine mounts	solid and in good condition
Coolant hoses	appeared OK – some corrosion on 1 fitting
Engine Oil	not tested
Coolant	not tested
Idle revs	approx. 600rpm
Max rated revs	4800rpm
Max speed on test	approximately 30 knots in smooth water
Alternators charging	not tested

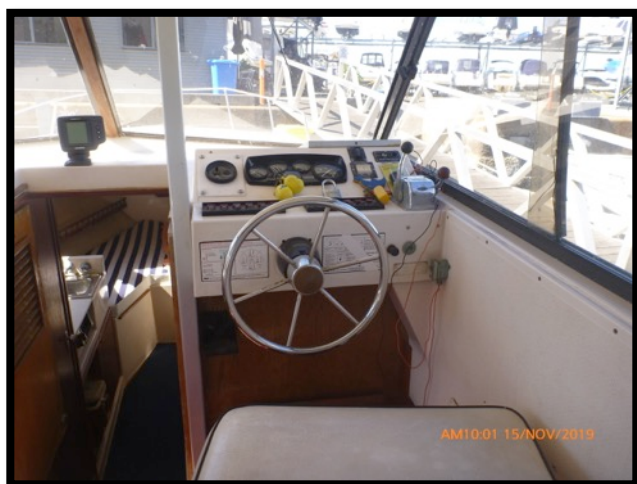
Electrical systems

System Voltage	12V DC
Switches	All switches appeared OK – some old
Bilge pumps	OK 2 x fitted manual control
VHF radio	OK – near new
Lighting	mostly original and working
Fresh water pump	OK
Navigation lights	tested OK – except running light
Chartplotter	Hummingbird Wide 128
Depth sounder	OK
Horn	not working
Hot water	OK
Anchor winch	LEWMAR – near new
Anchor winch controls	at both helms – old deck foot button n/w
Trim tabs	OK
Windscreen wiper	OK

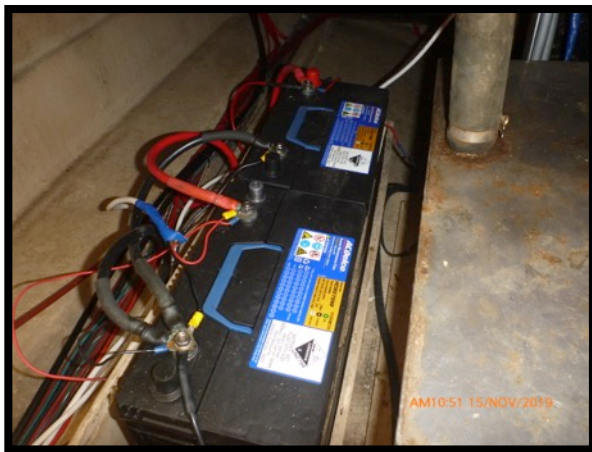
Batteries

Type	Maintenance free
Capacity / Number	2 x 680cca 97a/h
Location,	under cockpit floor
Age & condition	Appear to be near new
Securing	Safe dry area – need to tie down
Cables etc.	Appear in good condition
Isolator switch/s	OK
