CONDITION REPORT # 6158

"Urania"

In accordance with instructions from *Paul Hick*, the agent of the vessel's owner, *Ken Jenyns*, I attended an in-water inspection of a 16 metre aluminium sailing catamaran to prepare a condition report for insurance renewal purposes. The initial inspection was conducted whilst the vessel was afloat in berth # T13 at the Royal Queensland Yacht Squadron, Manly on 21st November, 2019 and concluded with inspections whilst out of the water at The Boat Works, Coomera between 17th February and 2nd March, 2020. The vessel was previously inspected by me out of the water on 14th March, 2012 at the Boat Works, Coomera.

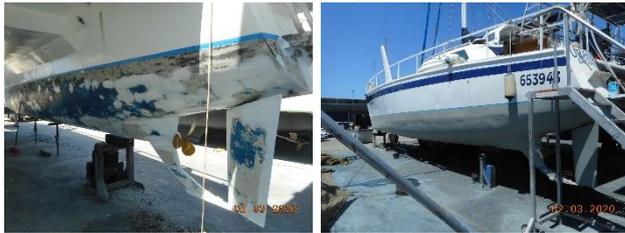
The vessel was slipped at The Boat Works in February 2020 for required underwater works including removal of most of the previous coating below the waterline and reinstating a proper antifouling paint system. After extensive abrasive sanding, the hull was prepared for spot priming and an application of a sealer coat using *Jotun Safeguard UNI ES* grey primer. After allowing sufficient time to cure, two coats of *Jotun Seasafe Ultra* black antifouling were applied along with an application of *Prospeed*, a silicon polymer performance coating, to the propellers.

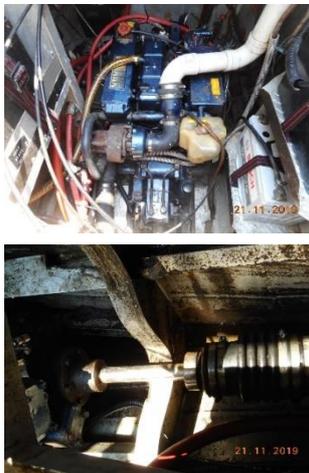
The vessel is powered by a pair of *Yamaha ME200FT* three cylinder, turbocharged marine diesels. The engines are fresh water cooled and rated to produce 48kW (64hp) and close coupled to marine reduction gearboxes. Engine hours are recorded as 2103 (1971 in March 2012). Engine and gearbox controls are sheathed metal *Morse* type cables controlled by single levers at the helm. The propeller shafts are 32mm Ø and sealed at the shaft logs with carbon faced 'dripless' compression glands. Steering is hydraulically controlled from a passive helm pump in the wheel to a single ram mounted on the port side steering quadrant.

Each quadrant is connected by stainless steel wires and a 12v slave pump operated by the autopilot (*pilot not working*) is connected to the same hydraulic system. The starboard engine is fitted with a belt driven *Jabsco* deck wash pump.

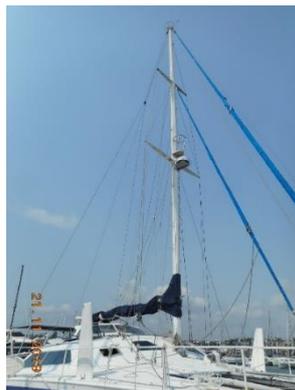
The vessel has a masthead cutter rig with twin furling headsails rigged off the inner and outer forestays and a mainsail slab reefed to the boom and supported in lazy jacks. The aluminium mast and boom are supported by two sets of in-line spreaders, fore and aft lower stays, continuous intermediate, upper and aft intermediate shrouds and a split back stay. An aluminium extruded hollow section whisker pole is carried on the foredeck. The standing rigging is all stainless steel and in average condition. The main forestay is supported by the connecting spar beam and the inner forestay is supported by stainless steel stays running either side to each hull.

Five self-tailing *Maxwell* halyard winches, one of which is 12v powered, are mounted on the coach house forward in the cockpit and five self-tailing sheet winches *Arco 52* and *Barlow* are fitted on the aft bulwark capping in the cockpit. A lightweight spinnaker is carried and can be rigged off either bow in light airs. Two headsails with UV weather strips and a mainsail in a zippered boom bag are rigged to the vessel.

- ✚ Resecure the pin in the boom gooseneck fitting.
- ✚ Replace the reflective tape on the life ring and fit a 16 metre length of floating line.
- ✚ The standing rigging appears to be over ten years old and as such, should be inspected and issued with a rigging or certificate or scheduled to be replaced.
