Oref : 17002/AZ(mi0515xr)

## CONDITION SURVEY REPORT

### S/Y MIYAGI MOON

At Aegina May/17

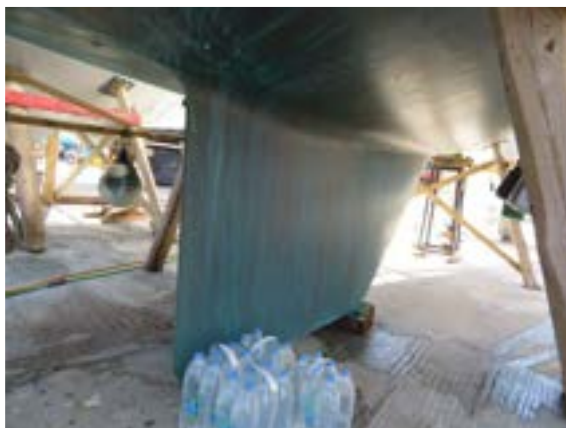
Encapsulated iron keel. No cracks at interface of the keel laminate and the hull. No grounding damages.

Keel externally intact

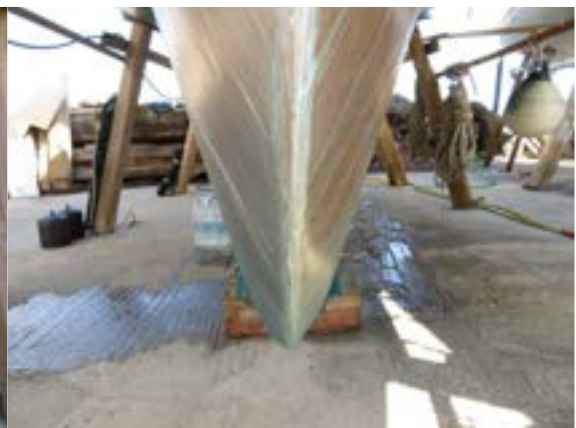
No damages at leading edge

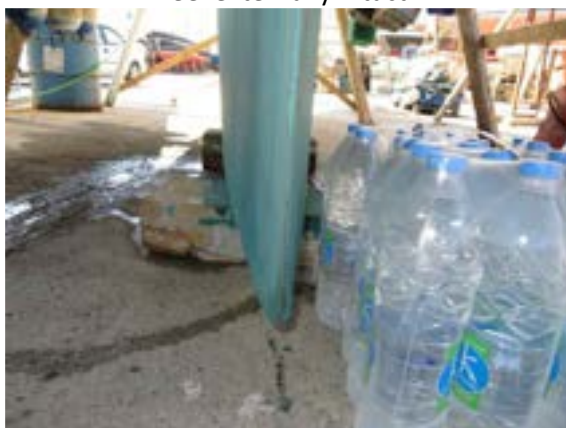
No damages at trailing edge

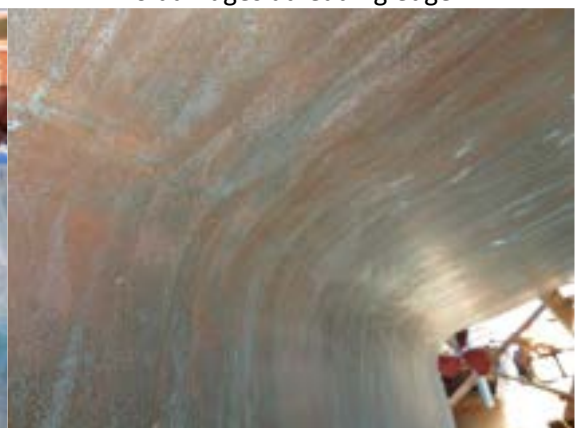
No cracks at interface of encapsulation and the hull

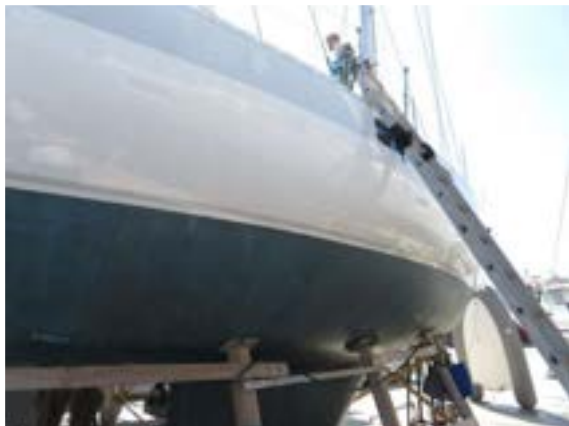
Topsides were recently painted with awlgrip to a high standard. Topsides were fair. There were no damages.

Topsides painted

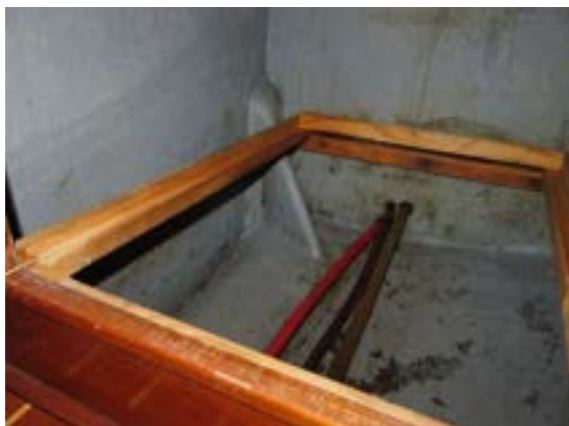
Intact bilge structure

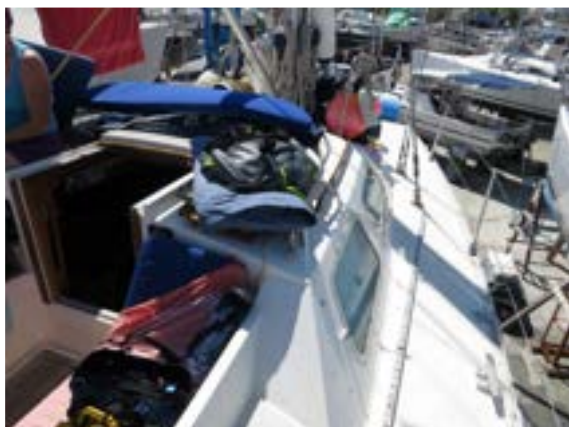
Deck moulding was heavily walked upon and there was no deflection or cracking sounds underfoot. The deck was without crazing. Hammer sounding did not find any delamination or voids.

Deck

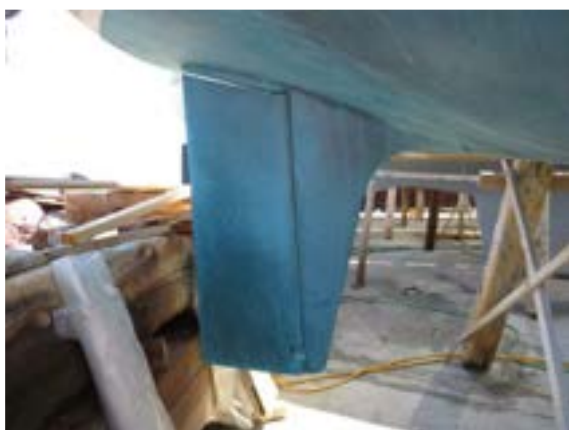
Skeg hung fiberglass rudder. No cracks at skeg interface with hull. Rudder was without splits between the two mouldings. Hammer sounding did not find any delamination or voids. There was no play at the rudder bushings.

Rudder without damages

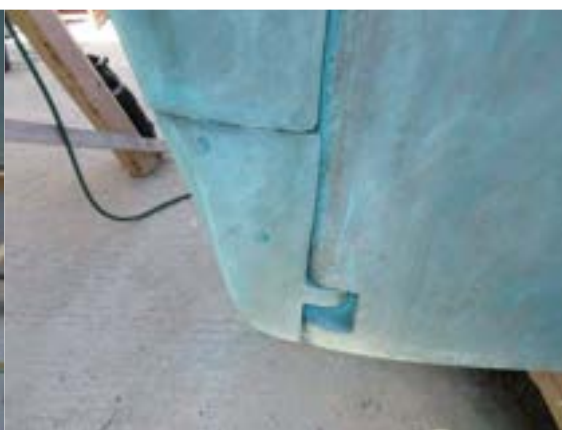
Lower bracket without wastage

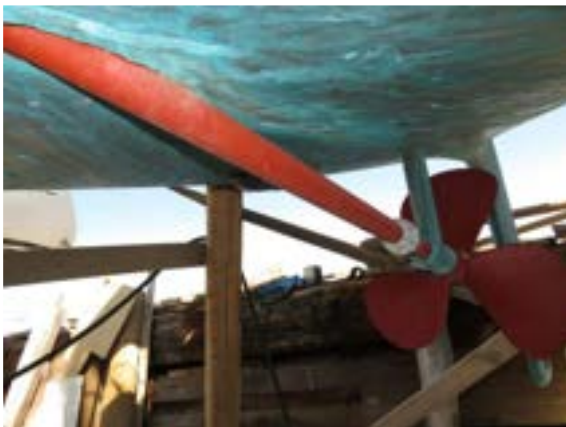
Shaft without pitting. P-bracket secure and without wastage. No excessive play at cutlass bearing. Propeller blades without damage or corrosion.

Stern gear

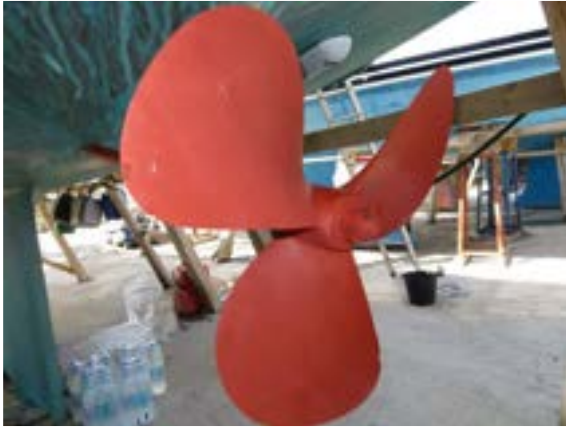
Propeller without damages to the blades

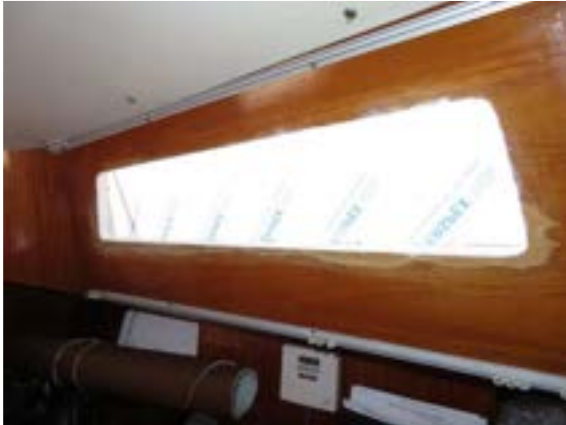
Side windows renewed

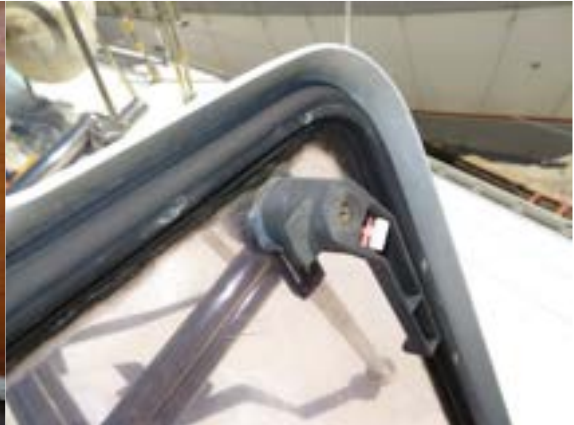
Hatch windows secure and plexiglass without damage. Seals were secure. Exposed sealant had sun deteriorated. Side window plexiglass was renewed.

Hatch window seals not deteriorated

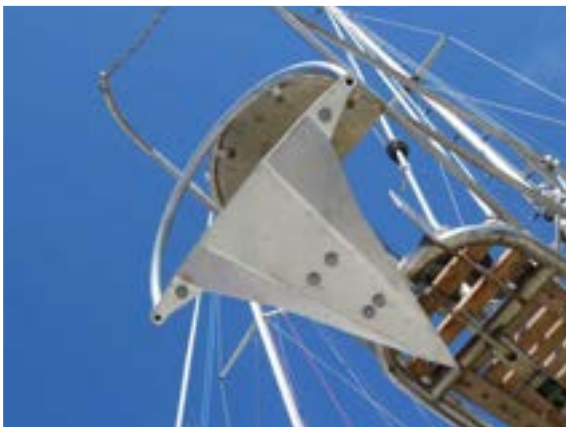
New anchor

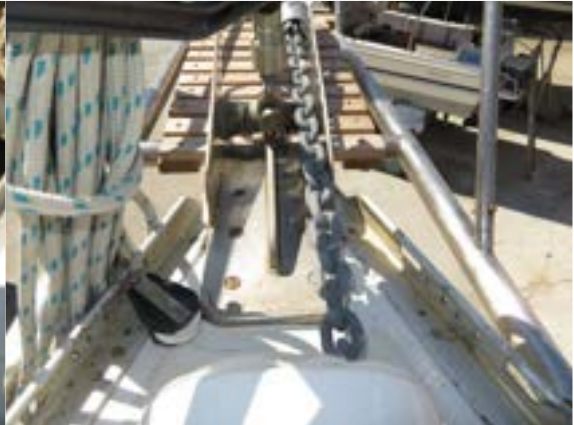
Anchor roller without damages

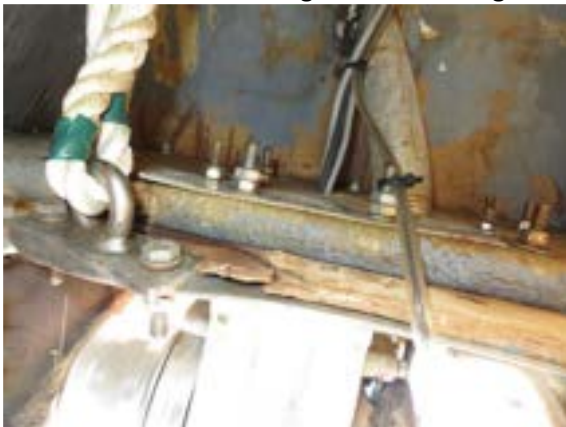
Anchor windlass securing bolts not corroded

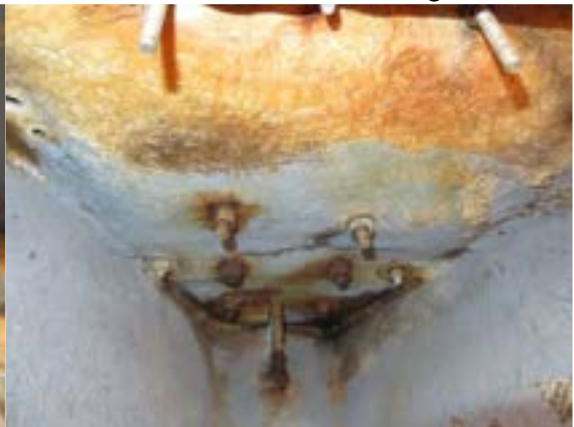
Anchor roller plate bolts are with corrosion and it would be prudent to draw one for inspection.

Anchor roller plate bolts corroded.

*Recommendation : Anchor roller plate bolts are with corrosion and it would be prudent to draw one for inspection.*

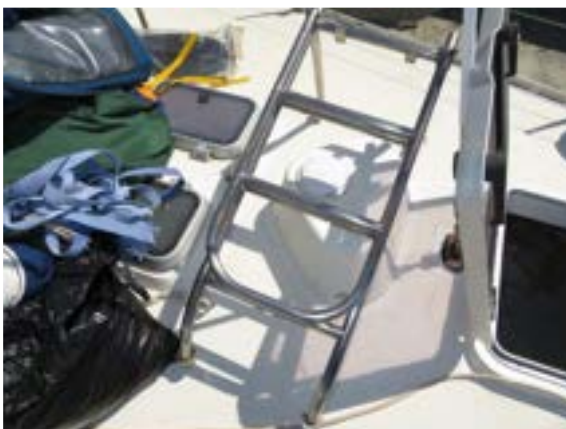
Stainless boarding ladder suitable for recovery of man overboard found without damages.

Boarding ladder

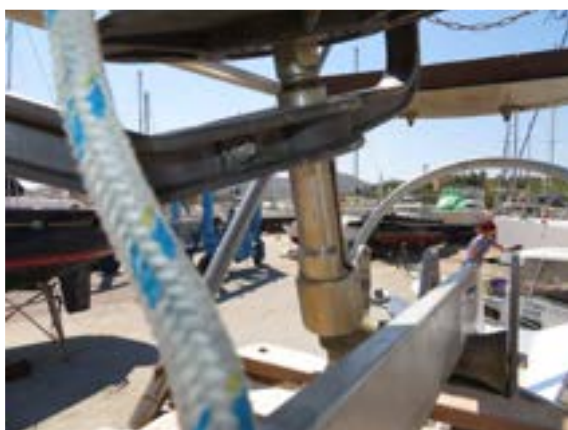
Foresail furler secure, drum without damages and with free movement. Looking up there is distortion to the foil but it is still of use. Staysail furler also secure and drum with free movement.

Foresail furler secure

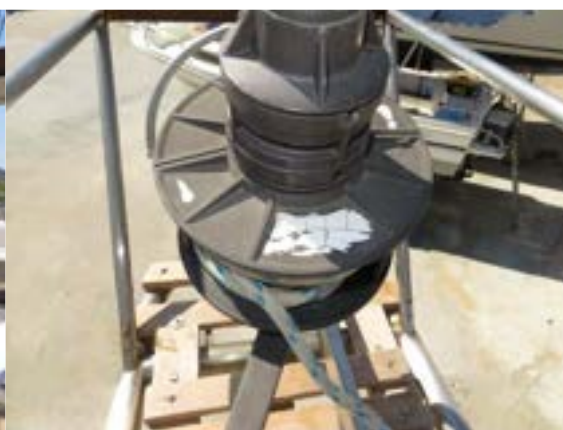
Drum without damages

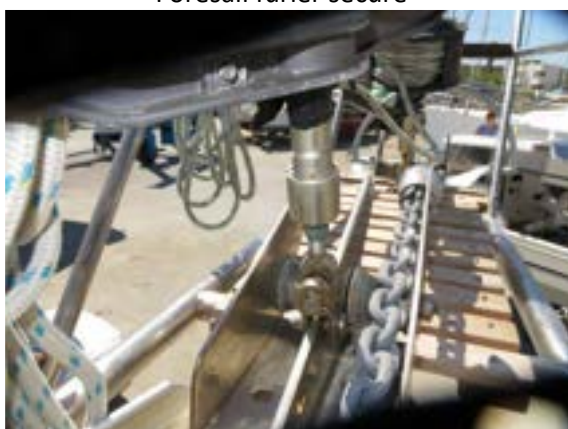
Staysail furler secure

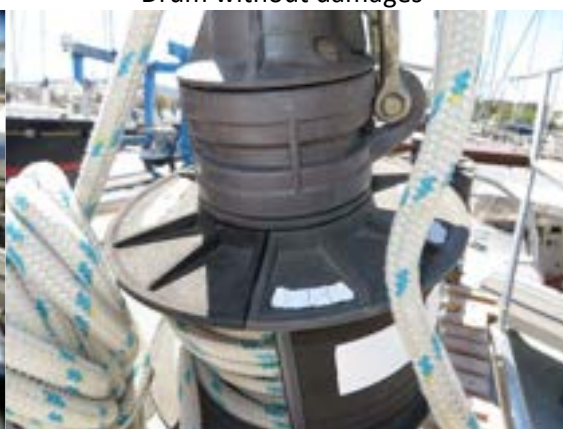
Drum without damages

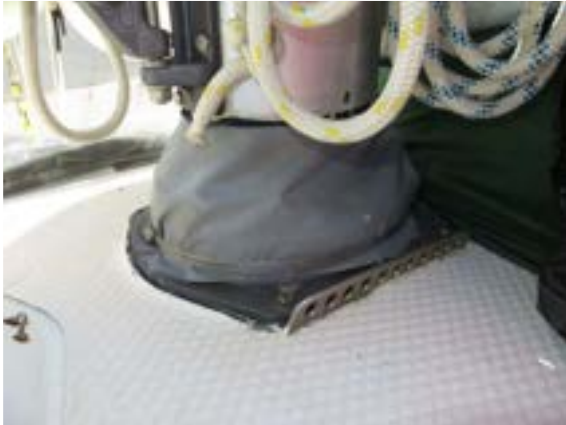
Mast boot without deterioration

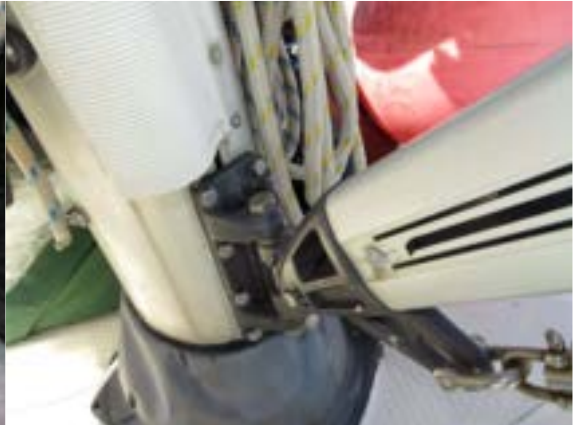
Boom vang secure

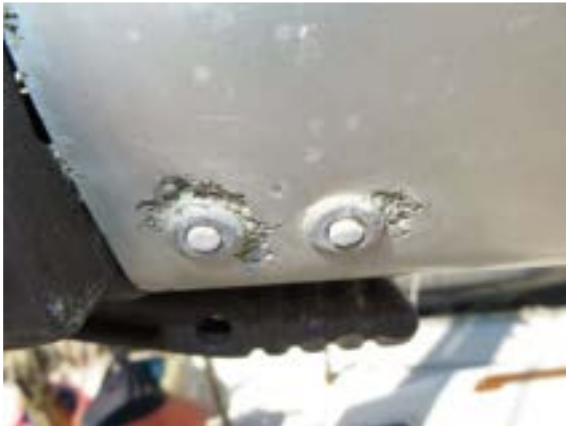
Minor galvanic corrosion at bimetallic interface of aluminium and stainless

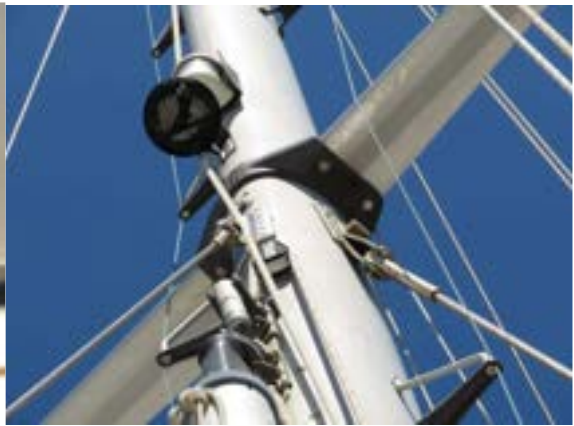
Spreaders secure

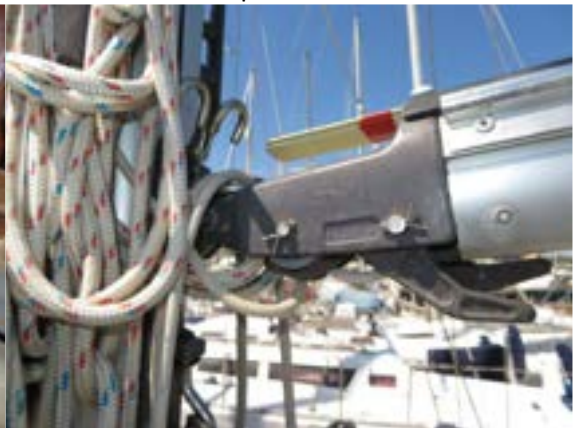
Mizzen boom gooseneck without fracture

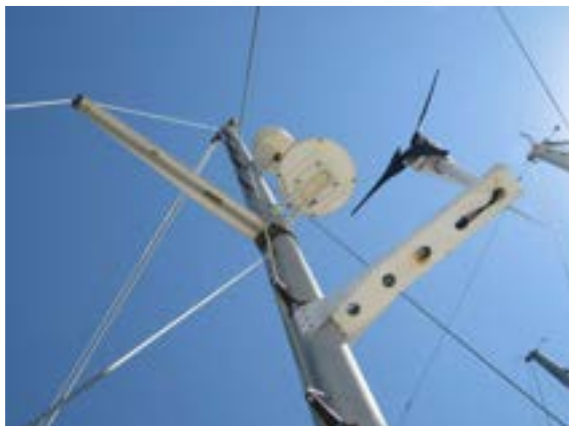
Spreaders secure

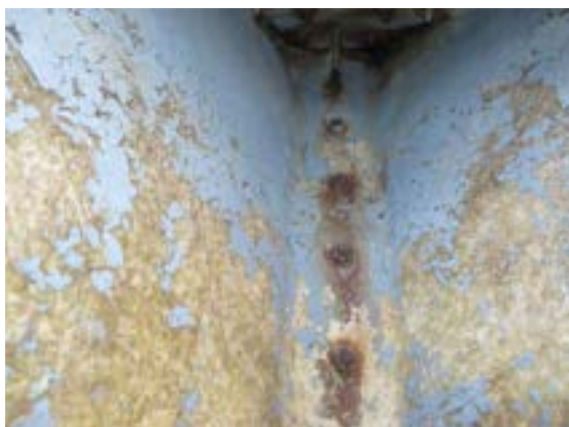
The stemhead fitting bolts are corroded. Draw one for inspection and consider replacement.

Stemhead fitting bolts corroded

*Recommendation : The stemhead fitting bolts are corroded. Draw one for inspection and consider replacement.*

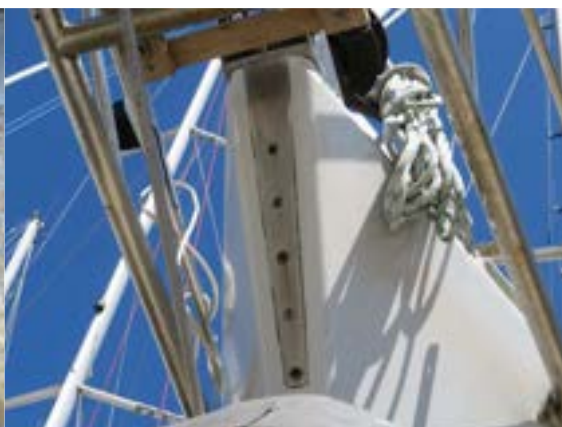
Exterior side no corrosion staining

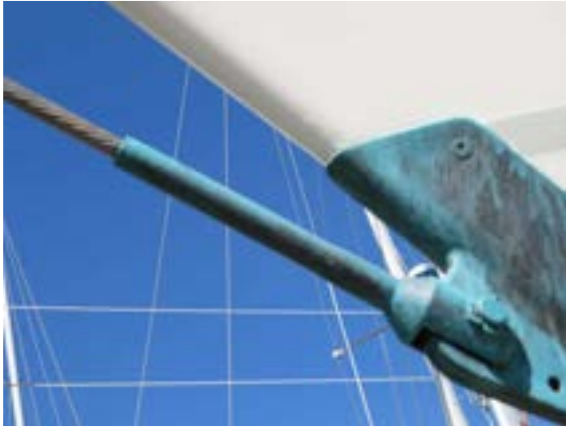
Bobstay secure

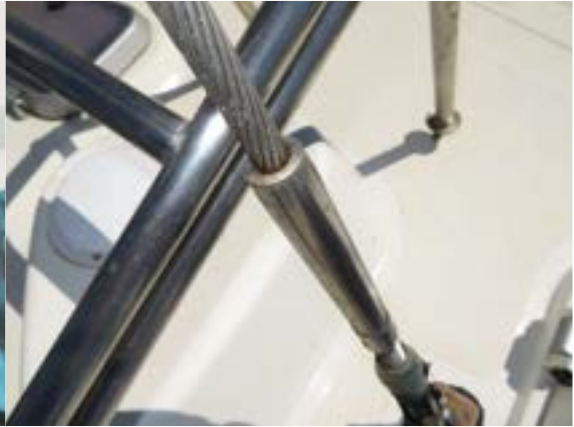
No corrosion at entry to swage terminals

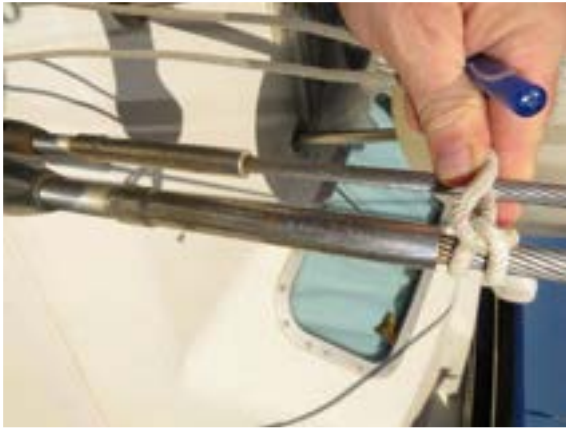
Swage terminals straight

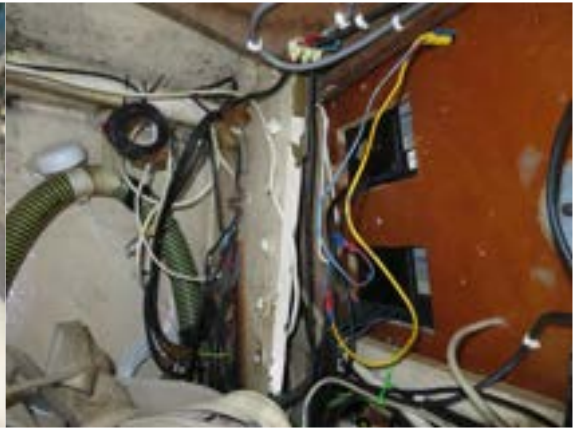
No corrosion staining to exposed chainplate bolts

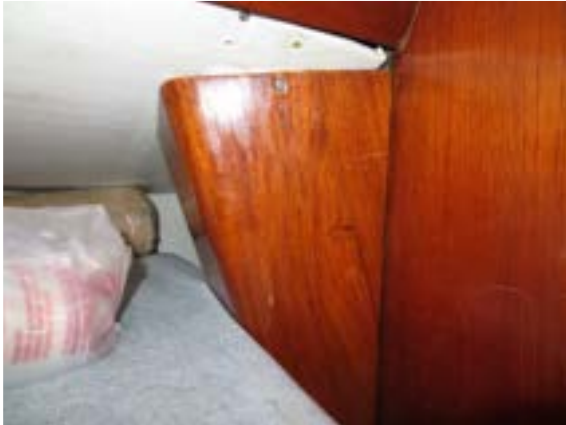
The shrouds chainplates are through deck attached to laminated in structure. The ones without lining were without corrosion to the bolts. The ones with lining not inspected but said to be in good condition.

Shroud chainplate behind lining

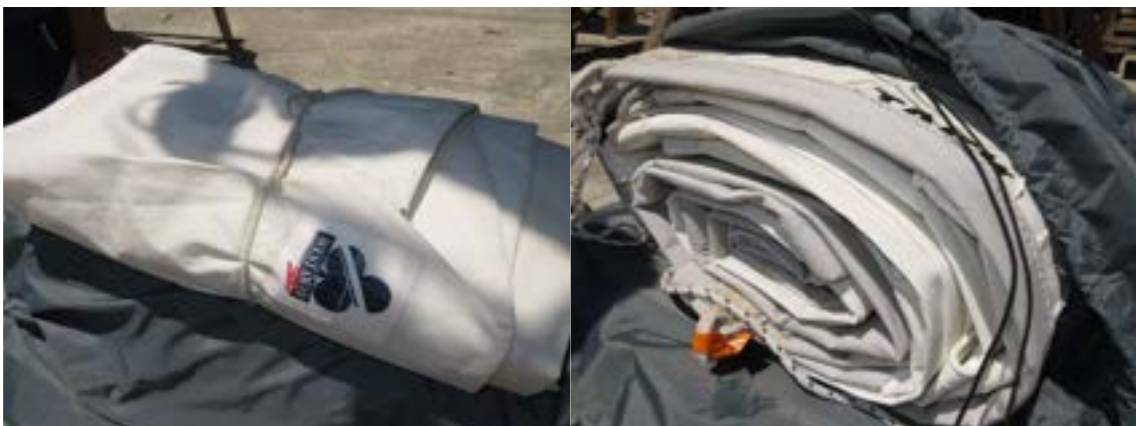
Sails were in satisfactory condition of 2007 and the yankee is new.

Sails in satisfactory condition

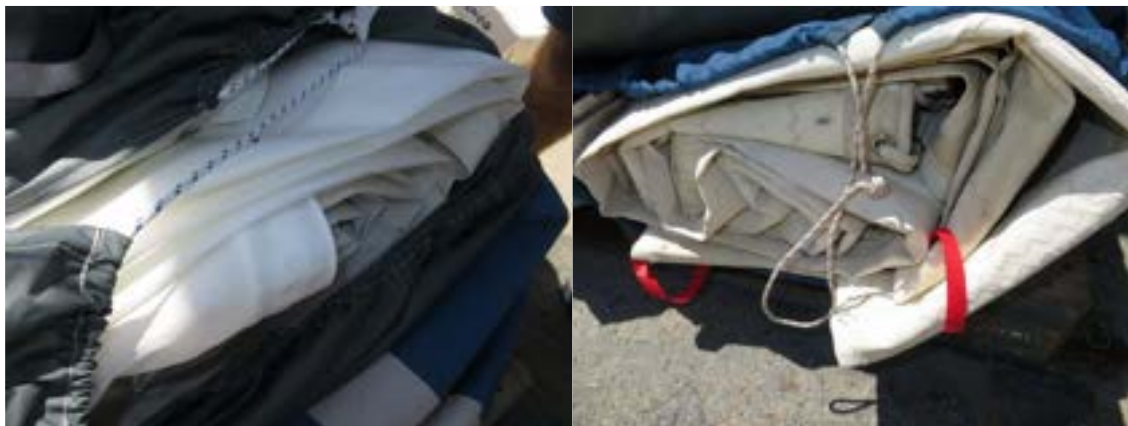
New sail

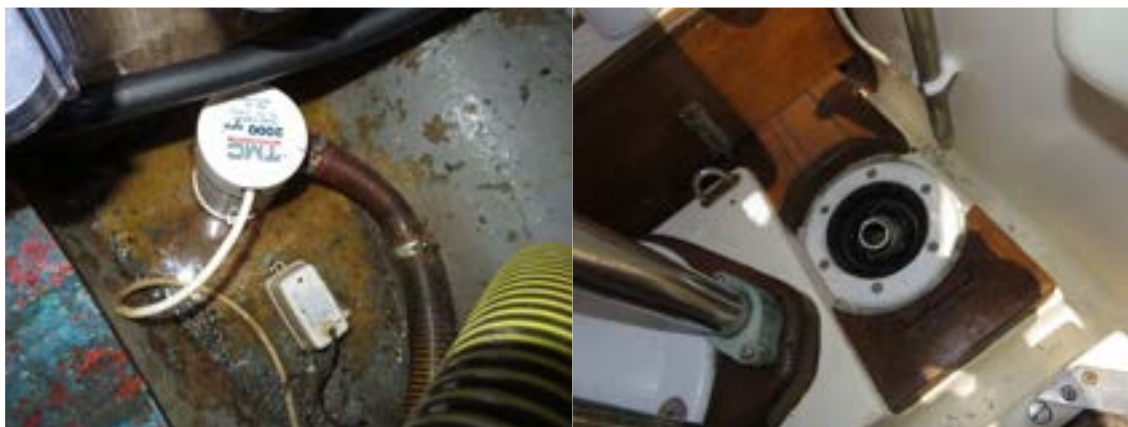
Automatic submersible pump in the keel sump. Manual pump also provided which was working but was with some sun deterioration. Both checked working. Bilge pumping arrangements satisfactory.

Submersible pump

Manual pump

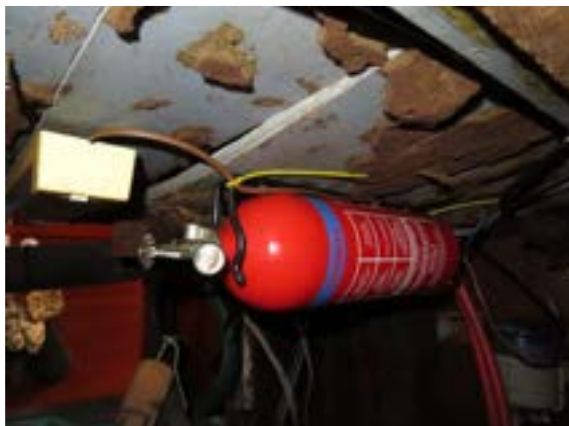
Portable extinguishers were not with recent servicing and were only 1Kg. type. Externally without corrosion. Engine compartment is protected with two automatic dry powder extinguishers. Fire blanket was provided.

Engine room fixed firefighting installation

*Recommendation : Service the fire extinguishers. Provide new portable extinguishers. Minimum total portable extinguishers 1 x 3Kg, 1 x 6Kg or equivalent smaller sizes.*

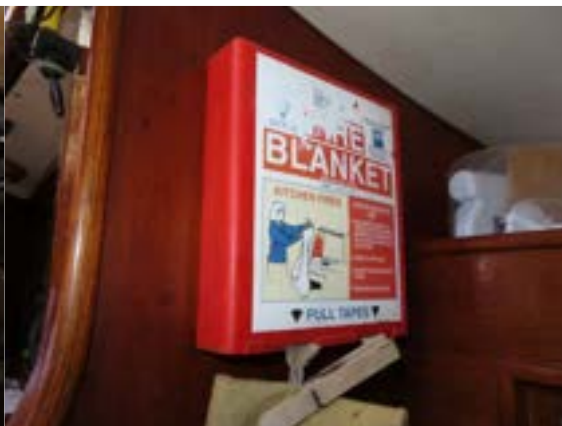
Fire blanket

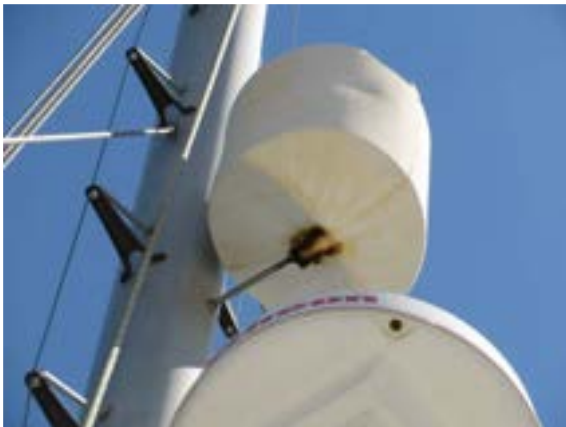
Radar reflector provided

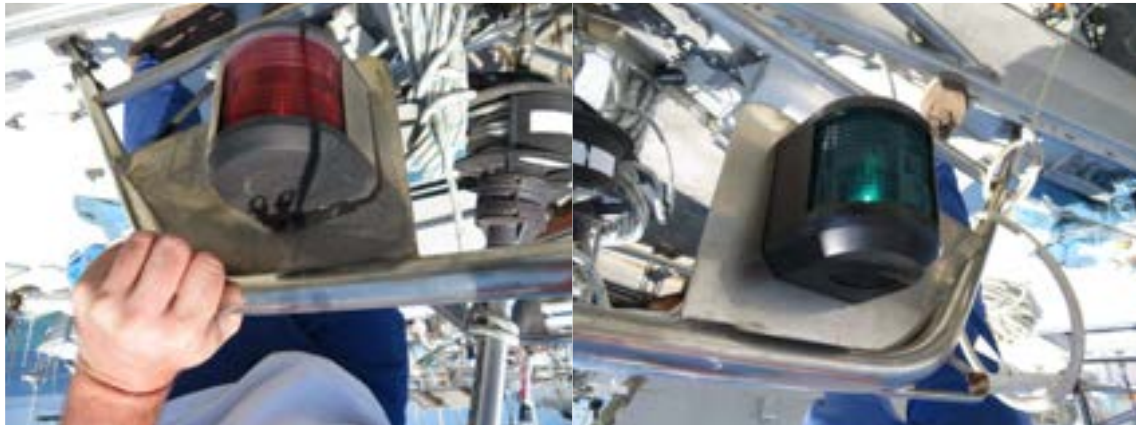
Navigation lights checked working. Anchor light not possible to see.

Side lights working

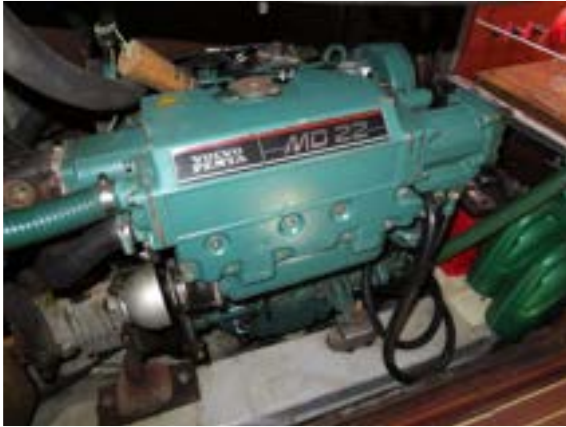
Engine with coatings intact

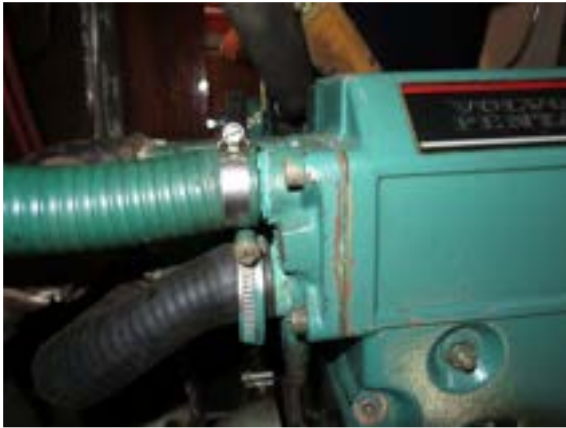
No leaks from heat exchanger

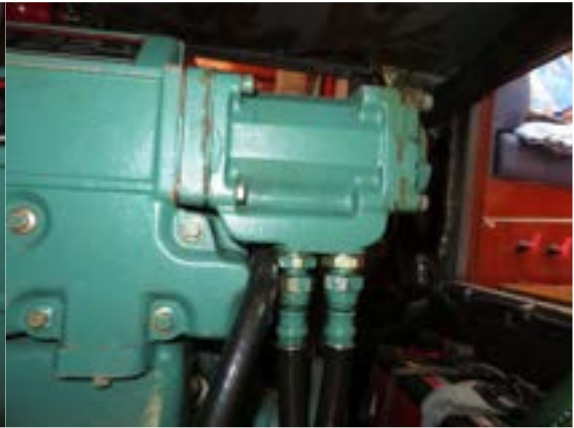
Other side also good

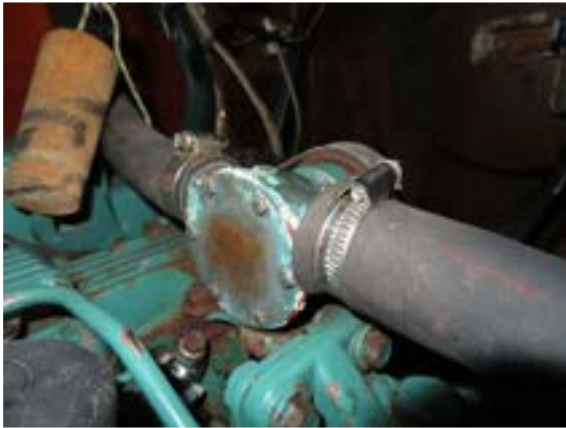
Impeller minor leaks only

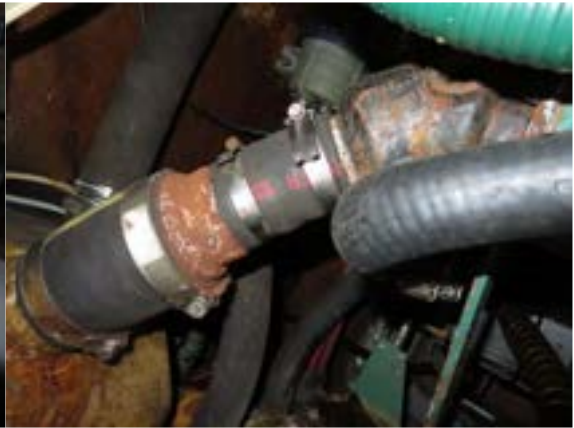
Exhaust intermediate connector  
corroded but no wastage

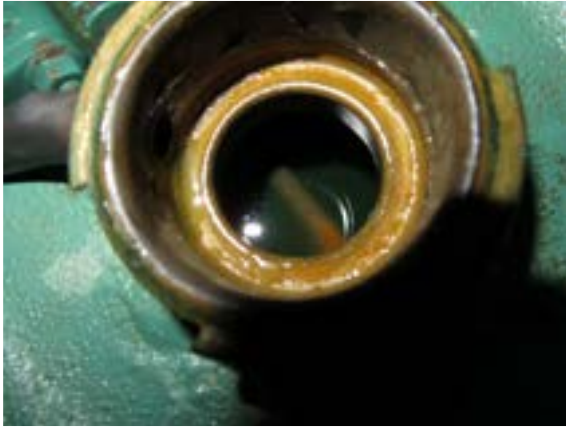
Coolant normal

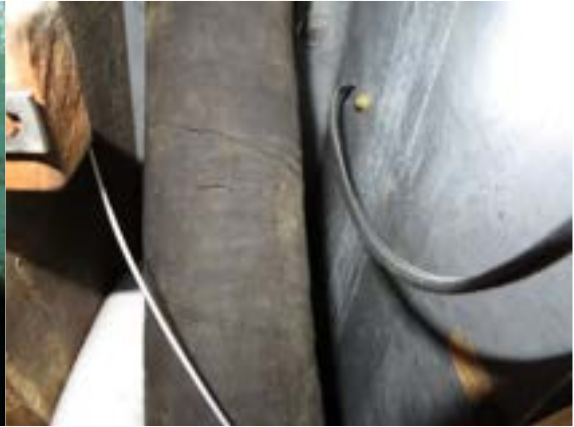
Engine exhaust hose is with cracks and requires replacement.

Exhaust hose with cracks

*Recommendation : Engine exhaust hose is with cracks and requires replacement.*

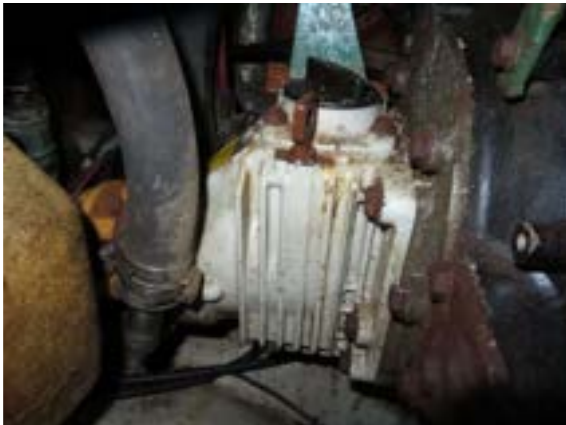
Reverse gear with coatings intact and no leaks of oil.

Reverse gear

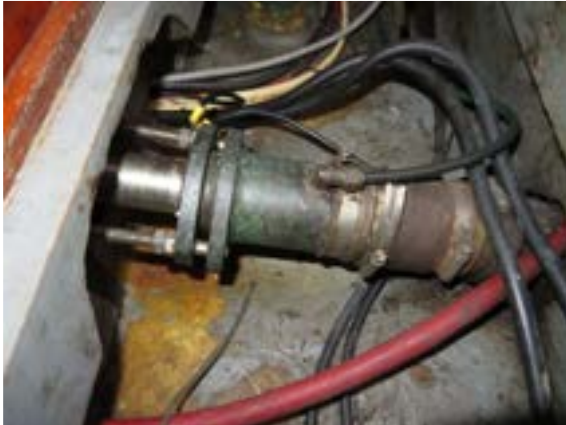
Traditional packing type shaft seal. Without corrosion. No sign of leaks. Hose clips not corroded. Gland material not deteriorated.

Shaft seal

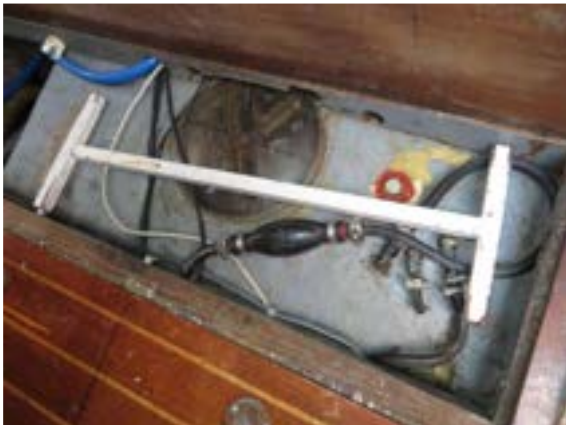
Fiberglass fuel tank. Externally intact. No leaks from connections. Fuel lines without deterioration. No leaks at primary filters. Some corrosion to connections at primary filters but no wastage. Shut off valve not provided at the tank.

Fuel tank externally intact

*Recommendation : Shut off valves to be provided at fuel tank on delivery lines.*

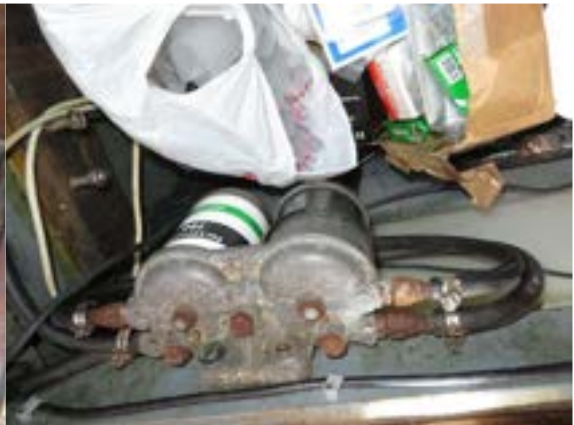
No leaks at filters

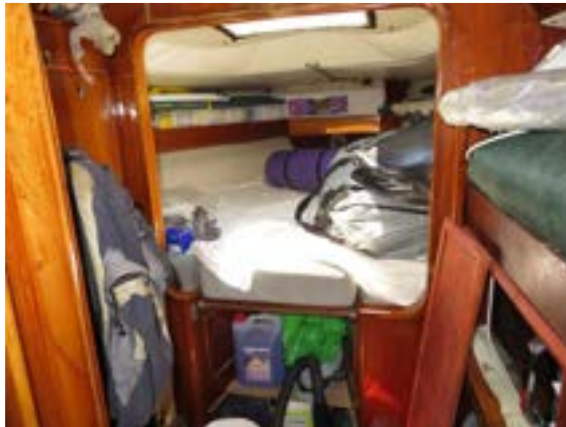
Forward cabin

Accommodation was in general good order. No serious wet damage or fungal rot found.

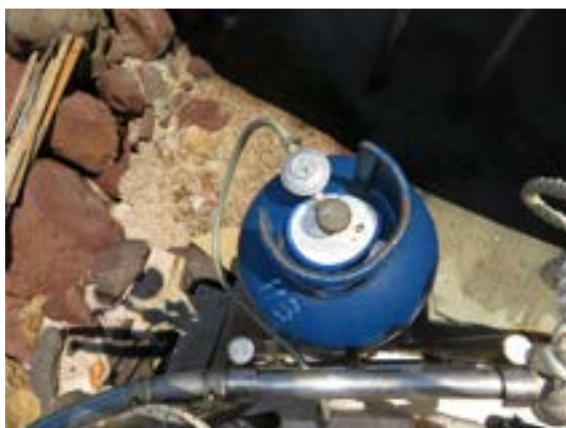
Gas cylinder is stowed on deck in the open. Electronic valve fitted. Manual shut off valve provided in the accommodation and this is behind linings so requires inspection.

Gas cylinder stowed on deck

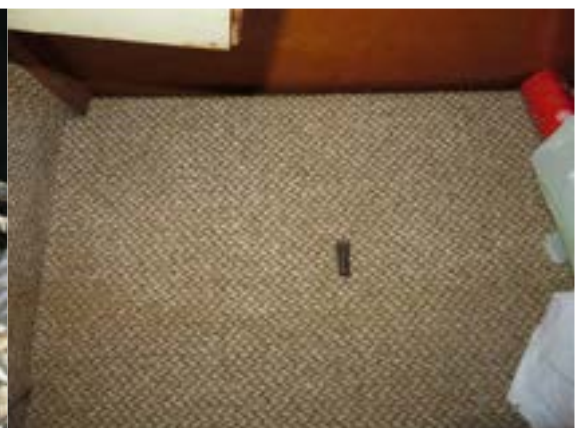
Hidden manual gas valve

*Recommendation : Remove linings to access the manual gas shut off in the accommodation to check for corrosion as it has never been inspected.*

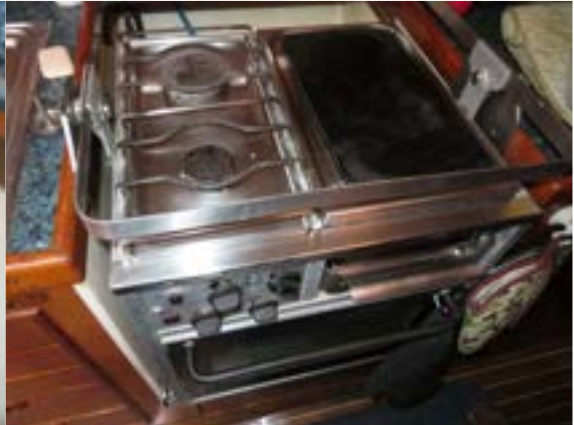
Gas cooker without corrosion

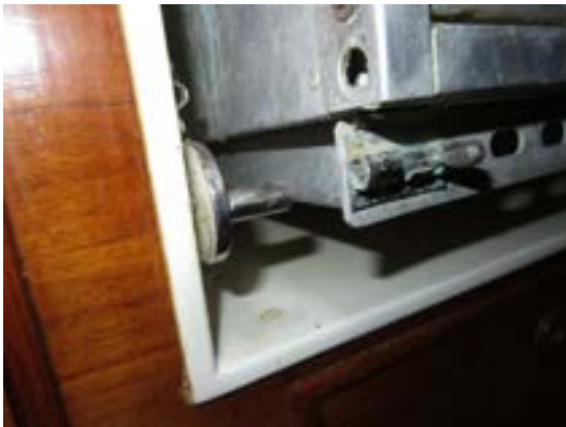
Cooker gimbal lock working

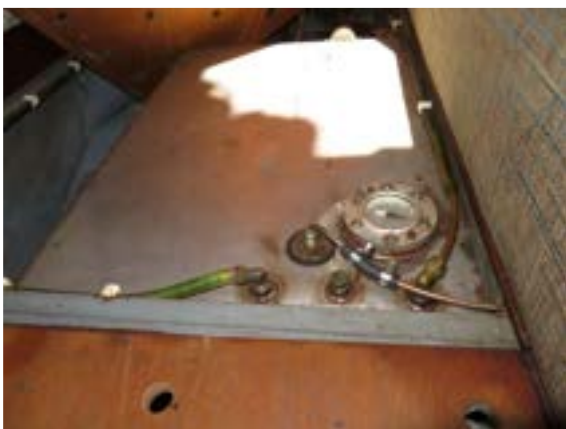
Stainless fresh water tanks externally intact. No sign of leak from fresh water pump.

Tank intact

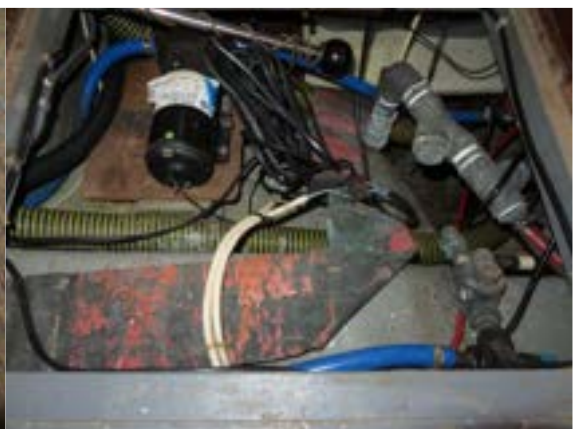
No sign of leak from pump

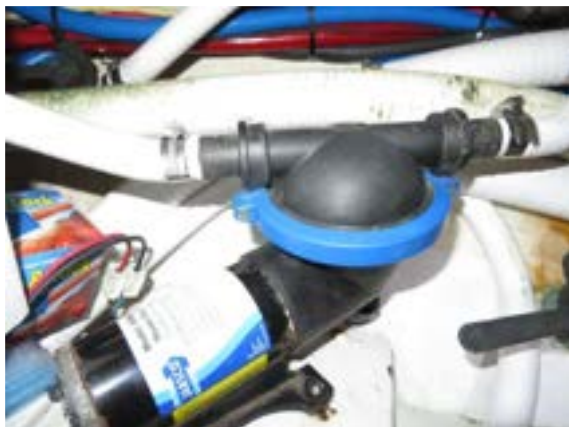
Shower drain pump no sign of leaks. System is directly overboard.

Shower drain pump

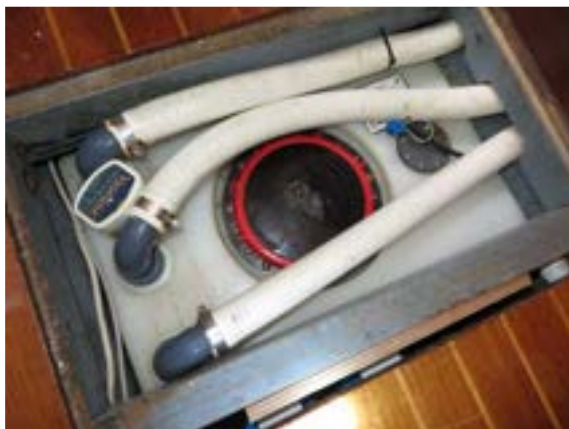
Manual toilets. No sign of leaks. Black water tank of plastic externally intact. Sanitary type hoses used and externally without deterioration.

Black water tank externally intact

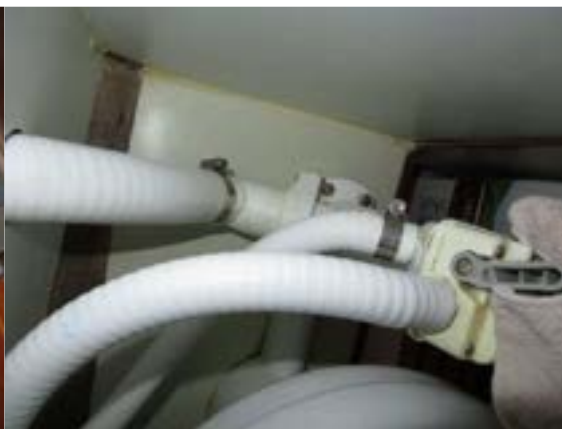
Manual pumps no leaks

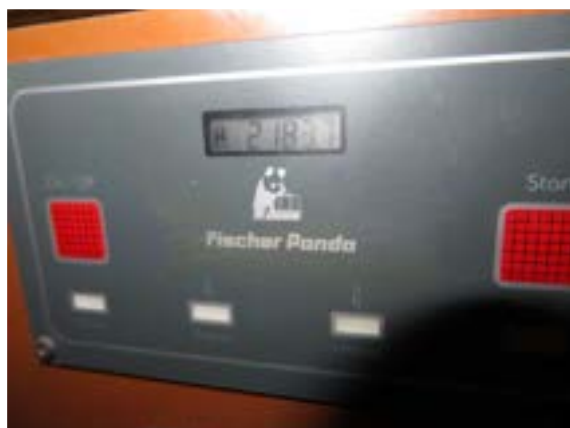
Fischer Panda generator hours 2183. Externally in satisfactory condition without leaks of oil or fuel. Exhaust mixing elbow is with previous insert welded as it was corroded through.

Generator hours 2183

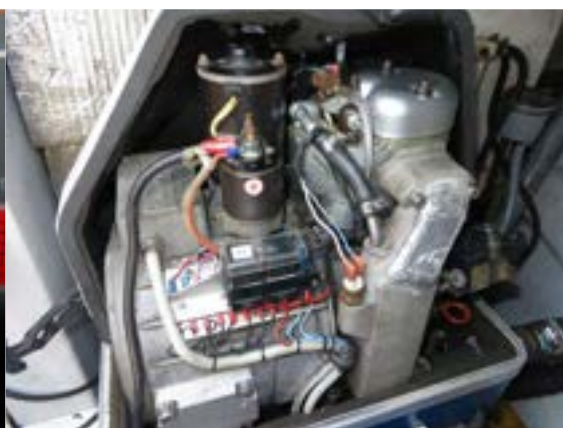
Generator without leaks

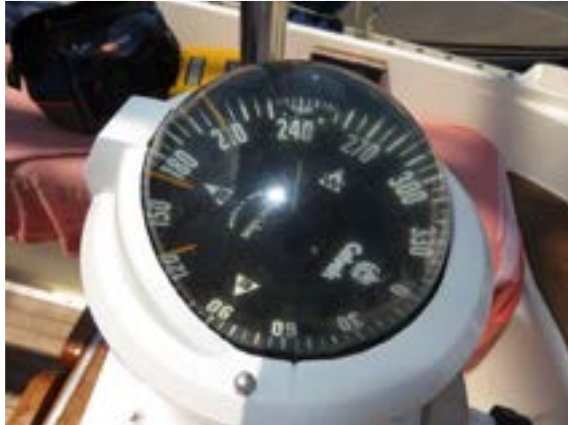
Magnetic compass with small bubble

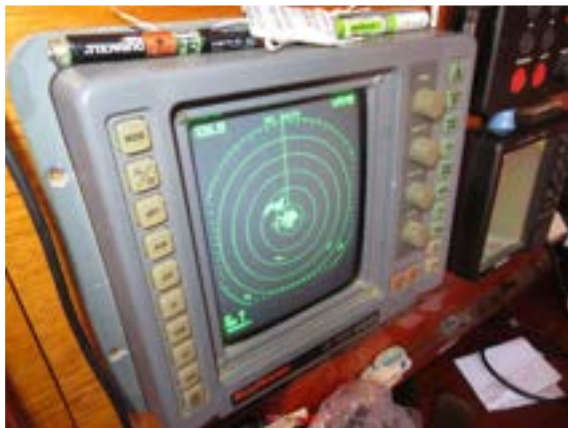
Radar working

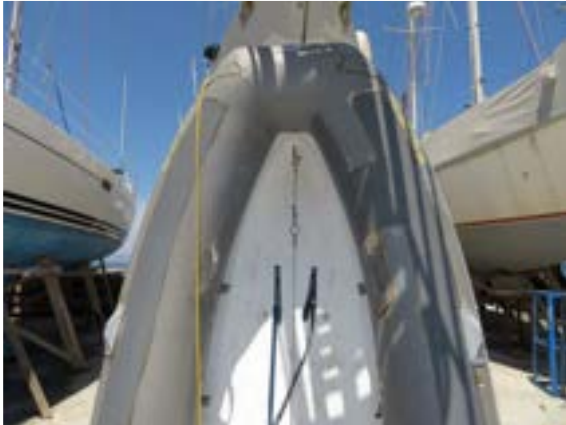
Outboard recently painted to a high standard. Externally intact. Propeller without damages. RIB Tender is old and with repairs but externally intact. New stainless davits of high quality are purchased and on board awaiting fitting.

Tender found fully inflated
