1974 East Coast 31 – "Crackerjack"

Purpose of Inspection: Pre-Purchase

Survey ID: 241121DB

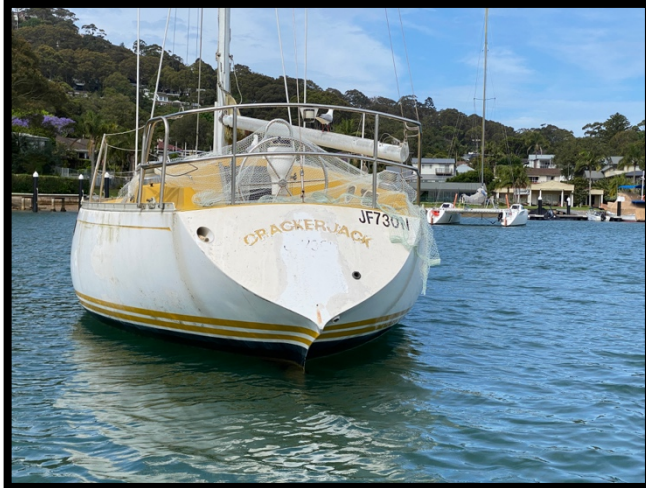
Hull

The white painted topsides show no signs of major repairs but need to be repainted. The black antifouling was water blasted while the boat was on the hardstand. There are signs of paint build-up and some osmosis blisters in the antifouling which is typical. These underwater areas may need some local repairs to any osmosis blisters or flaking paint at each annual haulout. The topsides will look a lot better when they are repainted.

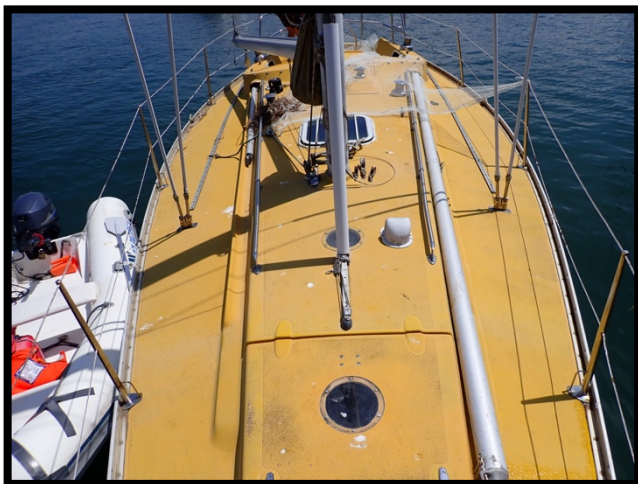
Deck

The bright yellow GRP deck appears to be in quite good condition with no signs of major repairs or damage. There are some small areas of crazing and flexing around a few of the deck fittings. This is to be expected and does not affect structural integrity.

Understandably, the deck layout is quite old fashioned with a lot of winches and cleats and most of the halyards and control lines are led back to the cockpit. The deck is glued to the hull and then bolted down through the alloy toe rail extrusion which is in quite good condition. There is a separate anchor locker at the bow.

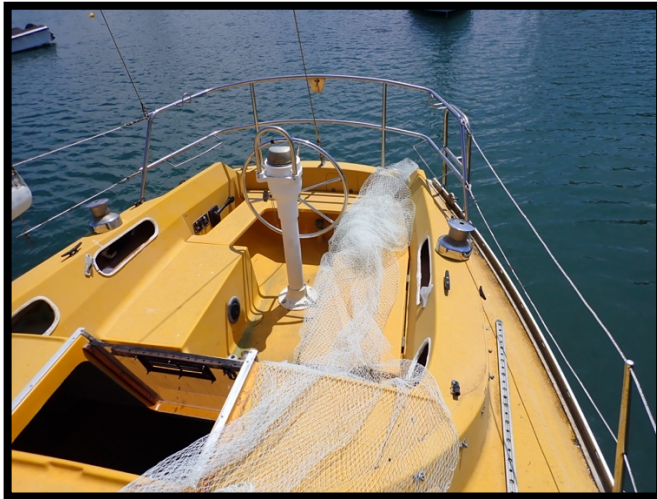
Cockpit

This cockpit has good seating with some open lockers for lines etc. There is non-skid on the seat tops and floors for extra safety.

The mainsheet track is at the front of the cockpit and a good-sized cockpit locker on the PORT side. The removable helm seat moulding can be removed to access the small gas locker at the transom. The steering pedestal is quite solid, and an emergency tiller can be fitted under the helm seat. The engine control panel is on the STBD side of the cockpit next to the helm and a boarding ladder is fitted to the aft rail on the PORT side.

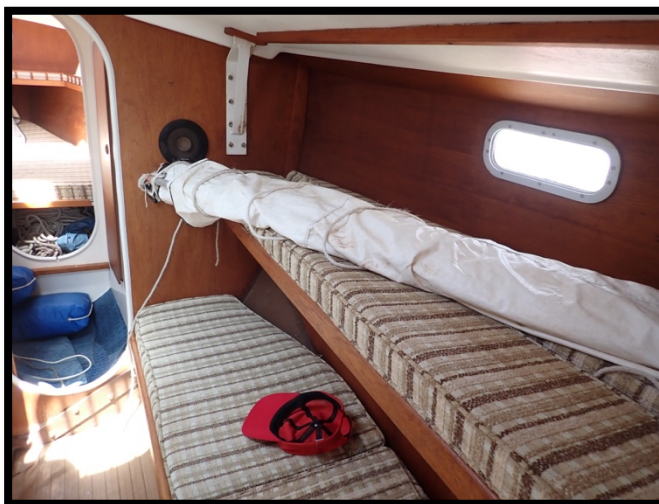
Bulkheads and floor structure

The bulkheads appear to be well constructed and show no cracking or movement. The floor support frames where visible are well built and the keel nuts are easily accessed in the bilge and limber (drainage) holes are adequate in most areas. There is a steel, load carrying frame structure which is well bonded into the hull.

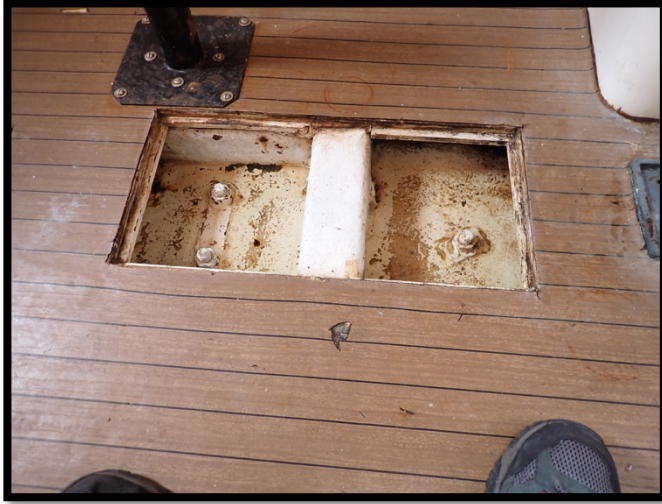
Bilges

Most bilge areas are accessible and although a bit dirty and wet in some areas, they appeared to be undamaged. There is a manual bilge pump which feeds from the main bilge. The speed and depth transducer is not working but is easily accessible.

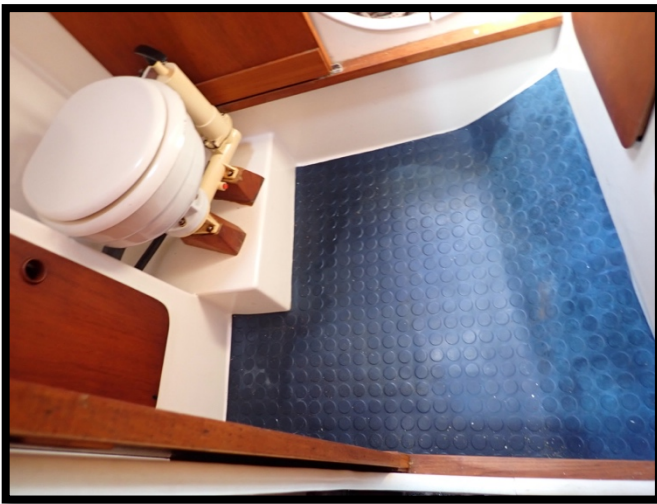
Floorboards etc.

The interior floor is covered with plywood veneer boards which are covered with vinyl flooring in some areas and there are some access boards to the important components such as keel nuts etc. The saloon area plywood floorboards have been water damaged over the years and can be replaced in the future.

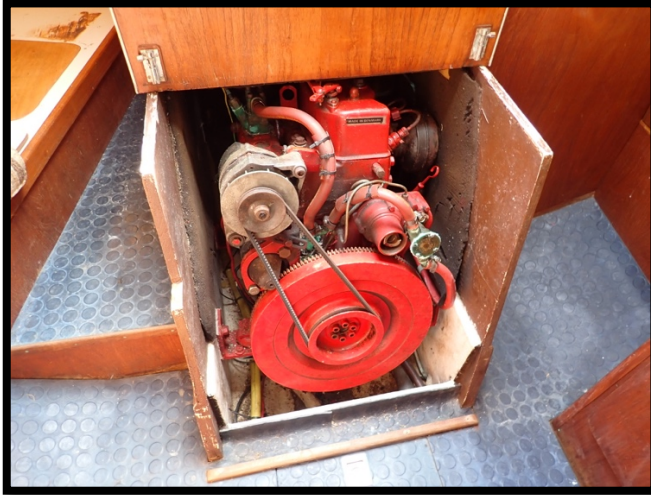
Engine bay

The engine bay is accessed from the main cabin by lifting the stairs and a lid panel away. There is also access from the quarterberth to the side of the motor and all the components behind the motor. There is some old insulation fitted in the engine space.

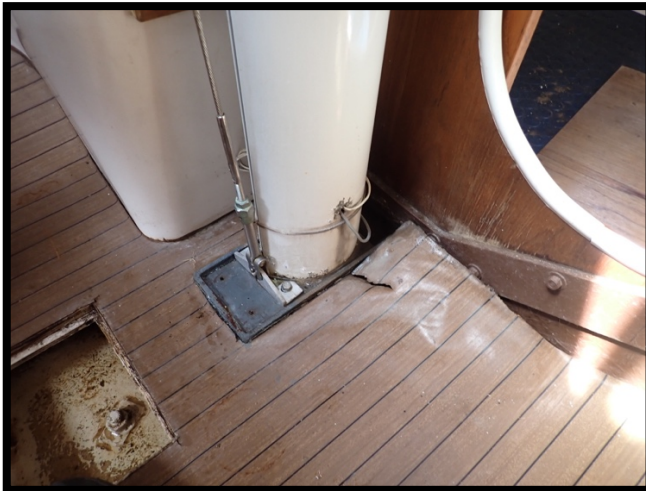
Mast step and deck collar

Appeared sound both above and below deck. The mast step area should be cleaned up and any corrosion removed or treated and the mast drain hole cleared.

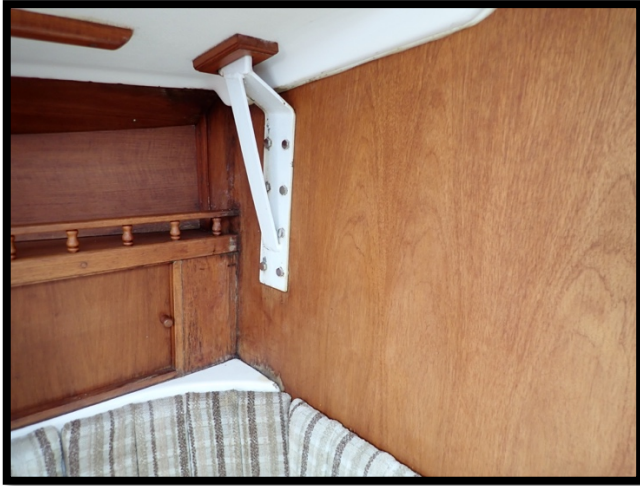
Chainplates

The plates and mountings appeared very solid and are tied to the mast step support structure. There is a metal ring frame support structure at the mast and chainplates.

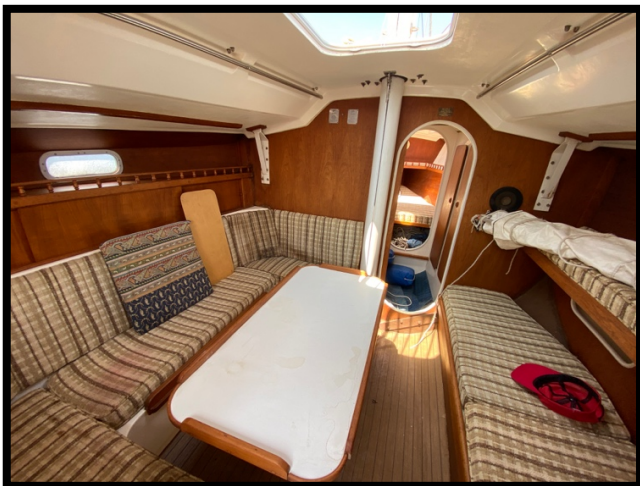
Internal Furniture

The original interior appears to be well designed, constructed and fitted and is very solid and functional. There appears to be very little damage to any of the timberwork. Any areas of worn or water-stained timberwork can be quite easily refinished or painted. The upholstery looks original but is still in quite good condition.

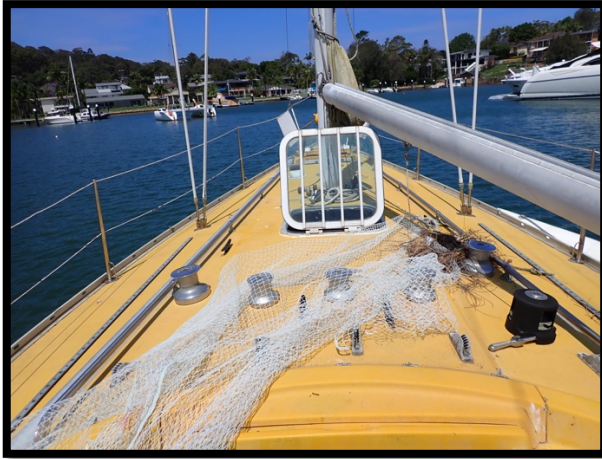
Windows and hatches

The foredeck opening hatch & cabin top hatch are original and well fitted and doesn't appear to leak. The 2 windows each side in the main hull appear are due to be replaced. An opening Portlight can be fitted above the quarterberth to improve ventilation. The Foredeck and main companionway hatch are well designed and built.

- Water test all hatches, windows and deck hardware – reseal or replace as discussed
- Fit a Boom bag with Lazy Jacks
- Fit a basic genoa furler
- Fit a simple Solar charging system
- Fit basic sailing instruments & a Chartplotter
- Repaint the hull topsides
- Fit a Bimini and or Dodger to protect the cockpit and interior

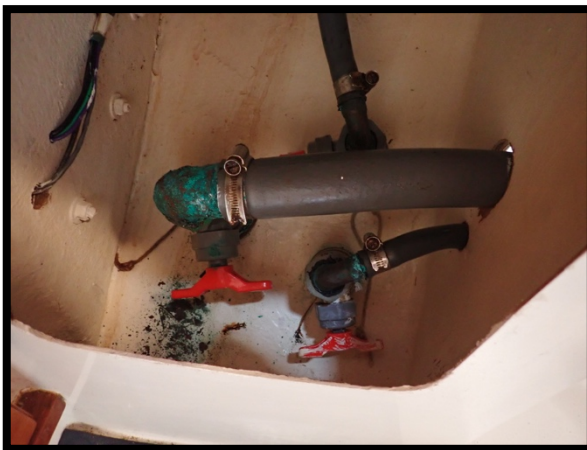
Seacocks and fittings

All valves and seacocks appeared to be in reasonable condition and turned on and off. Some are starting to de zincify which is very normal and should be monitored as part of the ongoing service and maintenance program. Given the age of the vessel and lack of use it would be good to replace all the valves.

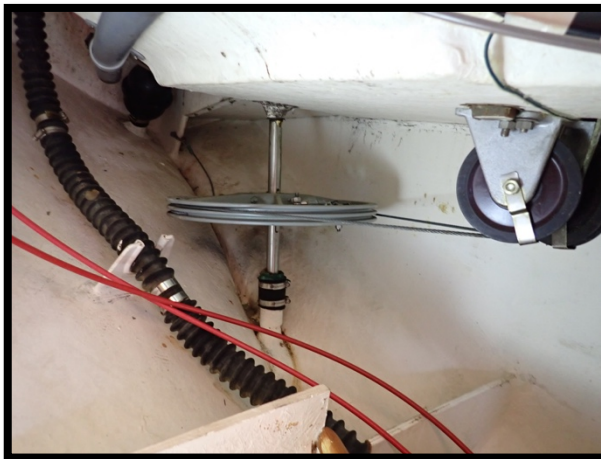
Steering system

Type	Wheel
Components	Components are in good condition

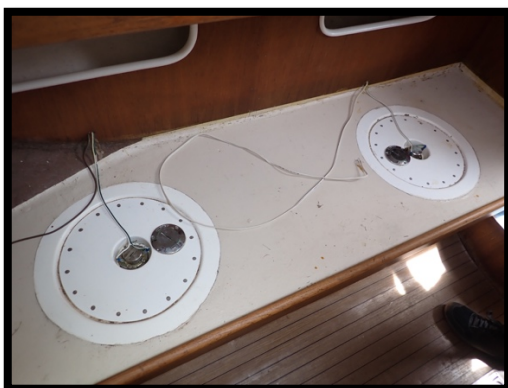
Tanks – Fuel, water & LPG

Fuel	1 x Built in under PORT settee
Fresh Water	2 x Built in under STBD settee
Grey waste	drains directly overboard or into bilge
Black waste	drains overboard
LPG	gas bottle in cockpit locker

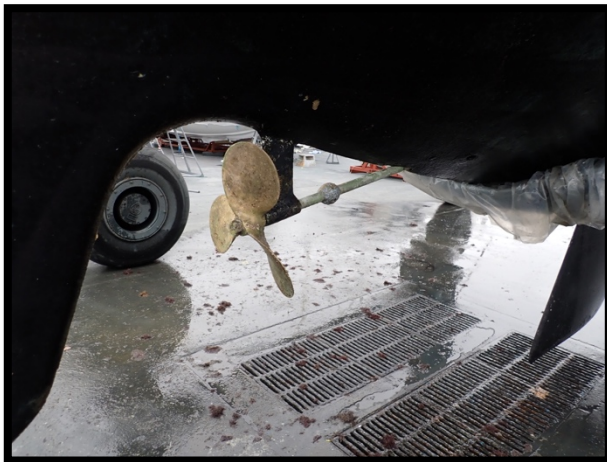
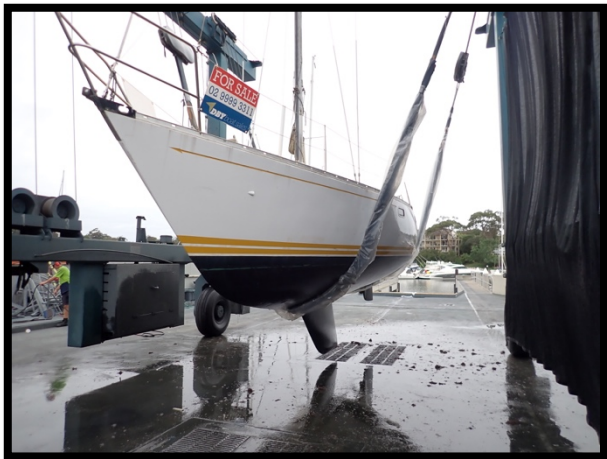
Haul out - Underwater

Topsides	painted hull is generally in good condition and no signs of major damage – however needs repainting
Keel	keel has some areas of flaking and blistering that should be repaired at next haulout to stop them getting bigger
Rudder	rudder appears sound and has some blisters that should be repaired at haulout
Antifouling	suggest redoing
Blistering/osmosis	some current minor blistering and evidence of old ones that have been repaired – redo annually
Prop	3 blade fixed – good condition
Propshaft	shaft OK and shaft bearing feels firm
Anode/s	approx. 75% intact
Skin fittings – intakes etc.	all appear OK and in good condition
Transducers	secure but not in use

- Replace antifouling
- Repair any osmosis blisters or areas of flaking
- Shipwright to check rudder bearing and shaft bearing
- Check all skin fittings and valves – replace as required
- Check keel bolts
- Clean and polish topsides – repair any dings or scrapes

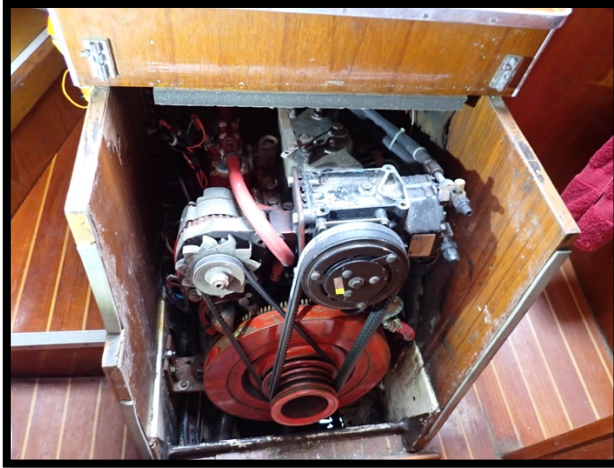
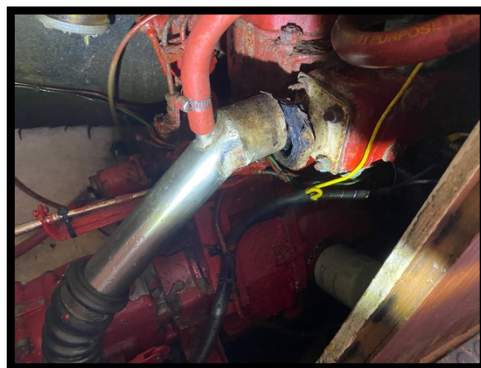
Make & Model	BUKH DV20
Power output	20hp
Serial number	???
Fuel type	Diesel
Engine hours	715 on gauge
Service history	???
Drive system	shaft drive 1" shaft
Exhaust system	OK
Fuel filters	OK
Throttle control	OK
Engine mounts	OK
Seawater Strainer	OK
Coolant hoses	Appeared OK – elbow needs repairs
Engine Oil & Coolant	Levels Ok
Alternator	condition appeared OK

- Exhaust elbow was cracked and came away on motoring test

- Mechanical – sort out exhaust elbow and test engine
- Mechanical – get mechanic to service and check engine
- General - Check all safety equipment and make sure of service expiry compliance
- General – Clean, Dry and check all lockers and bilges to remove any accumulated mold, dirt and debris
- General – confirm fuel and water tank capacity and check if gauges will work
- General – check/refasten jib tack fitting at bow
- General – service all winches and check/service all deck hardware
- Electrics – Fit new house battery and engine battery
- Electric – check operation original switches and gauges
- Rigging – replace standing and running rigging as discussed – including lifelines
- Sails – check all sails to be included

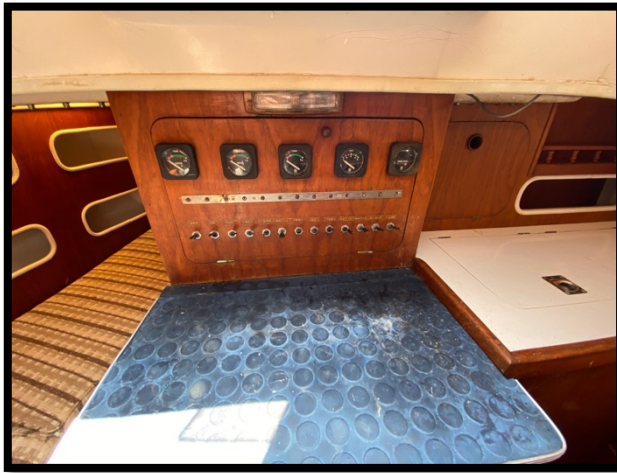
Electrical systems

There is only minimal electrics & electronics onboard and it all looks original. The house battery was missing and a battery booster was needed to start the vessel.

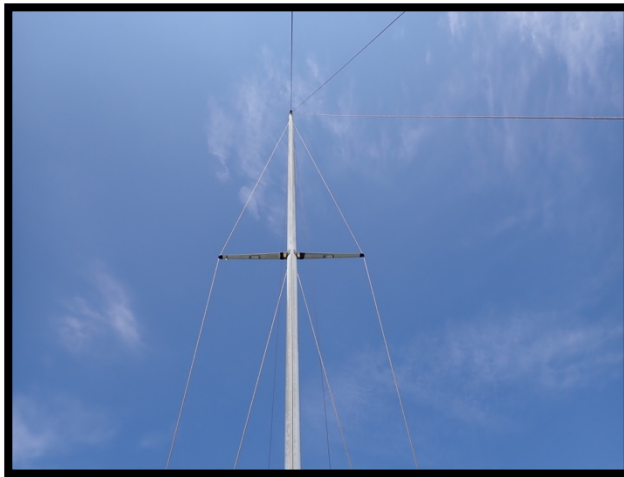
Spars & Rigging

Rig configuration	Sloop – keel stepped - 1 spreader masthead
Spar builder	Alspar
Spar construction material	alloy - mast, boom & spinnaker pole
Overall Condition	reasonable condition

Rigging age	Unknown
Standing rigging material	SS 1 x19 wire
Standing rigging condition	no damage observed from deck
Chainplates	SS deck plates down through deck
Mast base /under deck	appears sound
Sail handling systems	Hood twin foil
