## BLUEWATER MARINE SURVEYORS ABN 61 172 043 569

### Survey Report

**Vessel:** "Dory"

**Date of Survey:** 3 November 2021

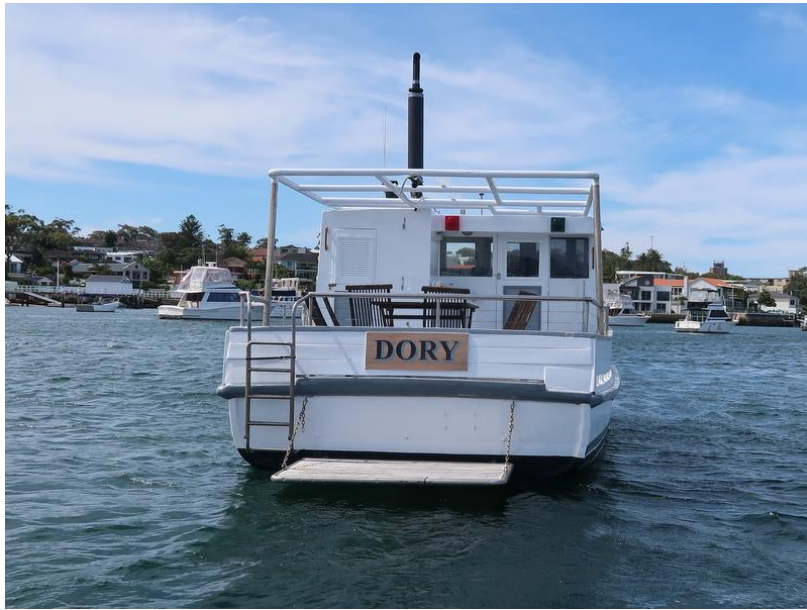
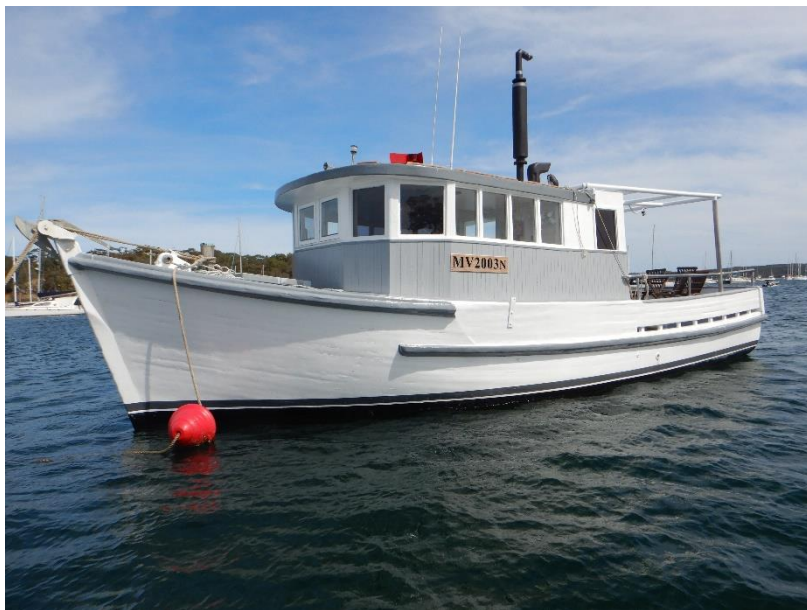
The topsides have been recently painted, the surface is unfair and shows plank movement.

There is evidence of movement in the bulwark planking.

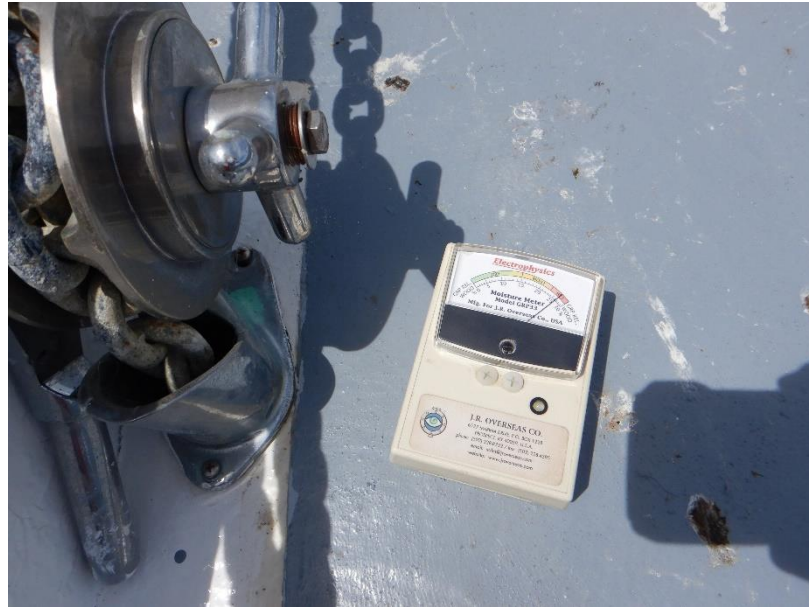
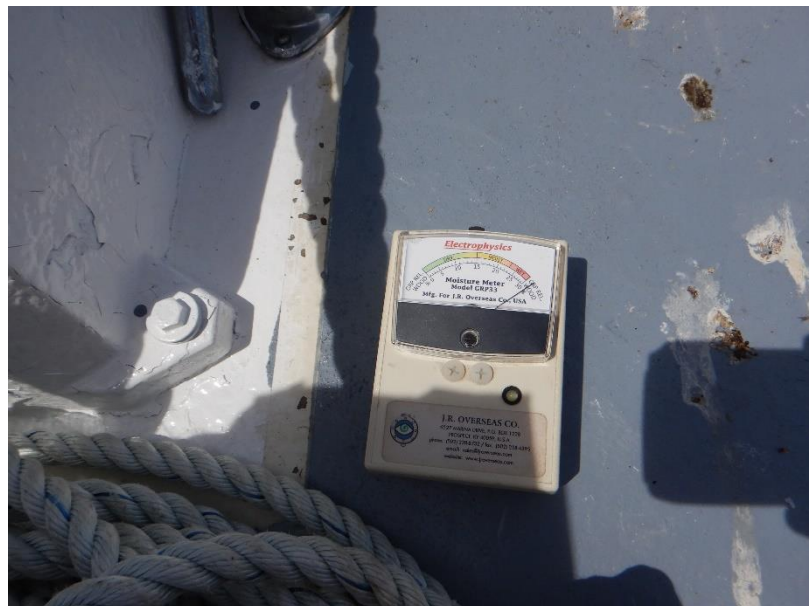
Fore Deck

The decks are sheaved and painted, possibly plywood over timber planking.

When percussion tested, they had multiple dull spots indicating delamination and/or deterioration.

When tested with a capacitance moisture meter showed high/excessive moisture. These readings were only taken at the time of inspection and are an indication only, more accurate readings should be taken at regular intervals over a period of time or invasive investigation would be necessary to determine the amount of deterioration that exists.

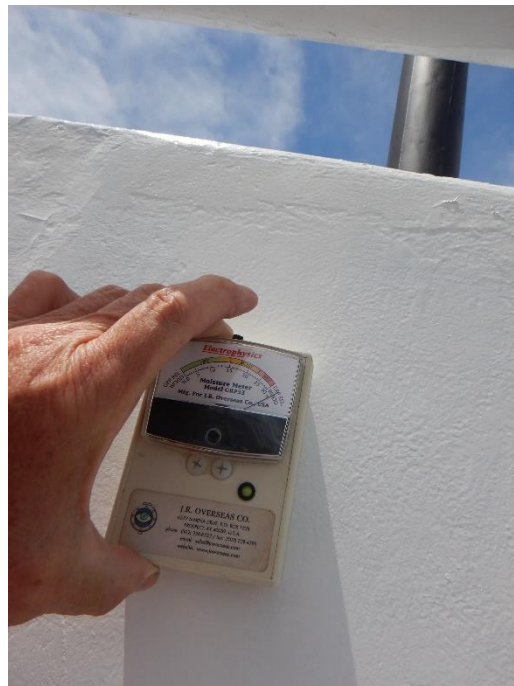
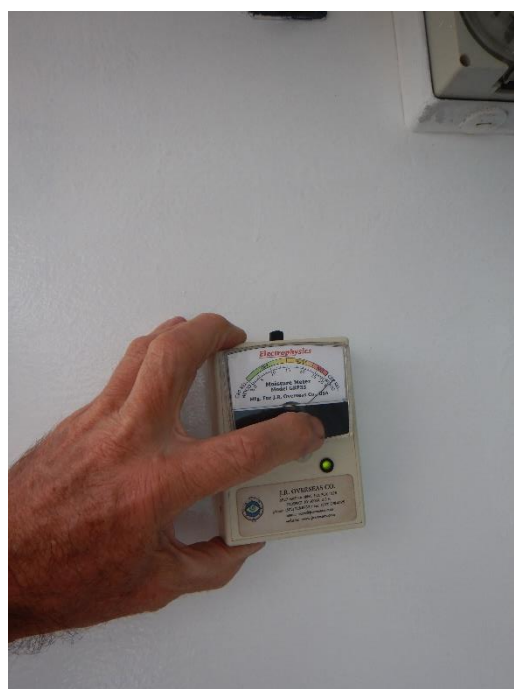
Contains a shower/head, outside sink and storage.

The sheaved plywood construction also when percussion tested, had multiple dull spots indicating delamination and/or deterioration.

When tested with a capacitance moisture meter showed high/excessive moisture. These readings were only taken at the time of inspection and are an indication only, more accurate readings should be taken at regular intervals over a period of time or invasive investigation would be necessary to determine the amount of deterioration that exists.

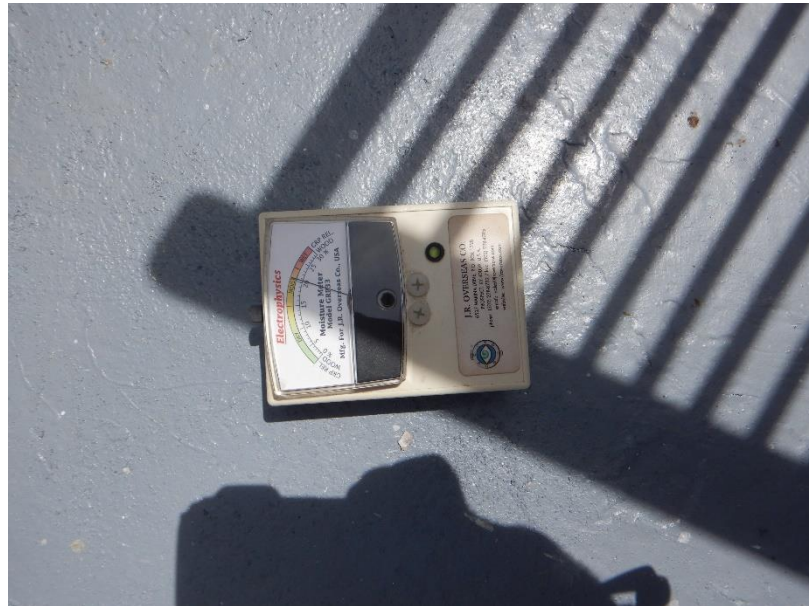
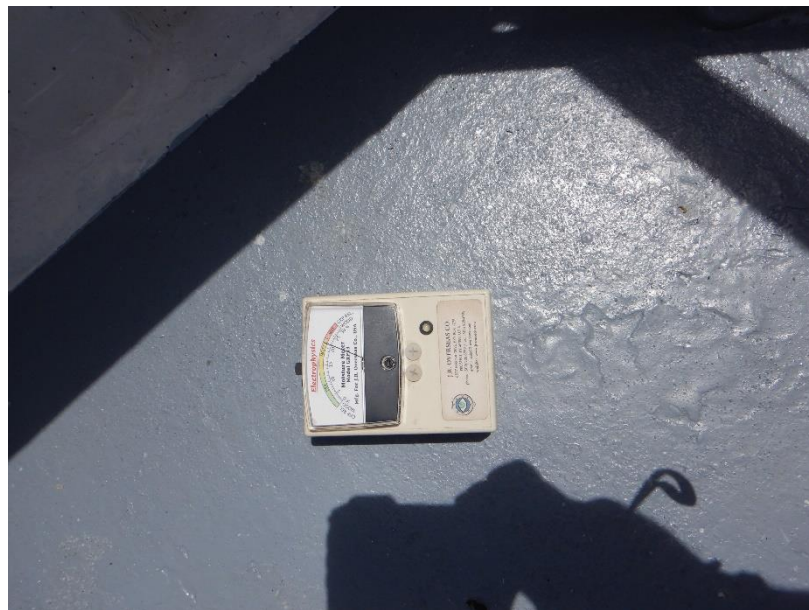
Cockpit Decks

The decks are sheaved and painted, possibly plywood over timber planking.

When percussion tested, they had multiple dull spots indicating delamination and/or deterioration.

When tested with a capacitance moisture meter showed high/excessive moisture. These readings were only taken at the time of inspection and are an indication only, more accurate readings should be taken at regular intervals over a period of time or invasive investigation would be necessary to determine the amount of deterioration that exists.

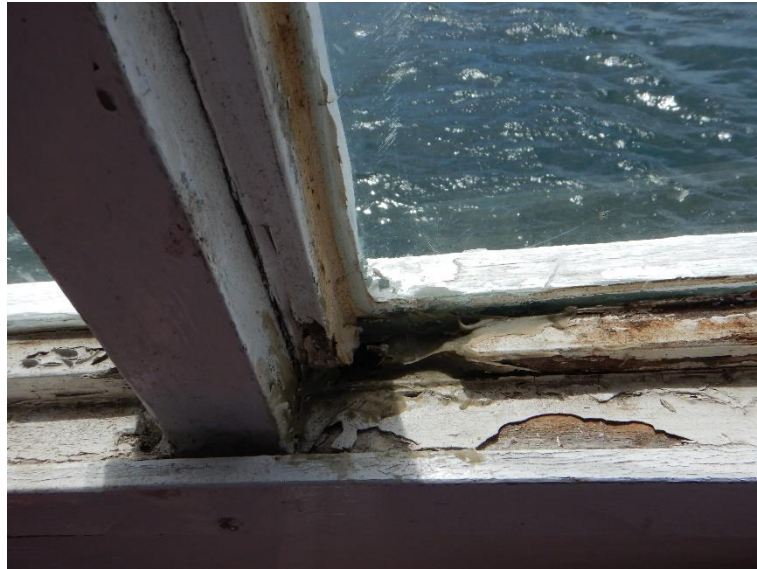
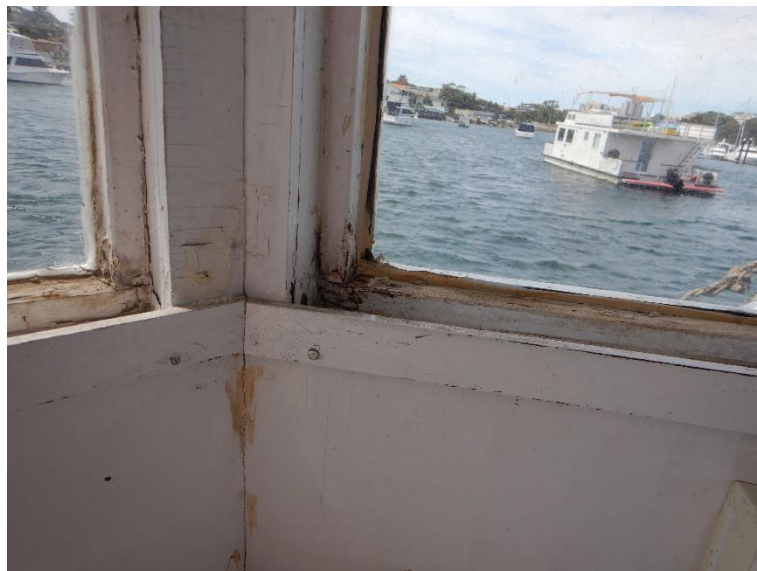
The windows are glass in timber frames showing deterioration and temporary repairs with polyester filler.

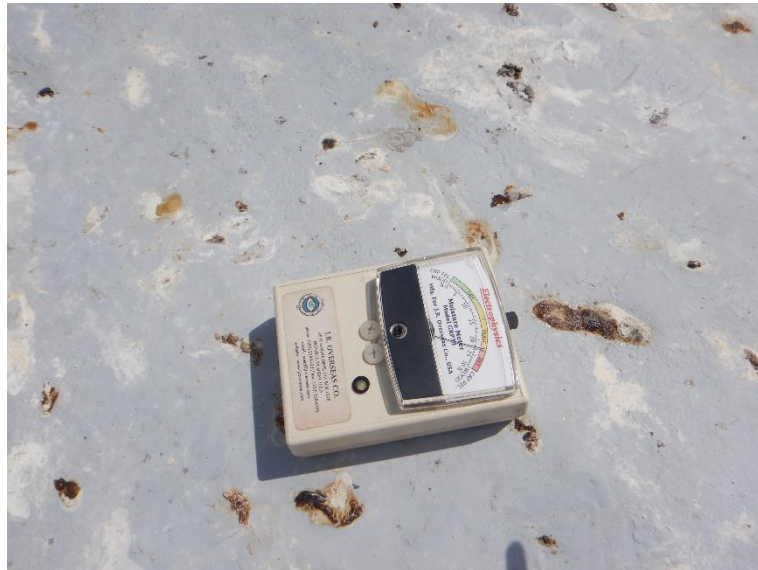
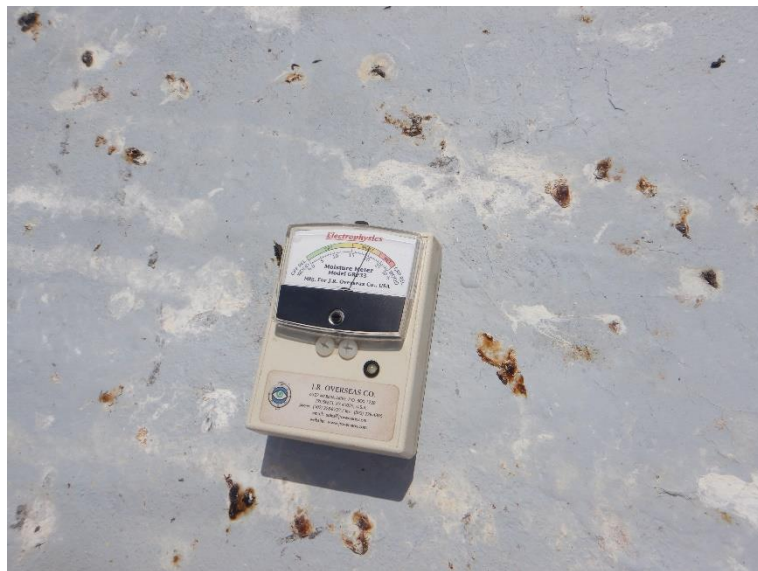
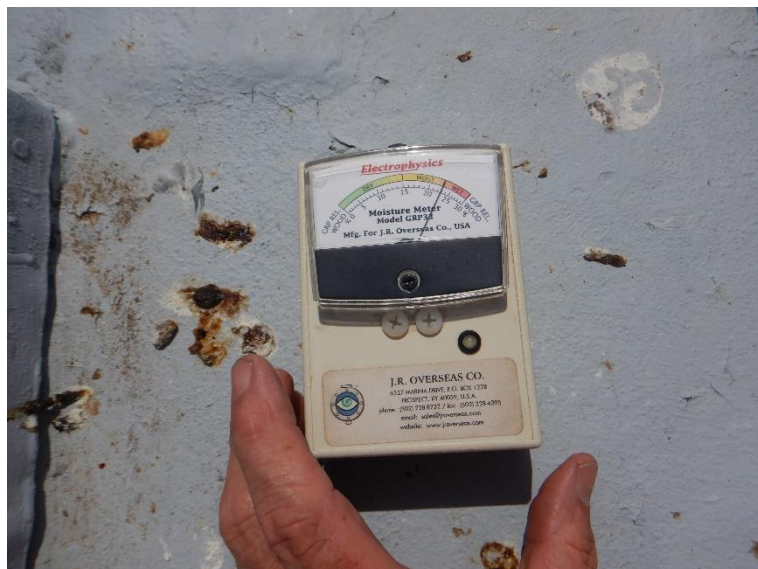
The cabin top was sheaved and painted, possibly plywood over timber planking.

When percussion tested, they had multiple dull spots indicating delamination and/or deterioration.

When tested with a capacitance moisture meter showed high/excessive moisture. These readings were only taken at the time of inspection and are an indication only, more accurate readings should be taken at regular intervals over a period of time or invasive investigation would be necessary to determine the amount of deterioration that exists.

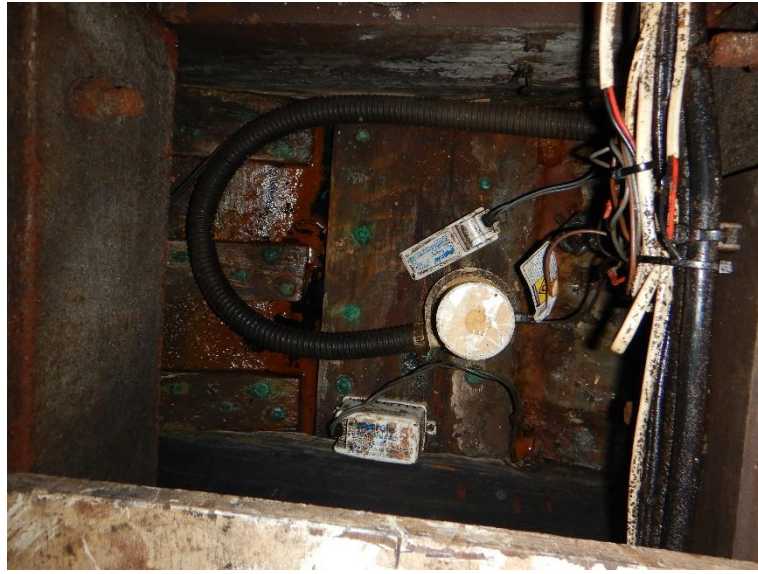
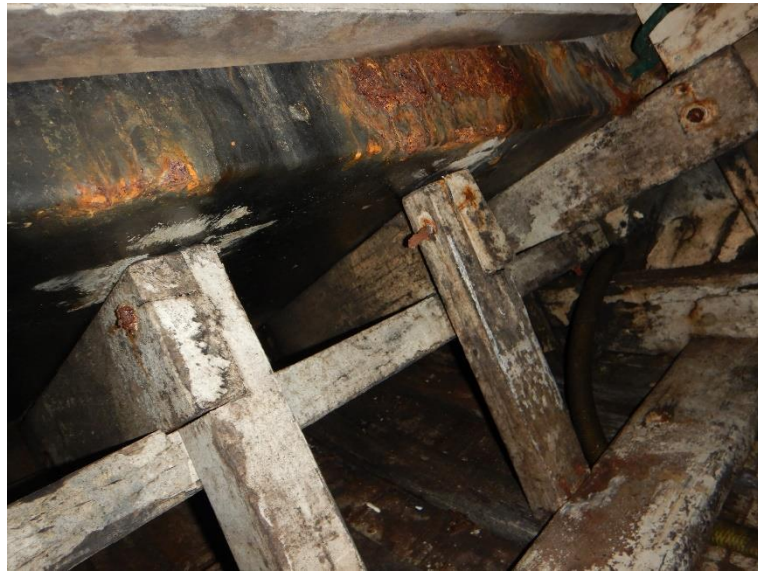
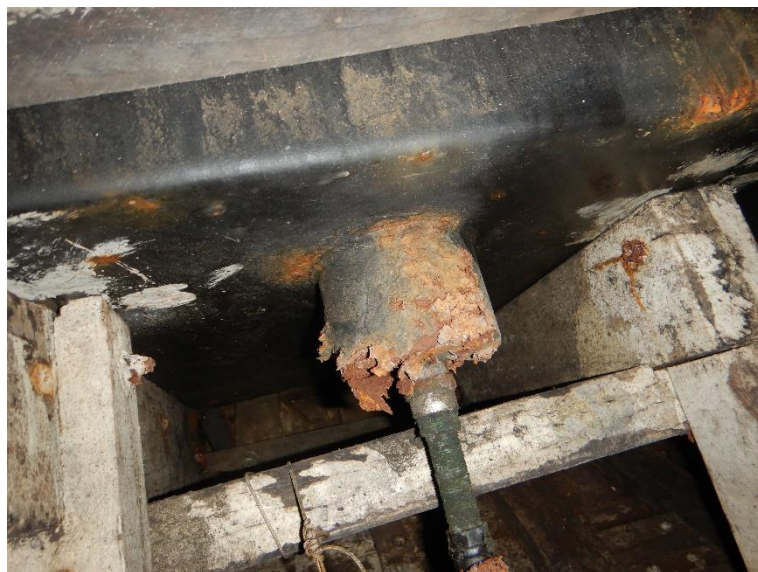
Fuel Tanks

Integrity of the fuel tanks and contamination of the fuel requires further investigation.

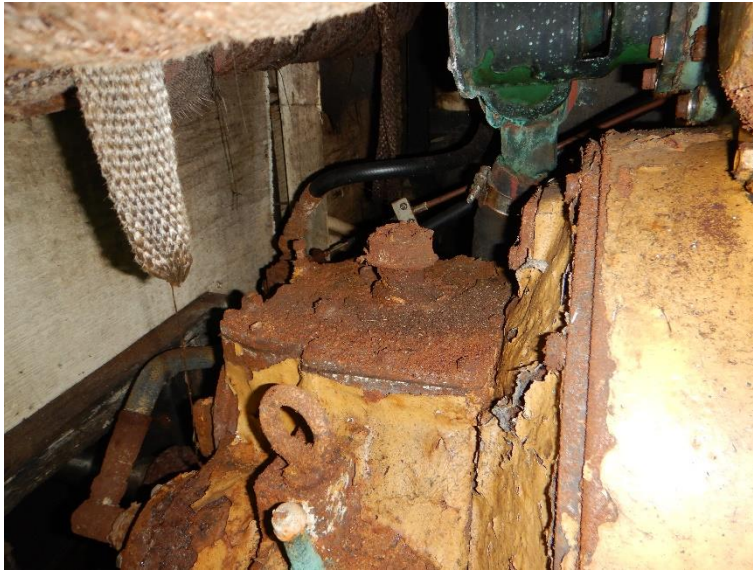
Surface rust is evident on unprotected steel surfaces.

Surface Corrosion

It is suggested these surfaces be cleaned, rust converted and coated with a suitable paint system.

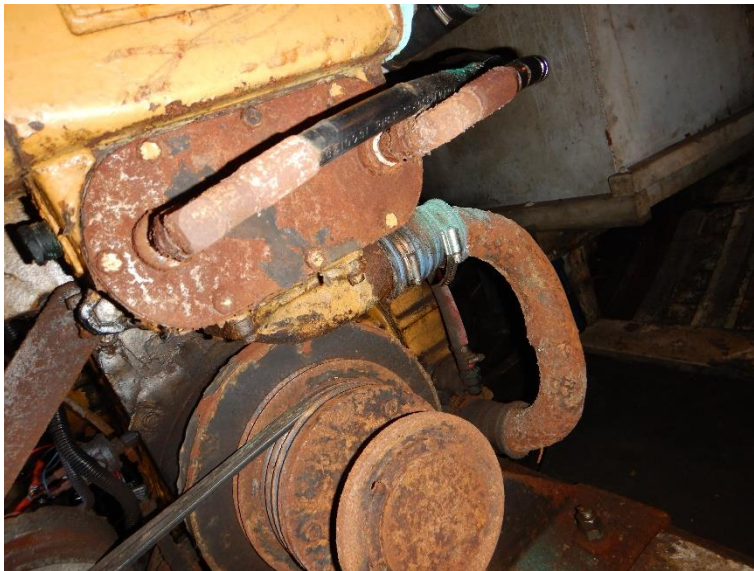
Hoses and clamps have deteriorated and require replacement.

Deterioration of hoses and clamps

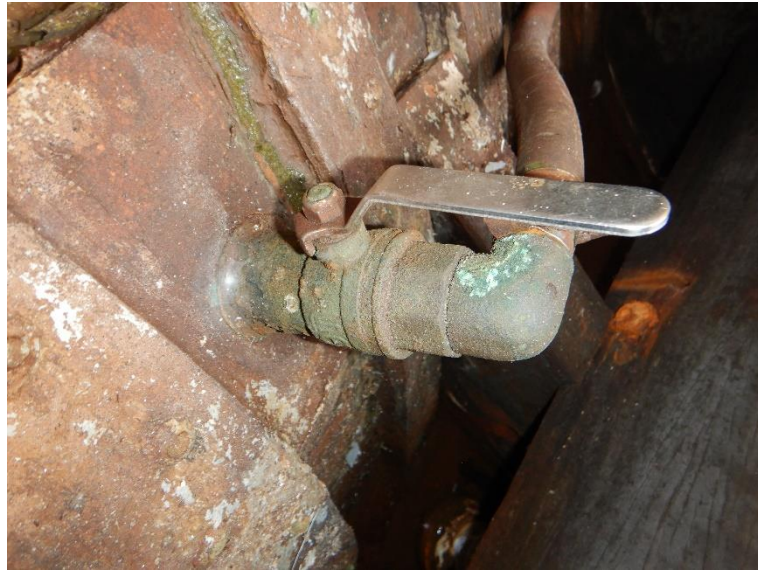
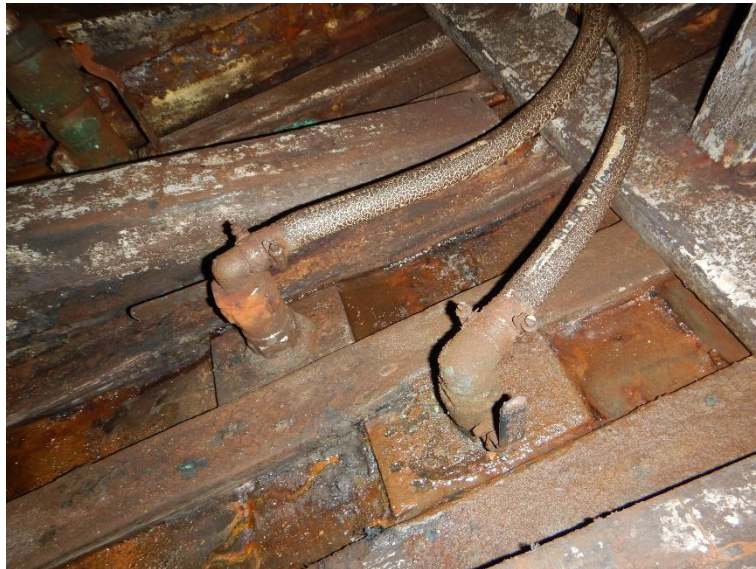
Replace through hulls

All through hull fittings and valves require cleaning, removal, check for corrosion and replace where necessary.

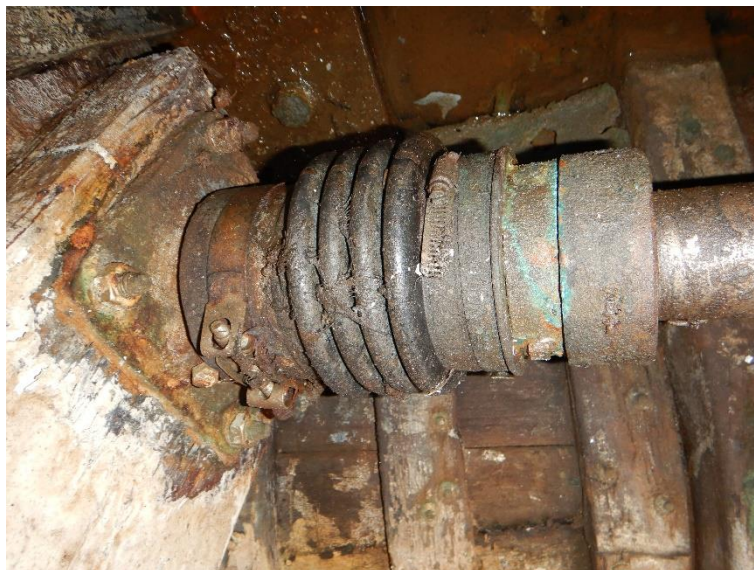
Replace stern gland

It is recommended that the Shaft Seal be replaced at the earliest convenience.

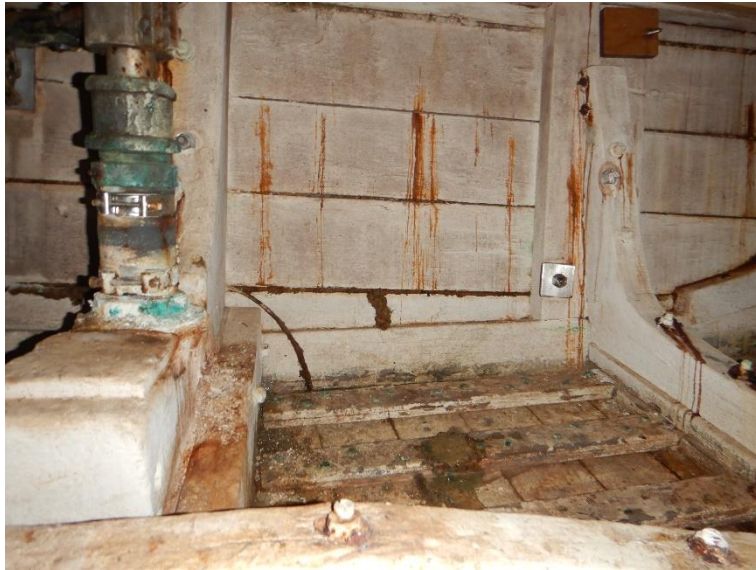
Replace rudder gland hose and clamps

The rudder gland hose and clamps should be replaced.

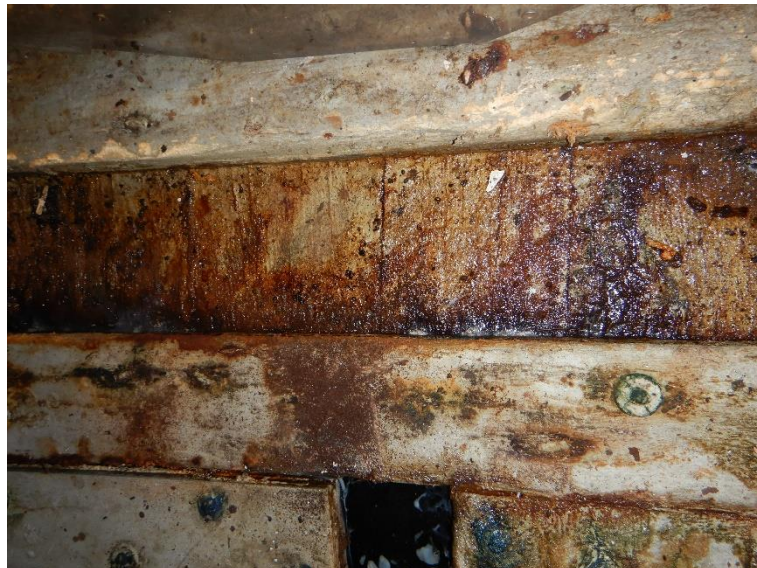
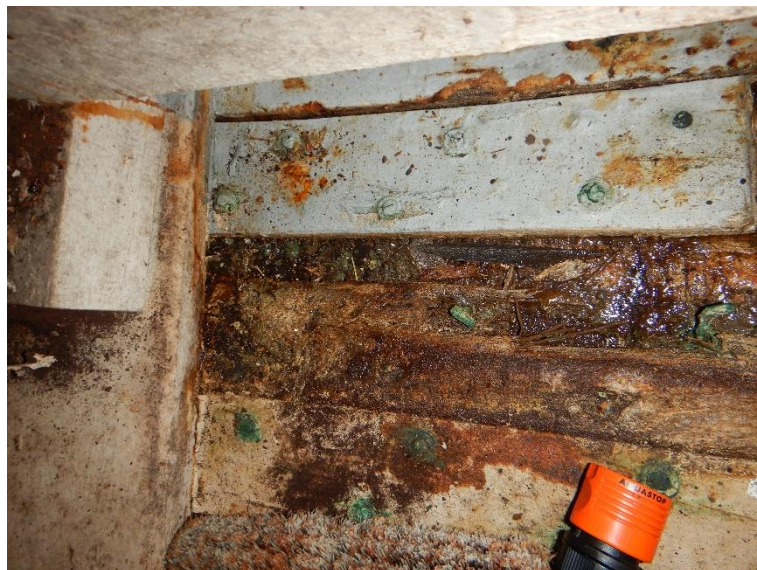
Weeps

Planking weeps require further investigation and rectification.

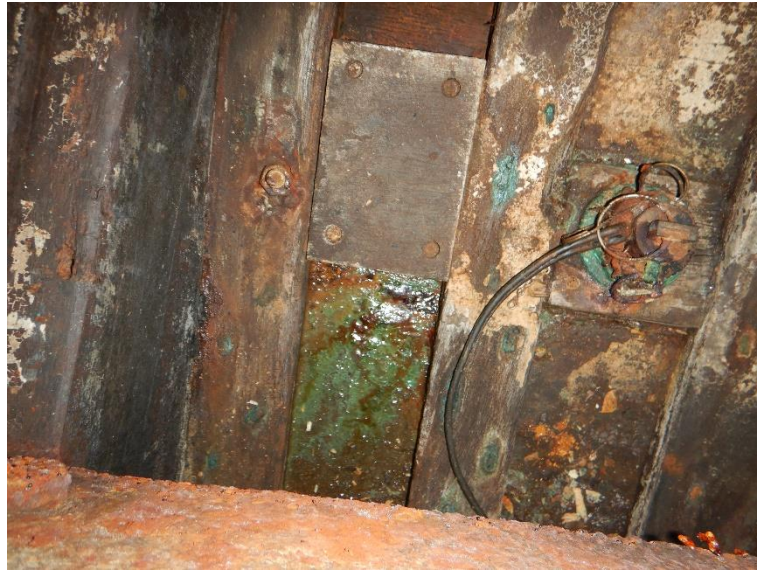
Planking weeps

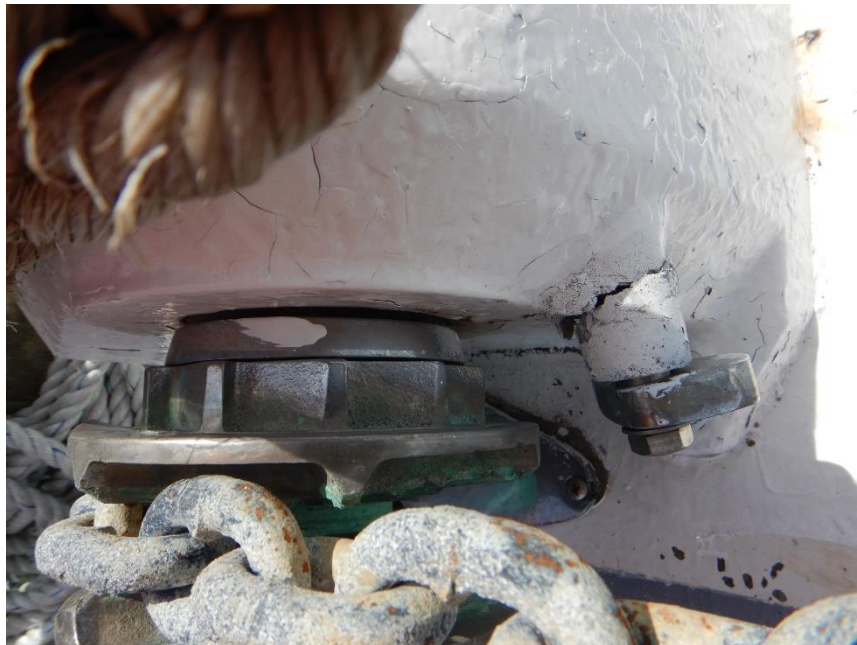
**Comment:** The winch casing has fractured.  
Deck switches require replacement.  
The anchor should be secured while underway.
