# SMALL VESSEL MARINE CRAFT INSURANCE RISK EVALUATION

FILE NO:	• VP-279
VESSEL NAME	• "LOLA"
VESSEL OWNER/PURCHASER	JACK TOOHEY
LOCATION	Afloat/Hardstand FSC
DATE	• 30/04/2008
SURVEYOR	VLADO PAVLOVICH
RECOMMENDED INSURABLE VALUE	• AU\$95.000.00.

VESSEL NAME	• "LOLA"
OWNER/PURCHASER	Jack Toohey
ADDRESS-EMAIL	• jack@2eservices.com
BUILDER	Hunter Yachts USA
BUILT	• 2003
LENGTH (OA) – METRES	• 10.70 metres
BREADTH (MLD) – METRES	• 3.66 metres
REGISTRATION NO	• BR-030
HIN NO	• AU-TWA016745-DK2
DISPLACMENT-DRY	• 6318 KG
SERVICE SPEED	Six (6) Knots/Max -Eight (8) Knots

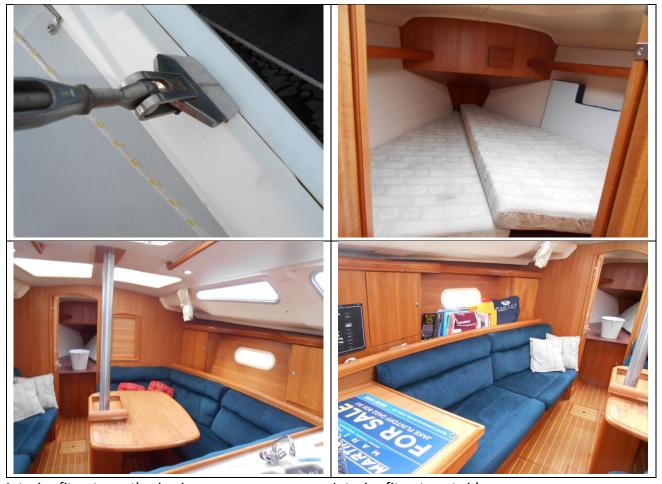
Interior fit out-weathering in areas
