Mast/Rig Report

Vessel Name: Lady Katherine

Vessel Type: Duncanson 35

Date of Inspection: 17th July 2024

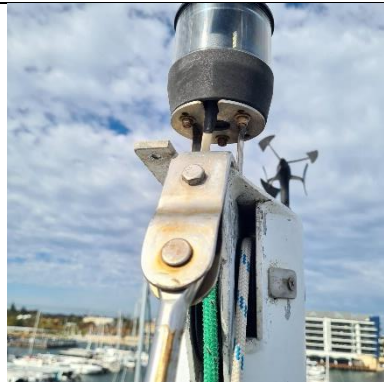
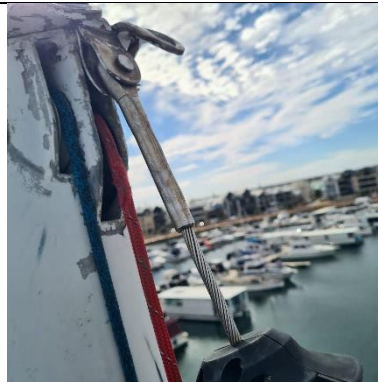
The exposed wire above the furler shows sign of a minor halyards wrap caused when furling. While the stay has been slightly damaged, there were no visible broken strands.

Forestay damage from halyard wrap

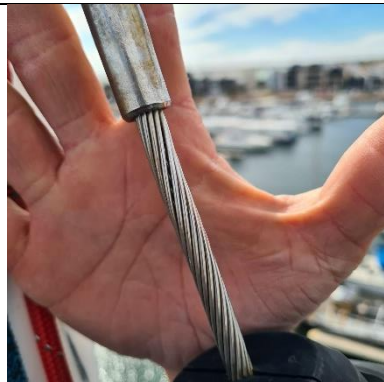
Forestay damage from halyard wrap

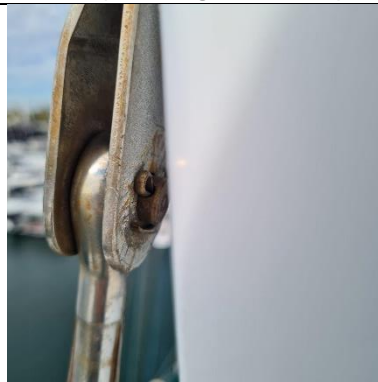
Cap shroud attachment

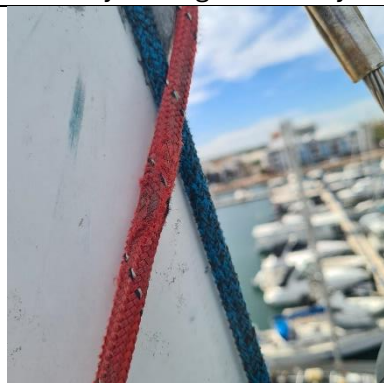
Minor damage was observed on the jib halyard likely from the halyard wrap. Sufficient tension on the jib halyard will help prevent further damage in the future.

Damaged to the jib halyard

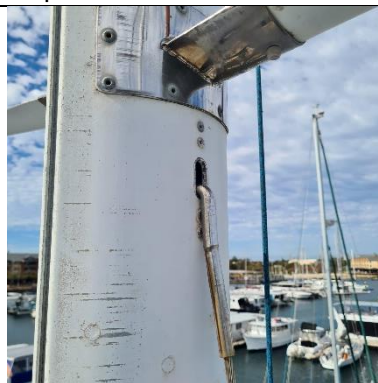
Spreader base attachment in good condition with minimum signs of corrosion.

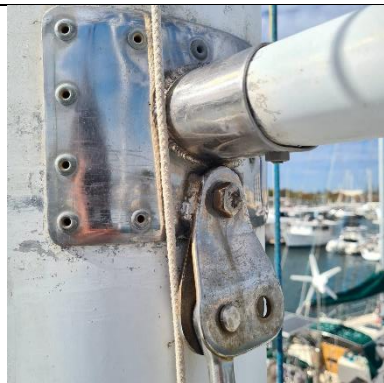
Missing forward lower. Has since been installed.

An up mast visual inspection was conducted on the yacht 'Lady Katherine' at Mandurah Marina. The mast, furler, standing and running rigging were all in good working order. Following the inspection, forward lowers were reinstalled on the mast to add additional support and improve mast bend.

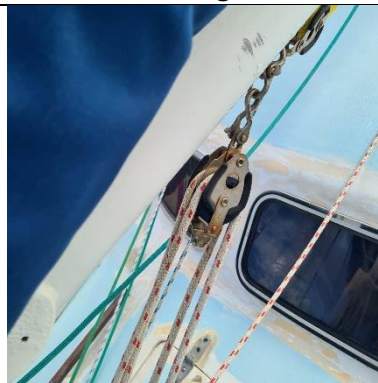
Cracked vang block has been replaced.

Cracked and damaged halyard and vang blocks were also replaced.

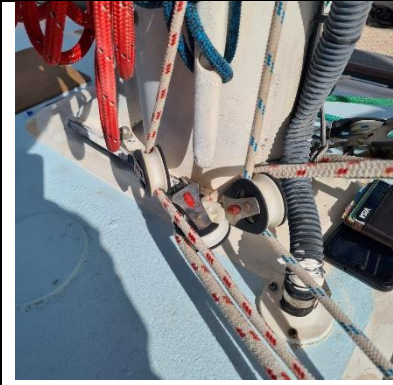
Damaged mast base blocks have since been replaced.
