Insurance Risk Survey

Riviera, 3350 Flybridge, 2001

Survey type:	Insurance Risk Survey
Survey No#:	IRS250107
Client:	██████████
Email:	████████████████████
Inspection date:	7th January 2025
In-Water location:	SYC, Sandringham, Victoria
Out-Water location:	SYC, Sandringham, Victoria

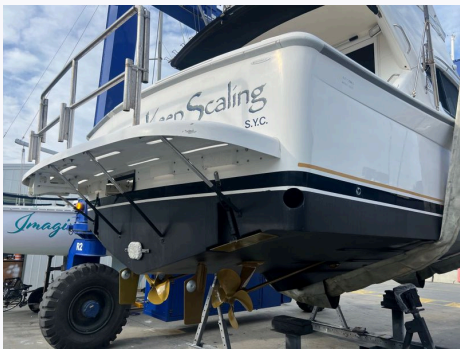
Ref # 2.1

Ref	Item	Material / Construction	Condition	Comments
2.1	Hull Bottom	FRP Composite	Sound	No damage or defect found to the hull bottom, appeared structurally sound throughout.
2.2	Keel	FRP Composite	Sound	
2.3	Bulkheads	FRP Composite	Sound	
2.4	Hull stringers	FRP Composite	Sound	
2.5	Bilge	Flowcoat	Sound	Note: It is important to check all bilges prior and post vessel operation and immediately following vessel launch for water ingress as part of your standard operating procedures.
2.6	Transom	FRP Composite	Sound

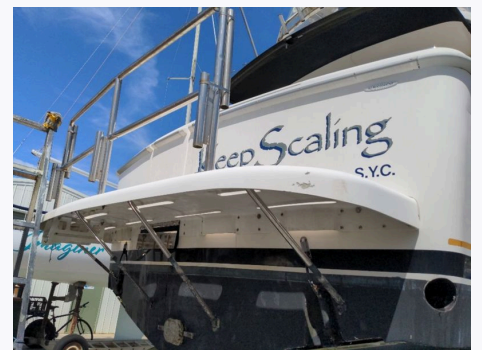
Ref # 2.11

2.7	Hull side / Topsides	Gelcoat / FRP	Sound	
2.8	Gunnel	Aluminium	Sound	
2.9	Bow Stem	Gelcoat / FRP	Sound	
2.10	Skin Fittings	Bronze	Sound	
2.11	Swim platform	FRP Composite	Sound	Some cosmetic wear to edges of platform which is consistent with normal wear tear.
2.12	Antifouling	Black Ablative Application	Good	Being prepared for new antifoul at the time of inspection
2.13	Hull anode	Zinc or Similar	Good	All being replaced with new

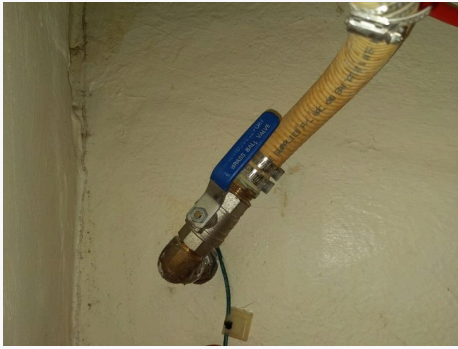
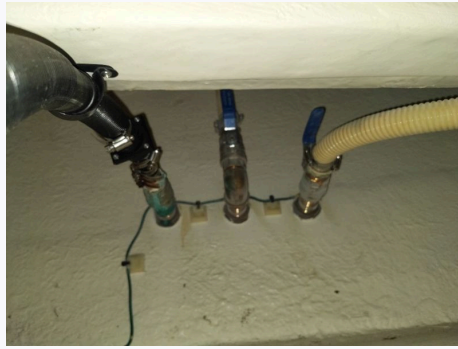
Ref	Item	Material / Construction	Condition	Comments
3.1	Seacocks	Bronze or similar	Sound	All exercised, appear serviceable. Note: It is recommended that all seacocks and valves be cleaned, inspected and valves exercised at least monthly as part of the vessels maintenance program.; Zeus Drives
3.2	Intake Grills	Bronze or similar	Sound	
3.3	Skin Fittings	Bronze or similar	Sound	
3.4	Transducers / Speed Logs	Thru-Hull Type	Sound

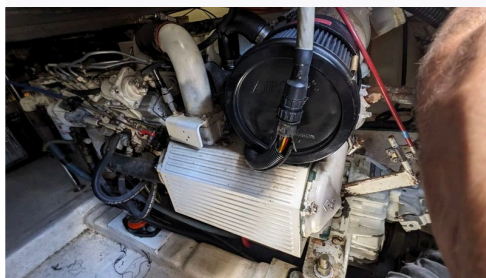
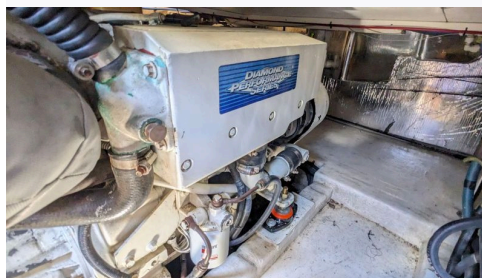
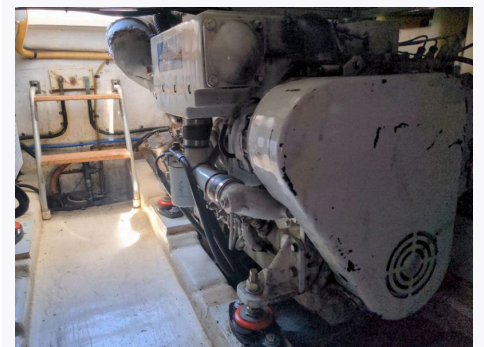
Ref	Item	Type / Make	Condition	Comments
7.1	Engine Block	Cummins	Sound	Cummins 4B-3.9 is a 3.9 litre 4-cylinder, 4-stroke, direct-injected, turbocharged marine diesel engine. There are oil leaks in areas around the engine.

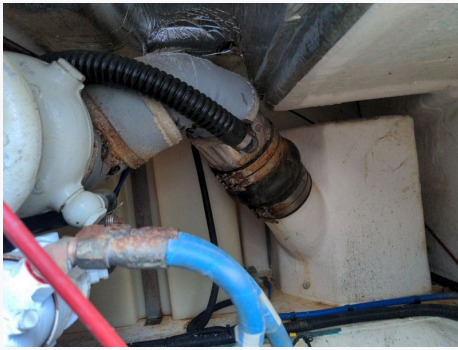
Ref # 7.5

7.2	Sump	Pressed Steel	Sound	
7.3	Manifolds	Cast Aluminium	Sound	
7.4	Fuel Delivery System	Fuel Injected	Sound	
7.5	Exhaust System	Reinforced Marine Hose	Sound	Some corrosion present on some hose clamps.

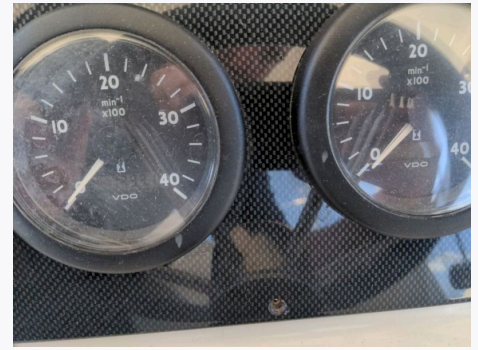
Ref # 7.26

7.18	Engine Oil	Oil	Sound	
7.19	Gear lube / oil	Oil	Sound	
7.20	Raw water pump	Impeller Pump	Sound	
7.21	Thermostat	Cast	Sound	
7.22	Throttle connections	Mechanical Terminals	Sound	
7.23	Gear shift connections	Mechanical Terminals	Sound	
7.24	Throttle levers	Morse Type	Sound	
7.25	Engine bilge	Flow coat	Sound	
7.26	Engine Hours	Helm Gauge Reading	Sound	Port: 1399 Stbd: N/A (Not legible)
7.27	Engine Operation	Engine was not operated		<p>The findings reported are from a visual inspection only, no assessment has been made of the internal condition of the engine(s).;</p> <p>Access to some parts of the engine, driveline and exhaust system were restricted by fixed components and preclude inspection.</p>

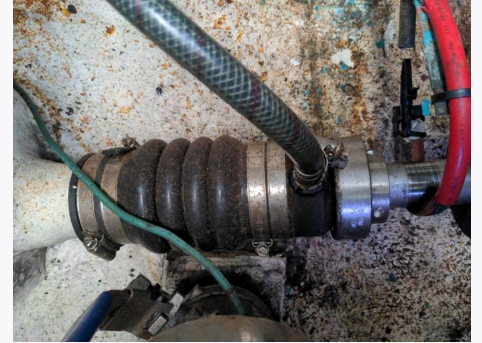
Ref # 8.5

Ref	Item	Type / Make	Condition	Comments
8.1	Type	Shaft Drive	Sound	Twin shaft drives
8.2	Gear Box	ZF	Sound	
8.3	Propellers	Bronze	Sound	Fixed 3 blade
8.4	Shaft	Stainless Steel	Sound	Appears to run true.
8.5	Shaft Seal	Dripless Seal	Sound	<p>PYI PSS type dripless seals, said to have been replaced in 2023.</p> <p>These seals have a limited services life. Please refer to manufacturers maintenance and service guidelines.</p>
8.6	Coupling	Flexible Type	Sound	
8.7	Skegs	Cast Bronze	Sound	Twin bronze skegs, securely mounted.
8.8	Skeg Mount (Internal)	Bronze Plate.	Sound	No signs of stress or damage
8.9	Bonding	Wire	Sound	<p>Appearing to be connected/ bonded where sighted.</p> <p>Bonding strap, continuity test and appears serviceable.</p>
8.10	Drive Anodes	Zinc or Aluminium	Good	Being replaced with new

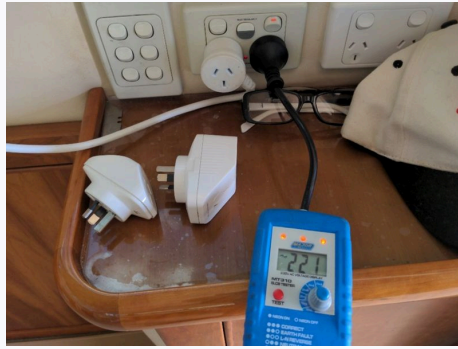
Ref # 12.5

Ref	Item	Type / Make	Condition	Comments
12.1	Shore Power Lead	15-amp Heavy Duty	Sound	
12.2	Shore Power Breaker	Trip Switch / Breaker	Sound	
12.3	Wiring & Cables	Insulated Wire	Sound	
12.4	Switch Panel	AC/DC switch panel	Sound	Switch panel with Xantrex True Charge monitor.
12.5	Power outlets / GPO	Australian Type	Sound	Tested using DETA-240 plug tester, resulting in a PASS.
12.6	Battery Charger	Xantrex	Sound	
12.7	Batteries	12-volt	Sound	House and Start banks.

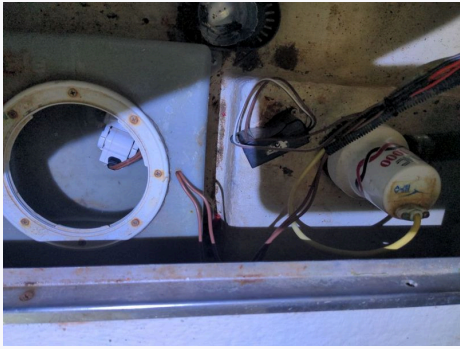
Ref # 15.1

Ref	Location	Number / Type	Comments
15.1	Midships Pump/s	2 x 12-Volt	One in engine bay and another under galley, both powered up with automatic float.
