Insurance risk assessment Survey

Vessel Name: 'Moonlighting'

Model: Riviera 35

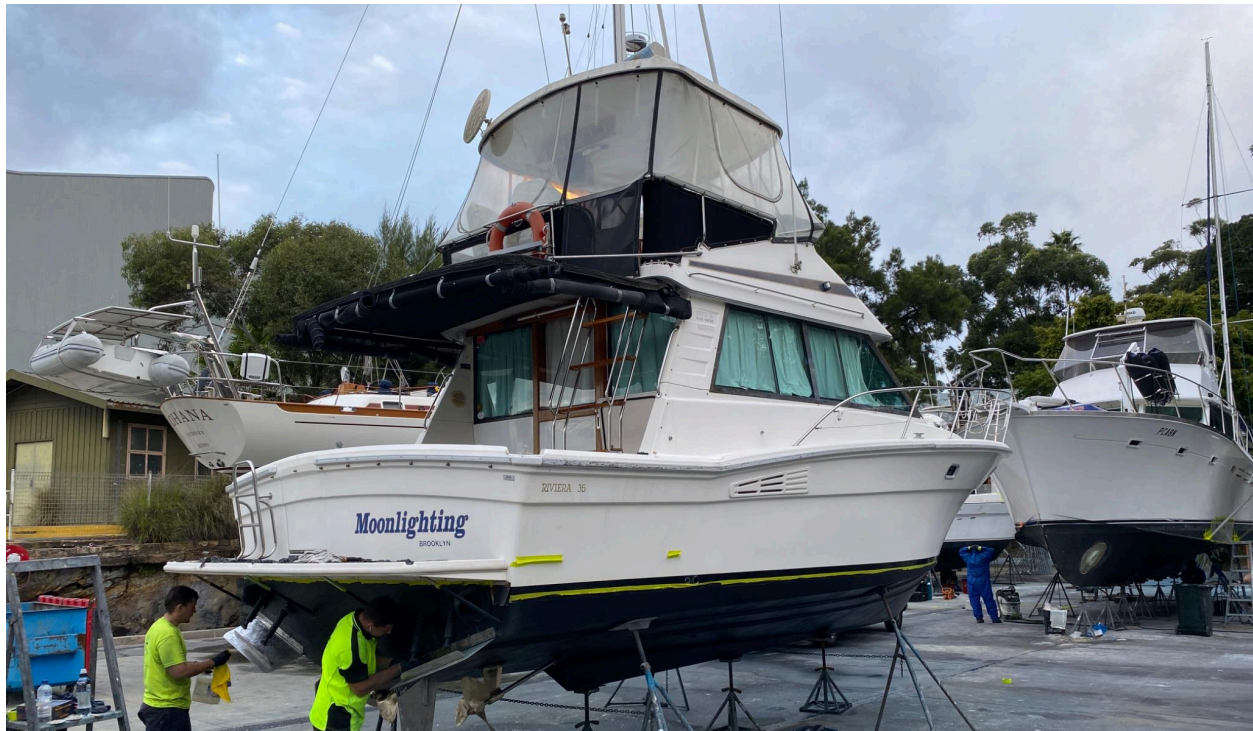
Hull Construction/condition

Construction/material-Hull:	Moulded FRP
Hull Underwater:	Good cond. Structurally sound. No soft areas, signs of movement, cracking, damage or osmosis evident.
Keel:	Good cond. Structurally sound. No soft areas, signs of movement, cracking, damage or osmosis evident.
Hull Above water:	Good cond. Structurally sound. No major repairs or damage evident. Gelcoat in good condition.
Hull/deck join:	Good cond. Structurally sound. No movement noted.
Transom:	Good cond. Structurally sound. FRP with no evidence of damage or movement.
Swim platform:	Good cond. Structurally sound. FRP/stainless steel supports found with no evidence of damage or movement.

Bulkheads:	Good cond. Structurally sound. Plywood/FRP with no evidence of damage, rot or secondary bonding failure.
Frames:	Good cond. Structurally sound. FRP/timber showing no signs of damage or bonding failure.
Stringers:	Good cond. Structurally sound. FRP/timber showing no signs of damage or bonding failure.
Engine beds:	Good cond. Structurally sound. Moulded FRP/timber showing no signs of damage or bonding failure.
Bilge:	Good cond. Structurally sound. Found acceptably clean and well maintained.
Bilge pumps:	Good cond. 3x automatic bilge pumps found operational.
Skin fittings:	Good cond. Metal. No sign of excessive corrosion or damage.
Seacocks:	Good cond. Bronze. All valves were tested and found operational.

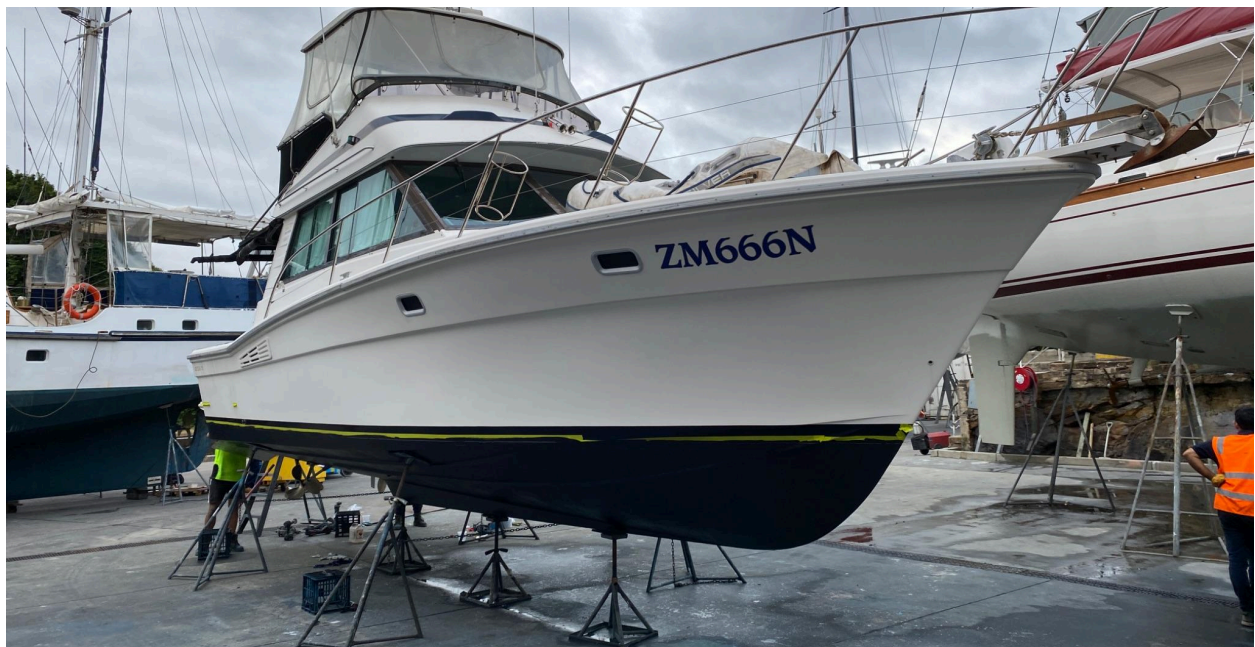
Deck Construction/condition

Deck:	Good cond. Structurally sound. No signs of excessive crazing, cracking or soft areas. Gelcoat in good condition for age.
Cockpit:	Good cond. Structurally sound. No signs of excessive crazing, cracking or soft areas. Gelcoat in good condition for age.
Flybridge:	Good cond. Structurally sound. No signs of excessive crazing, cracking or soft areas. Gelcoat/non-skid in good condition for age.
Cabin:	Good cond. Structurally sound. No signs of excessive crazing, cracking or soft areas. Gelcoat/non-skid in good condition for age.
Pulpit:	Sound cond. Structurally sound. FRP moulding found secure.
Bow fitting/rollers:	Good cond. Stainless steel fitting incorporating bow roller.
Bow rail:	Good cond. Fabricated Stainless steel, found secure and undamaged.
Cleats:	Good cond. Various, found secure and undamaged.
Windows:	Good cond. Aluminium framed glass sliding windows found operational and undamaged.
Grab rails:	Good cond. Stainless steel, found secure and undamaged.

Hatches/ports:	Good cond. Structurally sound, found secure and undamaged.
Lockers:	Good cond. Structurally sound, found secure and undamaged. Hinges and latches operational.

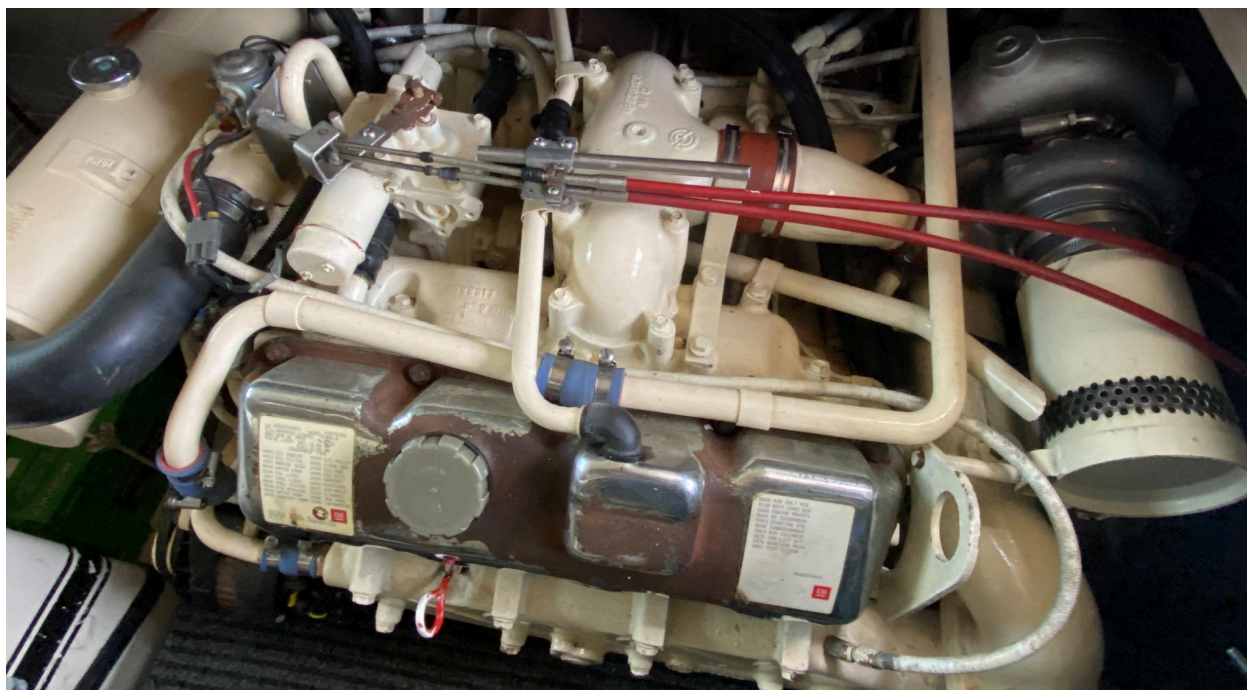
Motor and Machinery installation/condition

General:	Counter rotating motors appear to be running well, serviced regularly and show no sign of significant leaks or overheating.
Engine beds:	Good cond. Moulded FRP longitudinal engine beds
Engine mounts:	Good cond. Rubber mounts showing no significant wear problems.
Controls:	Good cond. Morse dual lever controllers at main and bridge helm positions for each motor. Found fully operational.
Exhaust:	Good cond. Through wet boxes and exhaust hose to transom.

Fuel Tank:	Good cond. Stainless steel of unknown volume.
Filler:	Good cond. Stainless deck fitting, fuel hose
Venting:	Good cond. Fuel hose to atmosphere through hull.
Fuel lines/fittings:	Good cond. Fuel hose, Brass fittings, stainless steel hose clamps.
Propellers:	Good cond. 2x Bronze alloy 3 blade.
Shafts:	Good cond. Stainless steel shafts found with no significant corrosion or damage evident.
Stern glands:	Good cond. PSS style glands. Operating as designed.
Rudders:	Good cond. Cast bronze with stainless steel stocks.
Rudder glands:	Good cond. Bronze stuffing boxes. Found operating as designed.
Steering linkages:	Good cond. Hydraulic steering system. Operating as designed with no evidence of leaks or damage.
Gas compliance:	N/a
