## PRE-PURCHASE REPORT # 5643

### *"Vindex"*

In accordance with instructions from, *Lance Duncan*, as the intending purchaser, I attended an inspection of a custom timber bay cruiser to prepare a condition report for purchase assessment and insurance underwriting purposes. The initial inspection was conducted while the vessel was afloat at her mooring at the Horizon Shores Marina, Woongoolba on 30<sup>th</sup> March and at Rudy Maas Marina, Woongoolba whilst out of the water on the slips on the 3<sup>rd</sup> April, 2019. The vessel was last inspected by me on 9<sup>th</sup> September, 2015 for the current owner. I confirm that I have no interest, financial or otherwise in the subject vessel or with the parties with whom the instructing party may be dealing. This report is addressed to the instructing party only and may not be used or relied upon by another party, other than the instructing party's insurer.

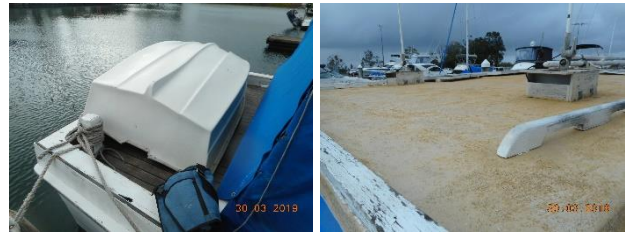
The vessel is a custom built timber sedan cruiser manufactured by *Millkraft Boatyards* of Byron Street, Bulimba in 1964 to a design by S. Watson. The hull is a 'sharpie' design with a full length hardwood keel, single hard chine with longitudinally planked Hoop Pine timbers copper fastened to a framework of 45/30mm transverse sawn timber ribs and 120/38mm longitudinal stringers. The scantlings are robust and typical for a vessel of this age and design. Some deterioration has commenced on the internal faces of the planking timbers which will benefit from a clean and treatment with a fungicide solution. The decks and cabin structure are marine grade plywood over sawn timber beams and have been sheathed in fibreglass with a painted non-skid finish. Some of the sheathing has started to lift along the sides of the cockpit roof which will need repair. The aft deck is longitudinally planked in Qld Beech and remains secure.

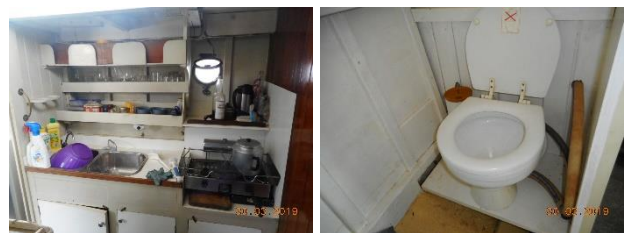
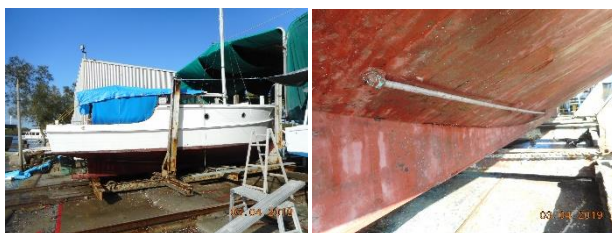
The underwater areas have been cleaned and sanded and the garboard seam on the port side raked and repacked. Prior to launching, the hull will be coated with a *Jotun* primer and two coats of *Sea Guardian* antifouling paint.

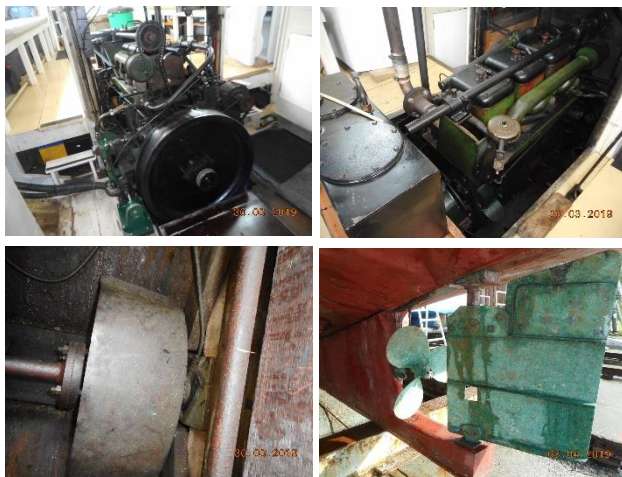
The vessel is powered by a *Lister JP-3* series three cylinder diesel engine rated to produce 23kW (30hp) @ 1200rpm through a 2:1 reduction mechanical gearbox. The engine is fresh water cooled using external keel pipes to exchange the heat from the fresh water cooling circuit. The engine is securely mounted to substantial timber girders and bearers. The gearbox is fitted with a removable 'cotton reel' section and drives a duplex stainless steel shaft

turning a fixed pitch three blade bronze propeller. The shaft is sealed internally with a greased stuffing box gland and supported in the shaft log with a grease fed composite bearing. The rudder is hung behind the propeller and supported in top and bottom bearings. Steering is a mechanically operated rod and box system from a wheel at the helm and has a portable emergency tiller. Through hull fittings and valves are bronze and in average condition.
