Survey Report for Insurance Purposes

Vessel: "Cutloose" (Adams 13 Metre)

Place of Survey: Shell Point Marina, Taren Point, NSW

Date of Survey: 18 February 2025

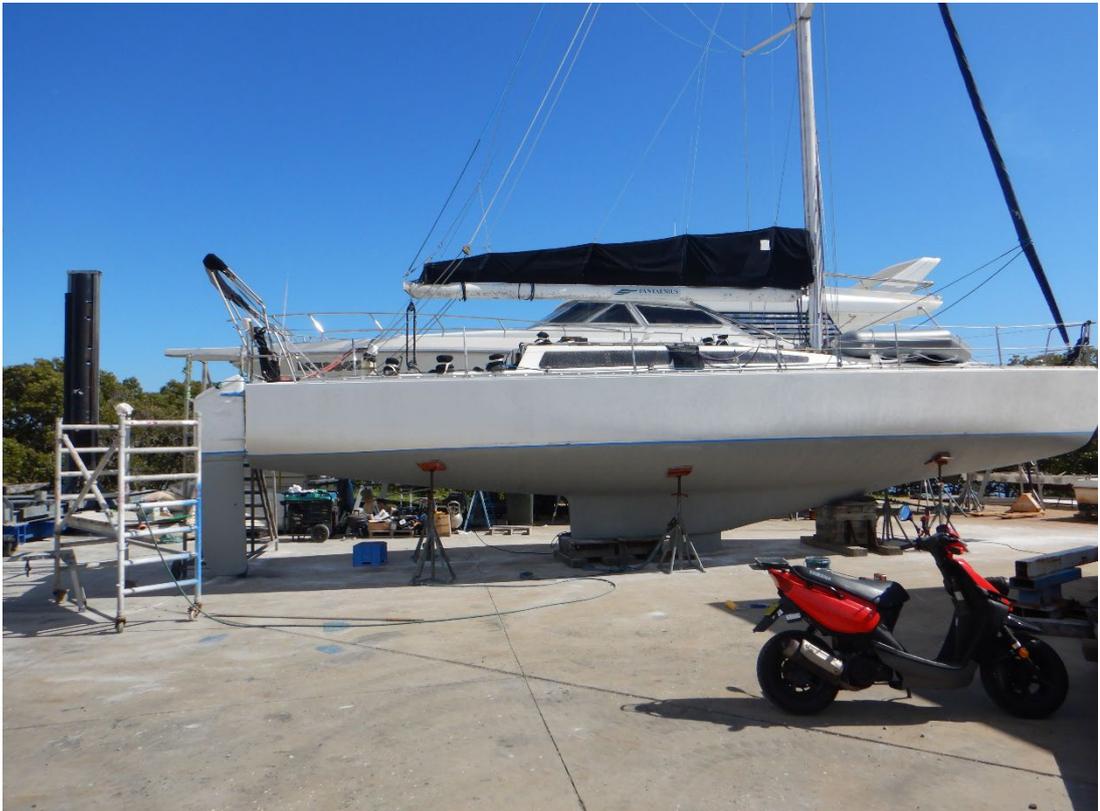
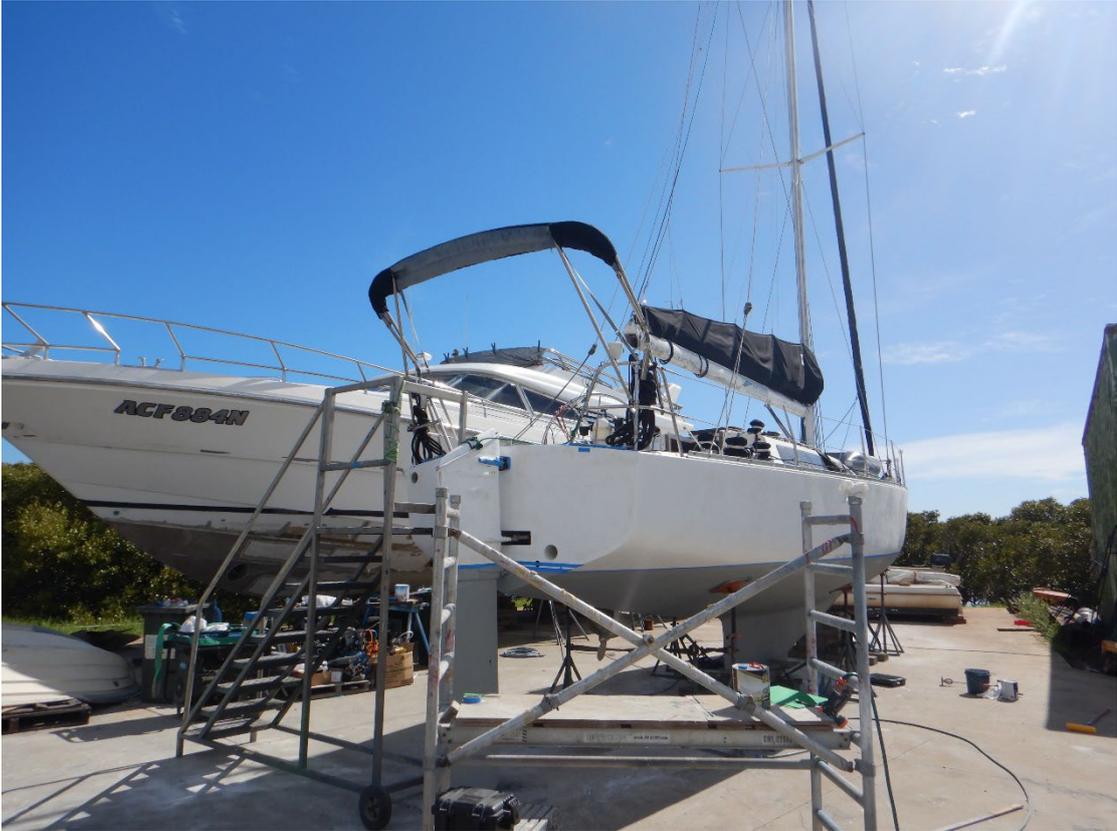
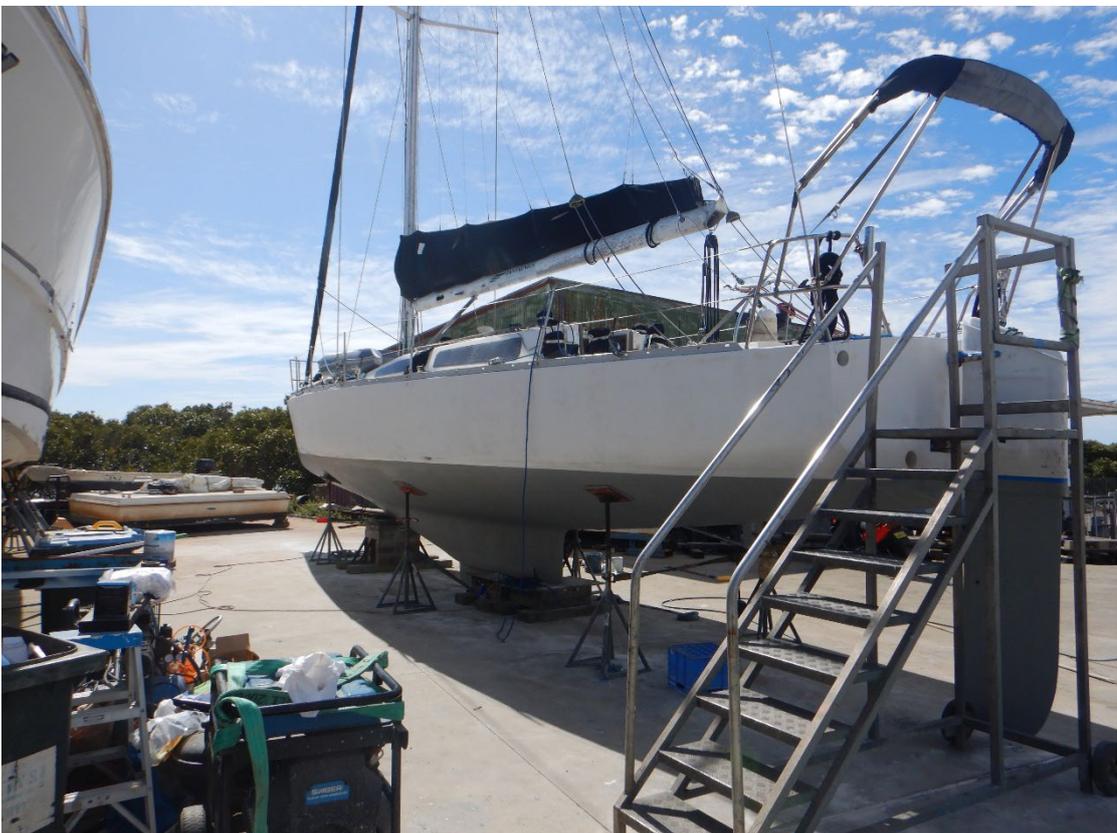
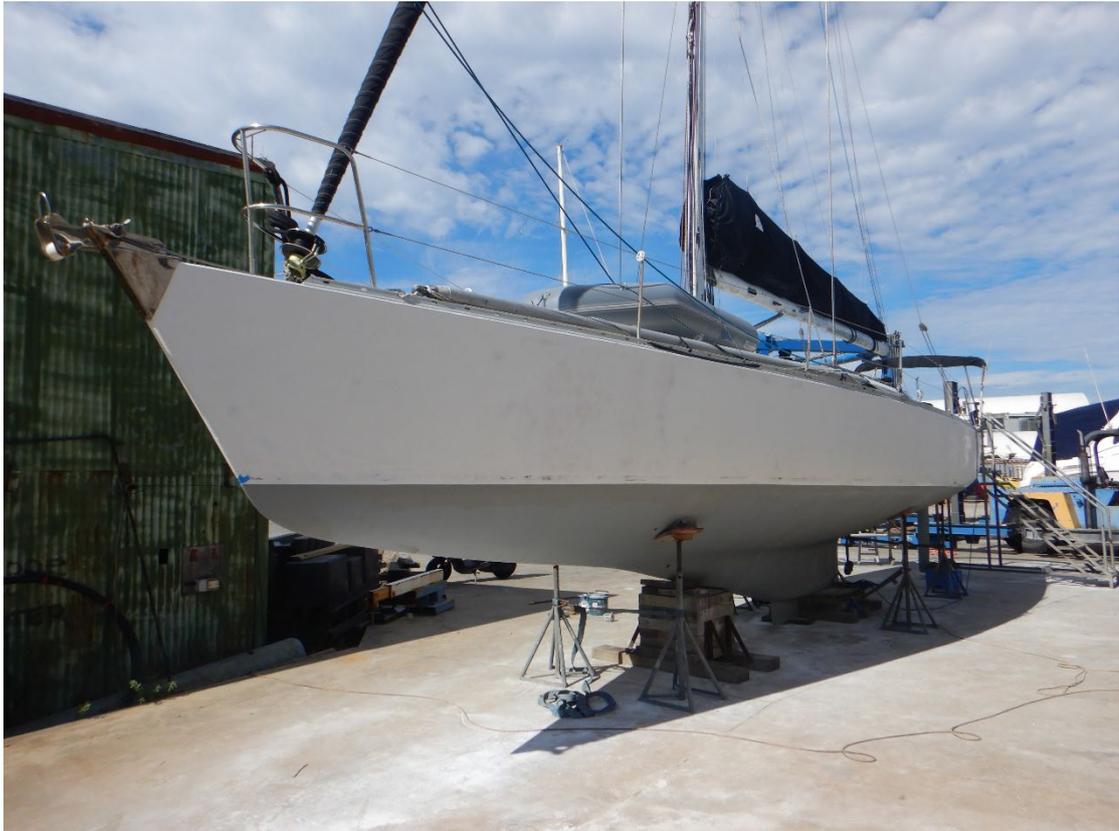
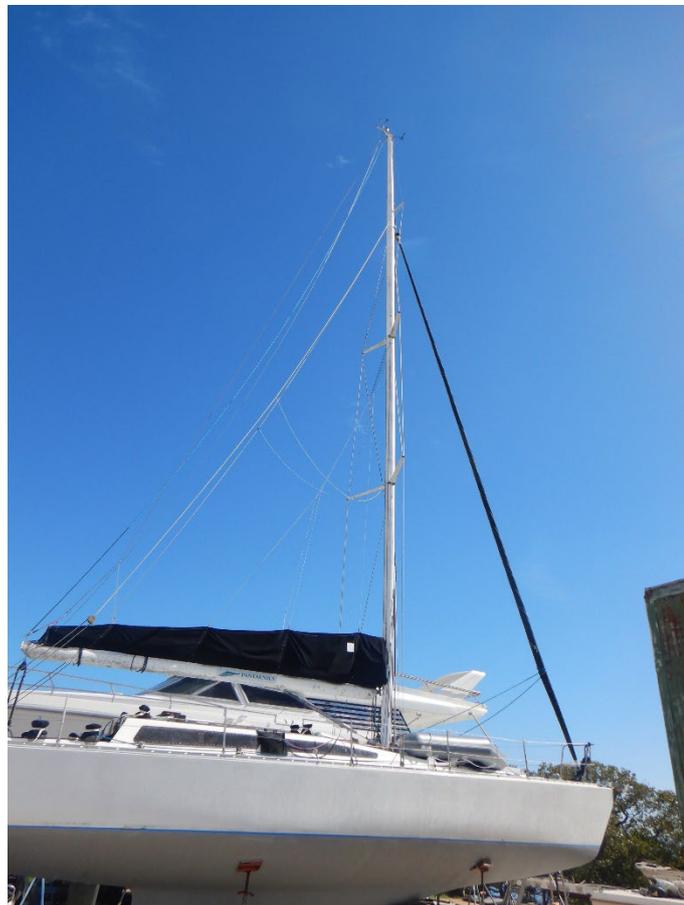
- Underwater Section:** Structurally sound and in good condition.
 The antifouling was to be re-coated after inspection.
 The underwater fittings are in good condition.
 Anode was to be replaced.
 The vessel was inspected on the ground with the hull/keel join in compression and the centre board was not able to be dropped and retracted within the space available; the hull/keel join showed no evidence of movement.
- Topsides:** Topsides had been prepared for re-painting.
- Deck:** Moulded non-skid in good condition.
 Pushpit, pulpit and stanchions well secured.
 Lifelines are s/s.
- Coach House:** The cabin is in good condition sound and free from excessive flexing or movement.
 The helm position is protected by a s/s framed bimini in fair condition.

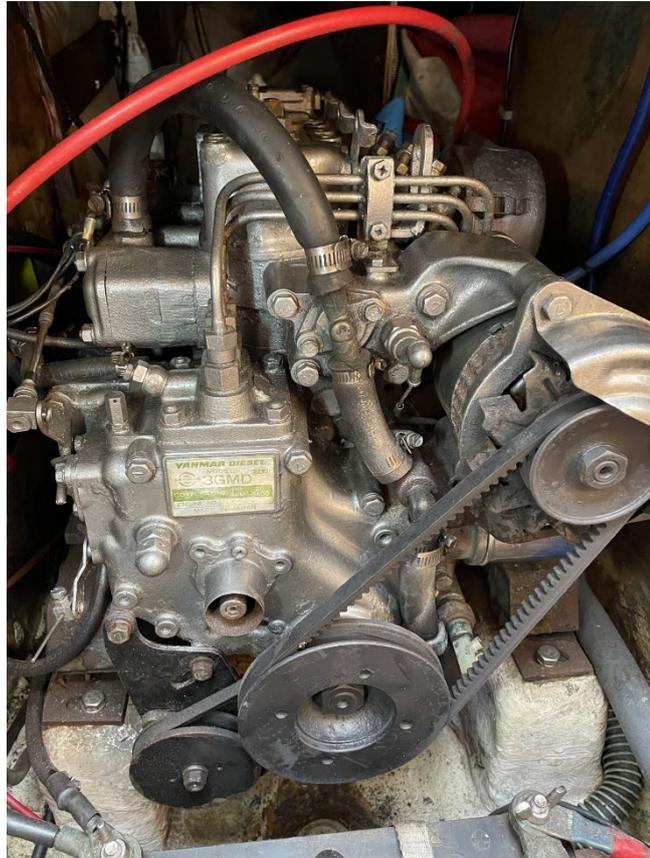
Engine:	Yanmar 3GMD	S/N: 01998
Gearbox:	Kanzaki	
Exhaust Type:	Wet through hull	
Bilge pump:	1x 12v Johnson at Mast step & float switch 1x Rule lo-pro 900 auto aft 1x Hendersen manual companionway steps	
Steering:	Wheel	
Fuel:	S/S – capacity unknown	
Water:	Alloy & Blader – capacity unknown	
Instruments:	1x Tachometer	1x Fuel Audible & Visual Alarms
Comments:	The engine installation is considered suitable for the type of engine.	
PLEASE NOTE:	The engine and engine installation has been visually inspected only.
