## S.V “Andrea Jay” Insurance Risk Evaluation Report Bundaberg Port Marina July 2025

File Number: 16993

S.V “Andrea Jay” Bundaberg Port Marina Qld 4670 July 2025

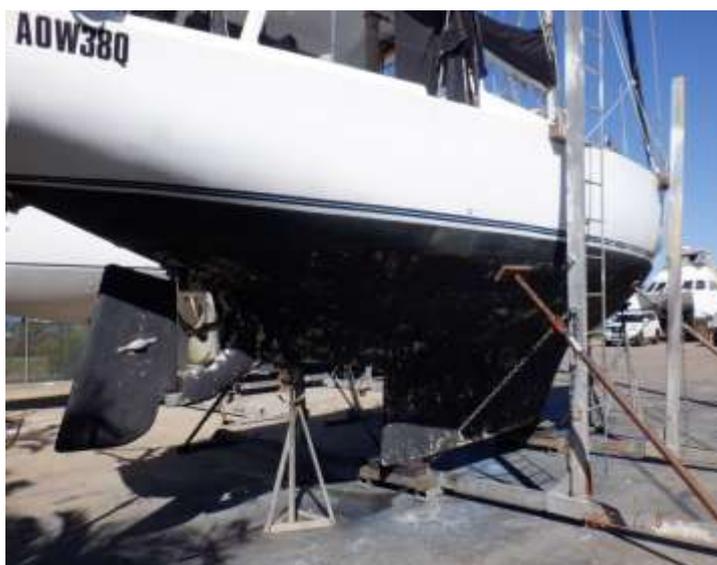
Random percussion soundings were taken to areas below the water line.  
No osmosis or delamination was noted.

No damage or electrolysis noted.

*Underwater profile*

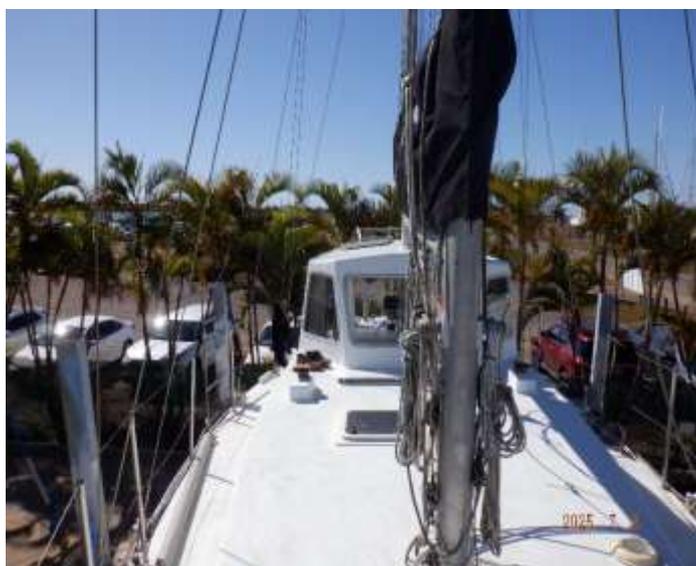
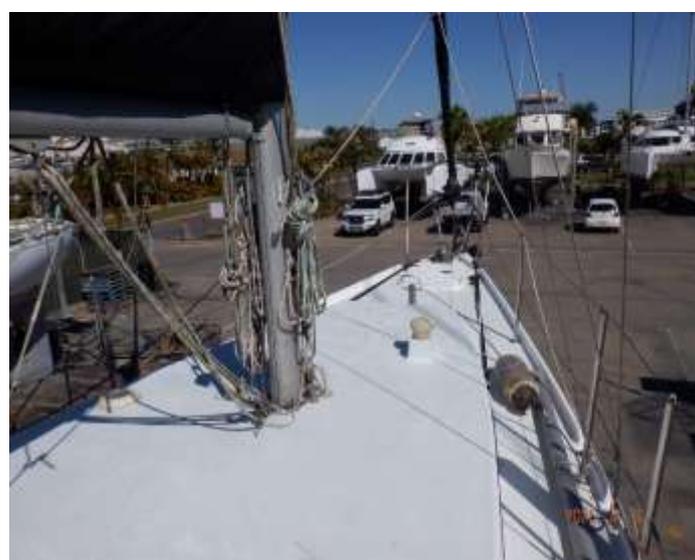
*Topside profiles: fore to aft and from cockpit to bow*

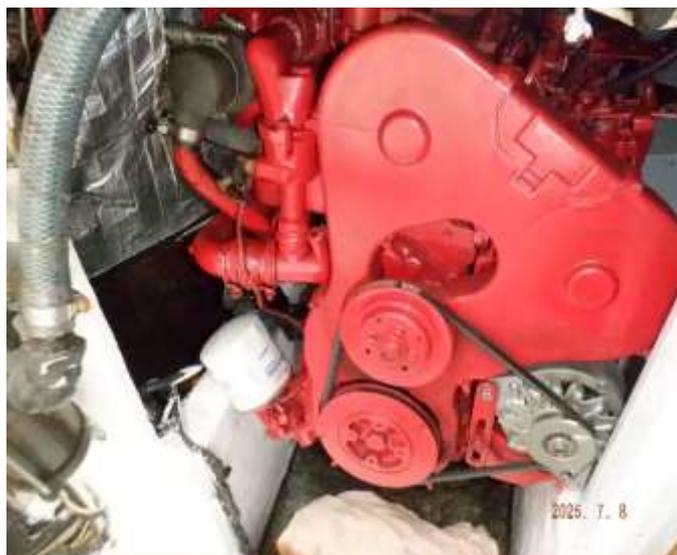
Presented clean and tidy.

*engine profile/ compartment under the companionway steps*

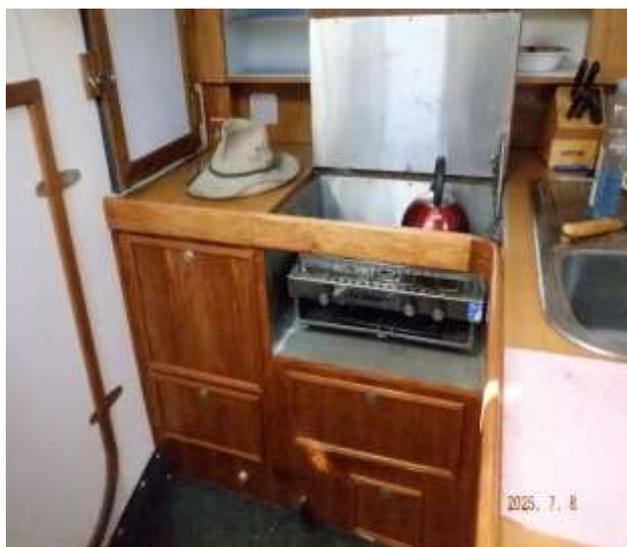
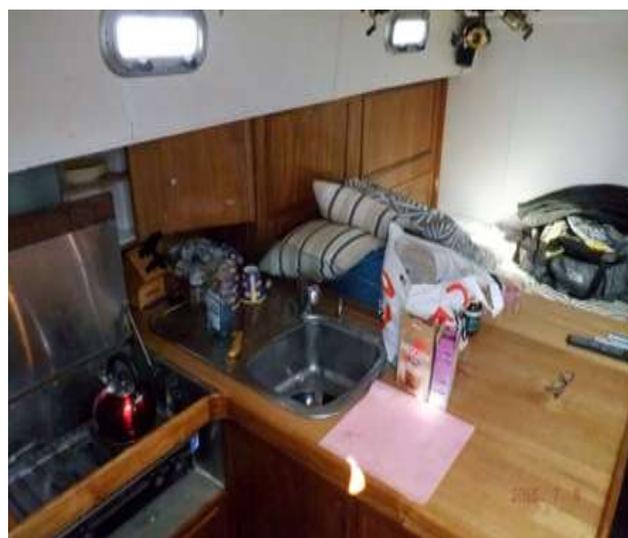
All the above items appeared consistent with the age of the vessel.

Internal profiles: galley – to saloon area portside

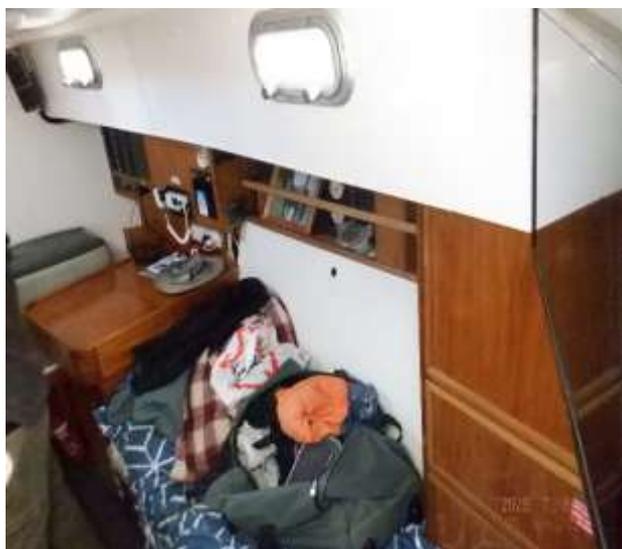
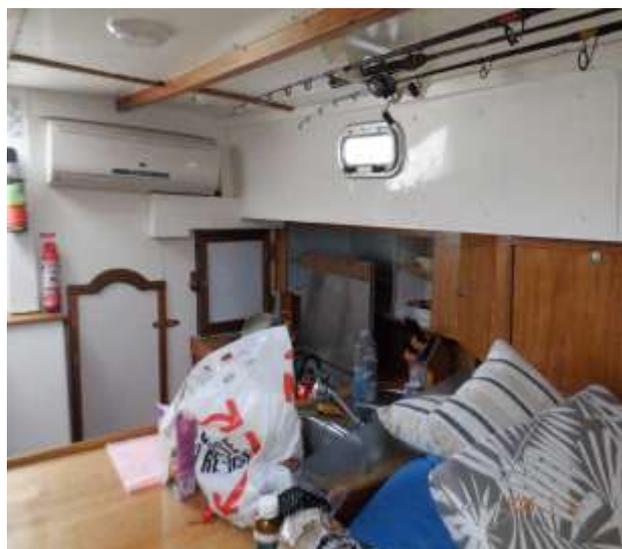
The internal fit out and decor presented consistent with the age of the vessel.

*Internal profiles: Saloon starboard side & from vee berth cabin toward companionway entry*
