# **Seaworthy Inspection Report**

22.06.2026 12:00 AEST

Natelle Two

Peterson 41

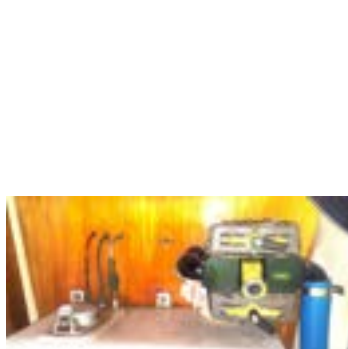
Photo 14

Aluminium fuel tank situated under companionway steps, forward of engine bay. No corrosion, split welds or leaks detected. Lines and pipe fittings secure with stainless steel clip connections. Age of fuel lines unknown, so should be verified.

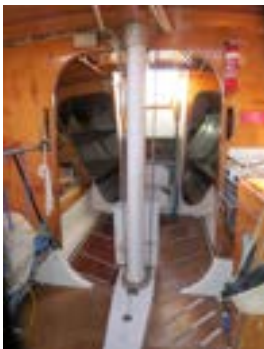
Photo 31

Percussion tested interior GRP. Vessel solid. Painted timber stringers, low moisture readings. Dry bilge areas

with exception of engine bay. Hardwood joinery and marine ply panelling throughout. Keel bolts inspected and percussion tested, all satisfactory. Timber housing had a minor slit, which can be epoxy filled. Cockpit sole lined in removable plywood panels.

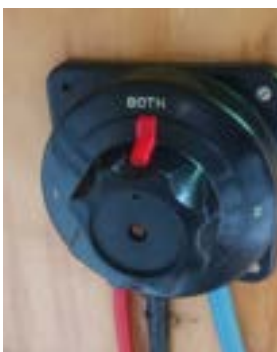
Photo 89

Both dead, no voltage.

2 battery changover dials, tested. One isolator was found during survey in the 'Both' position with a VHF switch remaining on. This could account for the dead batteries.

- Have an approved marine electrician inspect and tidy all wiring, terminating connections appropriately. Batteries should be charged and load tested. Replacement may be needed due to running completely flat, and their age is unknown. Test all electrical systems, lights and navigation once power has been obtained.
