1+1: Modification vs original design

STRUCTURAL MODIFICATION

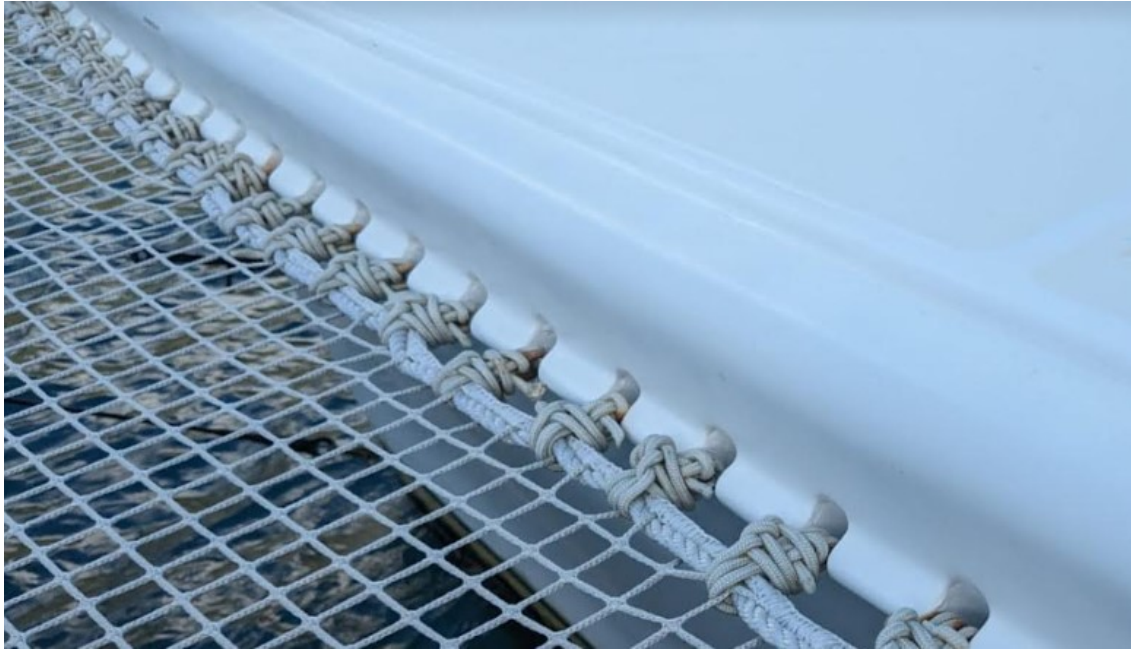
The aluminium rails used for attaching the net have been suppressed. All holes have been clogged. An Inox bar inserted in a stratification was installed

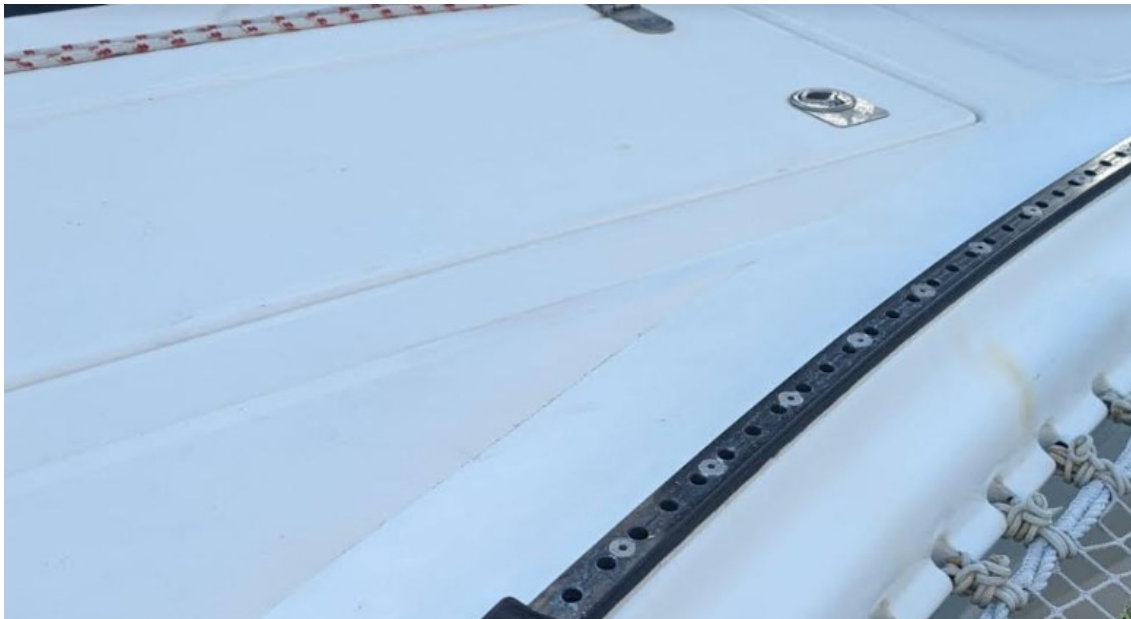
The solent rail was removed, all holes clogged. The rail was re-installed on a new epoxy structure.
