Survey Report for Insurance Purposes

Client:	Carl Allen	callenmd@yahoo.cor	n	
Vessel:	"Wahine" Nicholson 32 (197	72)		
Designer:	Peter & Charles Nicholson	Peter & Charles Nicholson		
Builder:	Rudder Yachts Pty Ltd, Brookvale, NSW			
Place of Survey:	Yowie Bay Marina			
Date of Survey:	5 July 2018			
Registration No:	PH17 N	H.I.N: AUW	WA097414FD1	
Dimensions:	L.O.A: 9.75m	Beam: 2.82m	Draft: 1.68m	
Hull Construction:	Moulded	Material: GRP (Glas	ss Reinforced Plastic)

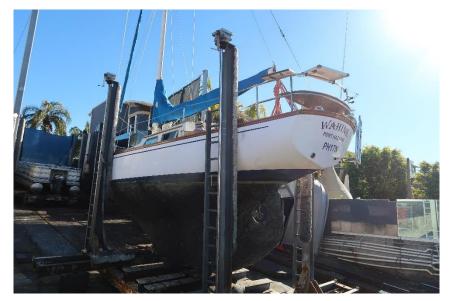
Underwater Section:

Percussion tested and found to be structurally sound and in fair/good condition.

There were two previous repairs around the shaft log and transducer, at next slipping they require "fairing" around the edges to ensure that they do not delaminate. The main part of the repair is sound.

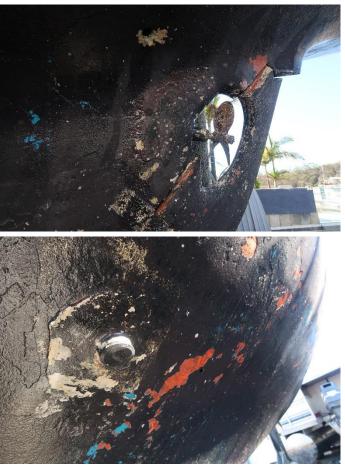
The skin fittings are metal and in good condition. The anti foul was recoated after inspection.
