DCV Survey Inspection Report (Year 2) Marine Lyn - MB363 / AMSA UVI - 432547

Marine Lyn - MB363 / 432547

Year 2 in water periodic survey

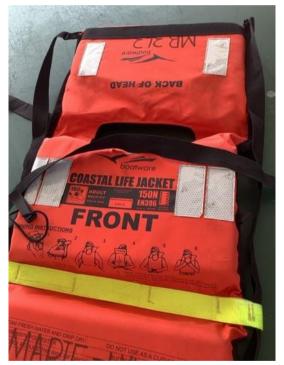
Life Saving Appliances		
The vessel is surveyed against th to Safety Equipment.	e following standard with regard	NSCV Part C7A Safety equipment
Types of Life Jackets		Coastal
Life Jackets 32 x 150 N jackets plus 4 kids jackets	s onboard	Satisfactory
Photo 7		
Quantity of Life Jackets		32
Whistles All jackets fitted with whistles		Satisfactory
Life Jacket Lights		Not Applicable
Lights not required for E waters		
Life Jacket Storage Labelled with Donning instructions to be displayed	qty and Donning Instructions	Sub-Standard
Life Buoy (MOB) Requirements		
	Life Buoy	L/B Light
Life Buoys (MOB) 2 x life buoys onboard and in sound of	condition	Satisfactory
Quantity		2
L/B Light		Satisfactory
Life buoy lights operational and attack	hed to life buoys	
Quantity		2
Buoyant Appliances - Appliance 1	Туре	
Carley Float/s	Life Buoy/s as buoyant appliance	Internal Foam Buoyancy
12 person Carley float plus 1 life buoy 40% total capacity for E water	y provides for 14 person capacity

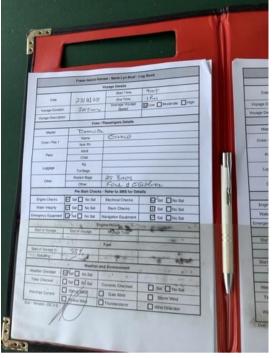
Photo 6

Vessel log books onboard and updated

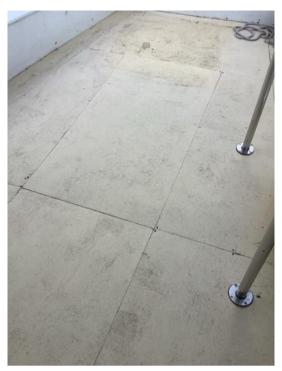
Photo 9

Timber plywood floor in a sound condition with floor bearers in a sound condition where accessible Timber decks in a sound condition
