Date: 27/03/2024  
Ref: 0324MV

## Condition & Valuation Report "Marie Vere"

### “Marie Vere”

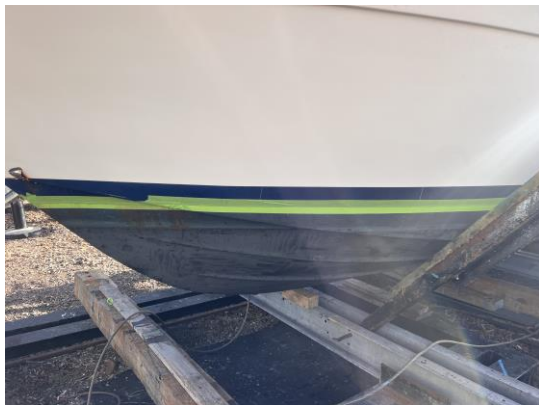
The vessel hull and superstructure is constructed from fibreglass and presents in good condition. External hull shows no visible evidence of deficiencies or leaks with fresh coat of antifoul applied at time of inspection. Sea inlets are free of obstruction and gelcoat finish above waterline shows nil deficiencies. Zinc blocks were replaced or within limits and all below waterline fixtures were secure with nil deficiencies.

Profile after pressure wash

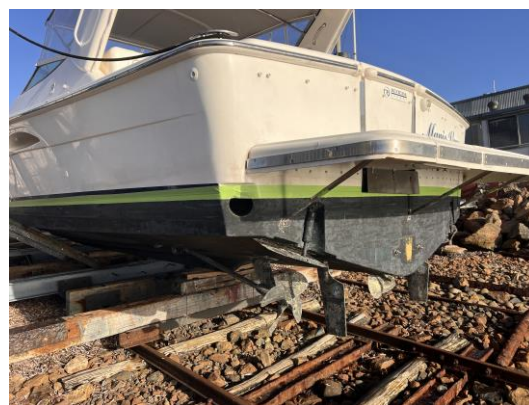
Clean Drive Train

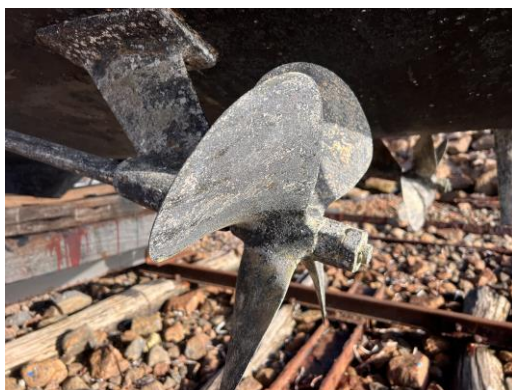
Vessel is fitted with twin shafts running through aft bearing and struts which present in good condition. Aft bearings have minimal wear, and no evidence of damage or deficiencies are evident to either propeller or shaft.

Propellers are bronze 4 blades in Good Condition and rudders are secure with minimal back lash.

Port Propellor and Strut

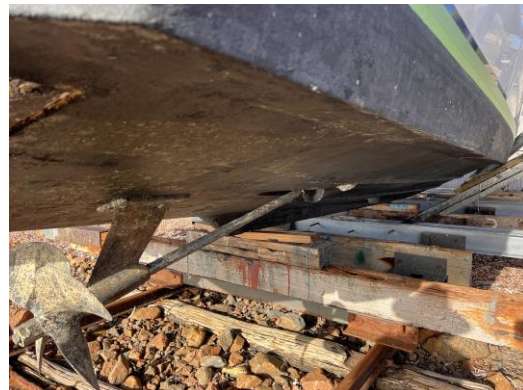
Starboard Drive Train

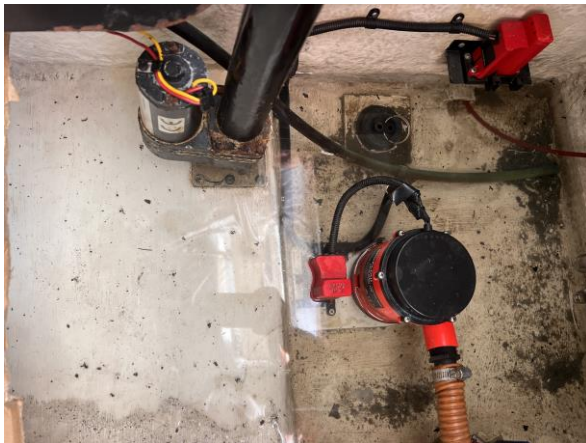
Accessible areas of inside hull present in Excellent condition with no evidence of damage or deficiencies. All areas show good coat of gelcoat with no visible major cracks or chips in gelcoat. All skin fittings and fixtures present in Good condition with no evidence of leaks or deficiencies.

Engine Room Bilge

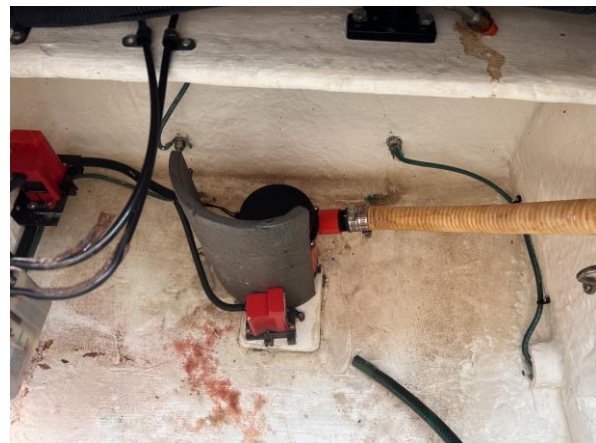
Tiller Flat Bilge

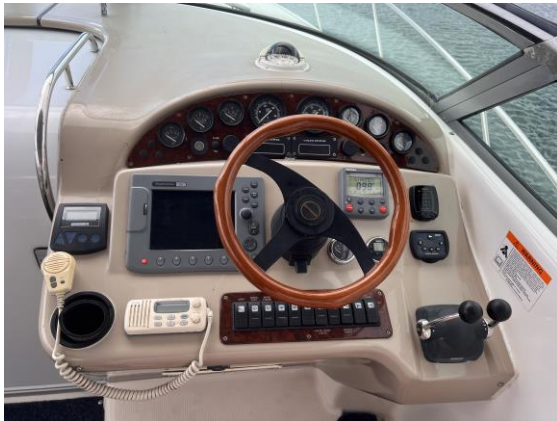
The vessel is equipped with factory fitted electronics which are laid out across the Starboard helm. All equipment is as per factory installation and in Good Condition.

Starboard Helm

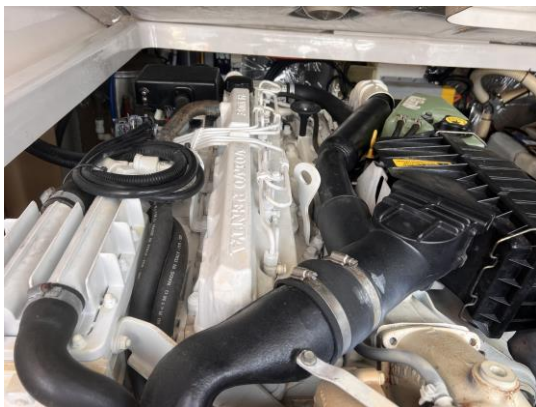
Main Engines are 210kw 6 Cylinder Volvo KAMD300 close coupled to Volvo HS63AE gearboxes. Engine hours are recorded as 388hrs to Port and 390hrs to Starboard with both engines/gearboxes presenting in good condition with no visible evidence of major leaks or deficiencies. Engine mounts are secure, exhaust is secure, and regular maintenance has been performed to both.

Port Engine

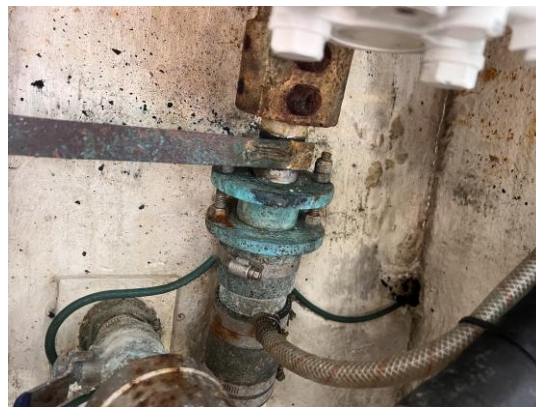
Shaft seals show evidence of minor leaking over time leaving cosmetic rust to coupling surfaces.

Starboard Coupling

- Ensure all safety equipment is valid.
- Clean and apply protective spray to shaft glands and surrounding fittings.
- Clean and apply protective spray to cockpit clear zips and fittings.

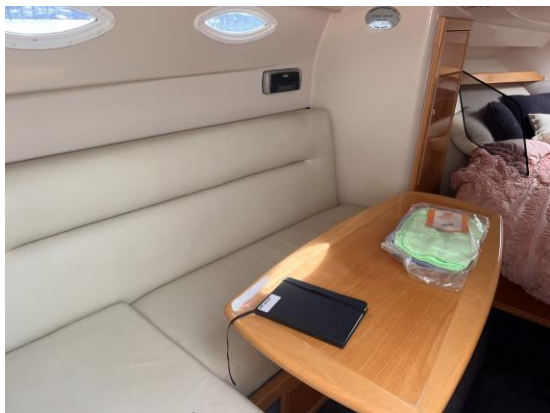
Vessel galley area is located down and forward of the cockpit area and is noted as in Excellent Condition. There is a large L Shape dining area to Port and Galley area to Starboard. All areas of the accommodation and galley area are noted as in Good Condition with nil deficiencies to wall, floor or ceiling coverings. A Vacuum Flush toilet is located to Starboard in a combined shower area and this area is also noted as in Good Condition.

Port Side Dining

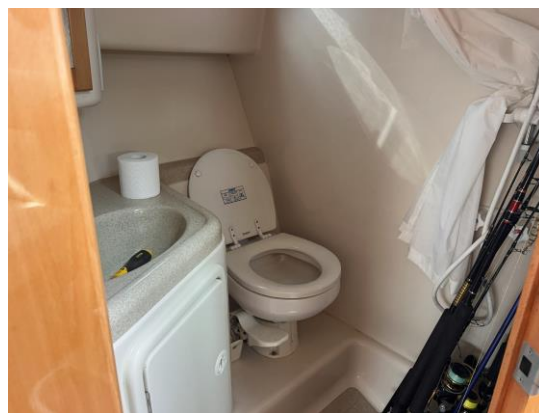
Toilet / Shower
