Oref : 17002/AZ(mi0515xr)

## CONDITION SURVEY REPORT

### S/Y MIYAGI MOON

At Aegina May/17

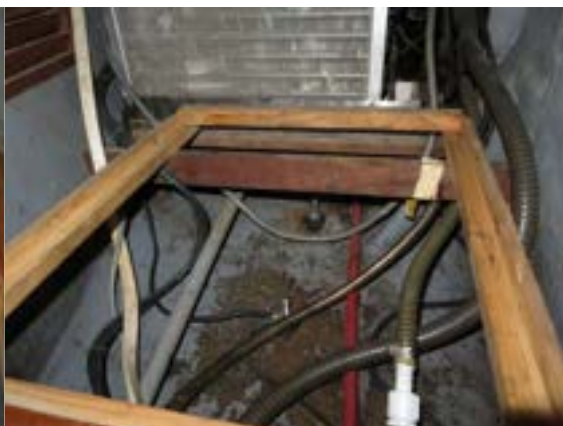
Intact bilge structure

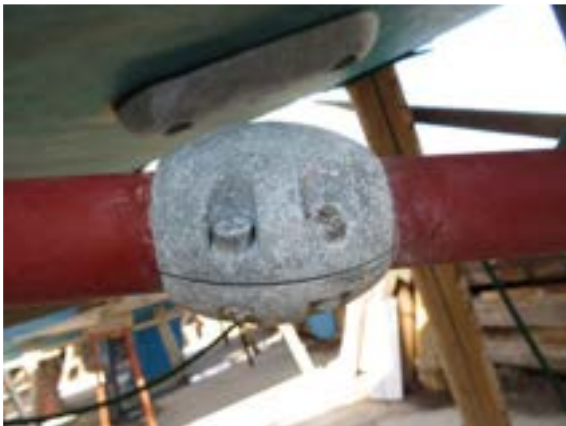
Shaft anode new

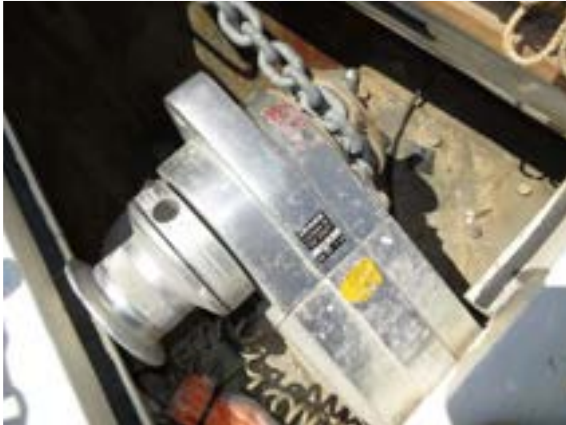
Anchor windlass casing without wastage

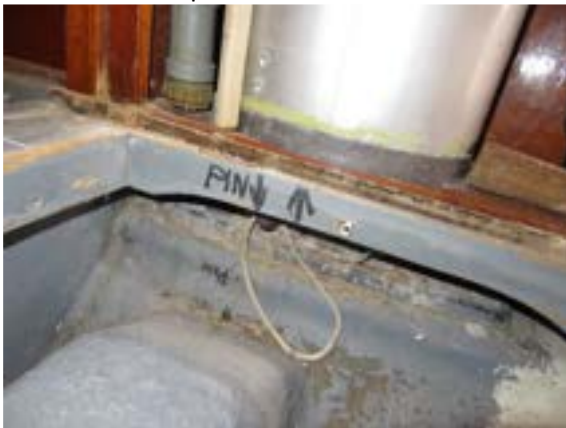
Mast keel step intact

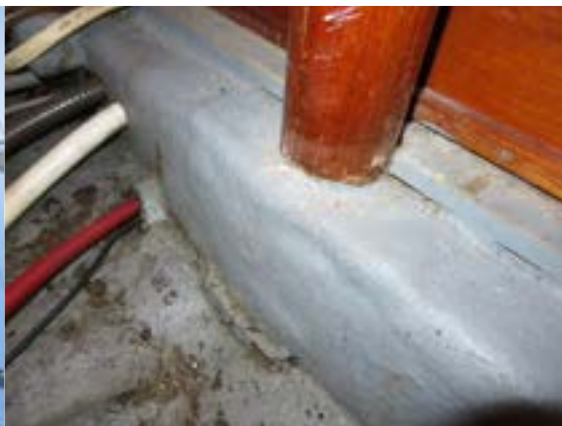
Aluminium deck stepped mizzen mast. Looking up the extrusions fair and the spreaders secure. Boom looked straight. Boom gooseneck was secure and without fracture. Laminations in way of the compression post foot were with a void on the starboard side which may be from original construction as the structure looked intact.

Laminations in way of mizzen compression post intact

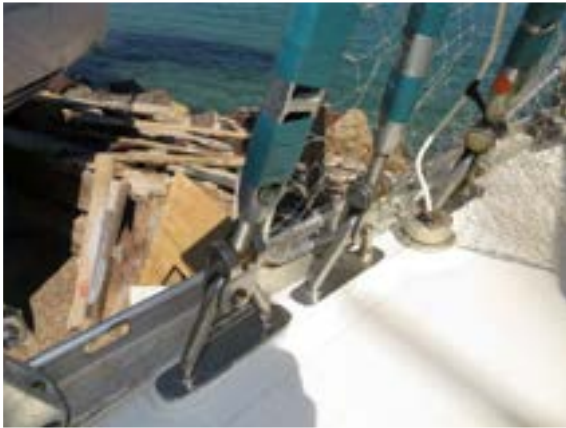
No crazing or delamination in way of shroud chainplates

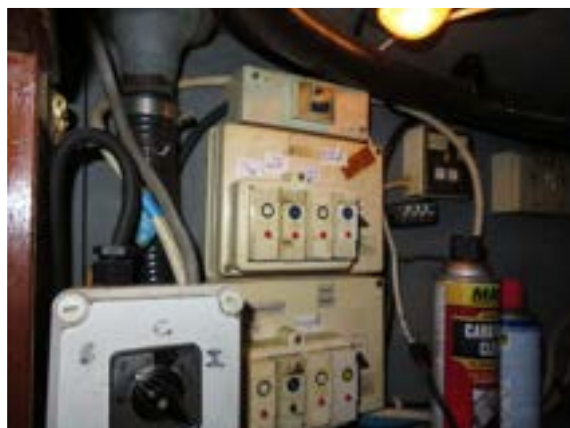
Shore power RCD
