## BLUEWATER MARINE SURVEYORS ABN 61 172 043 569

### Survey Report

**Vessel:** "Dory"

**Date of Survey:** 3 November 2021

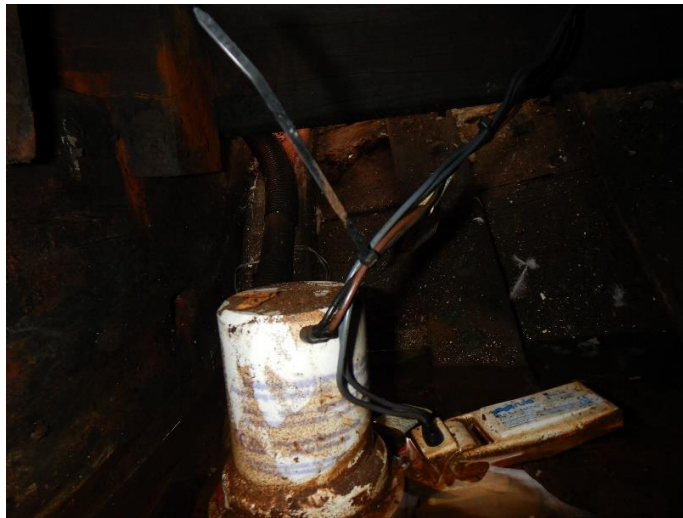
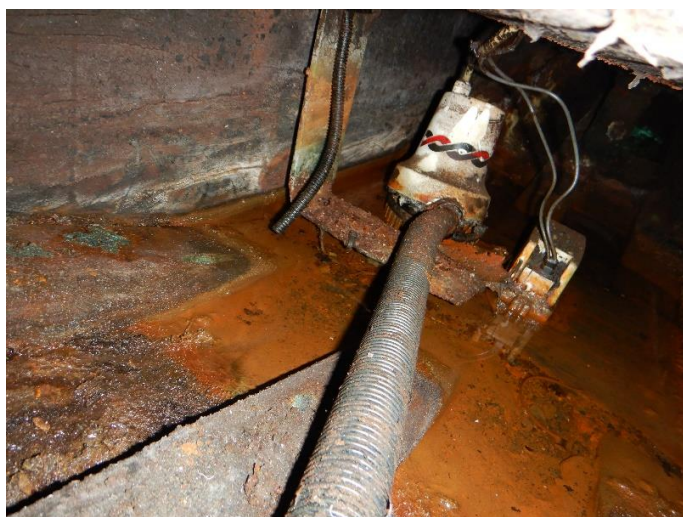
Surface rust is evident on unprotected steel surfaces.

Hoses and clamps have deteriorated and require replacement.

It is suggested these surfaces be cleaned, rust converted and coated with a suitable paint system.

All through hull fittings and valves require cleaning, removal, check for corrosion and replace where necessary.

It is recommended that the Shaft Seal be replaced at the earliest convenience.

The rudder gland hose and clamps should be replaced.

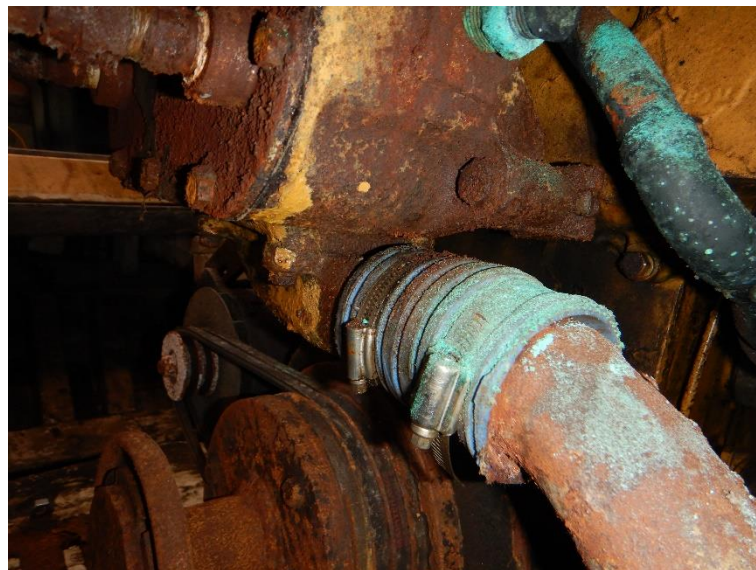
Deterioration of hoses and clamps
