Insurance Risk Survey

Riviera, 3350 Flybridge, 2001

Survey type:	Insurance Risk Survey
Survey No#:	IRS250107
Client:	██████████
Email:	████████████████████
Inspection date:	7th January 2025
In-Water location:	SYC, Sandringham, Victoria
Out-Water location:	SYC, Sandringham, Victoria

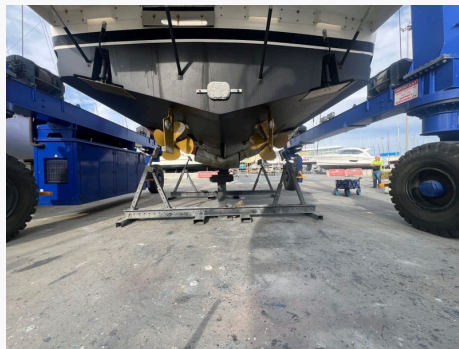
Ref # 2.6

Ref	Item	Material / Construction	Condition	Comments
2.1	Hull Bottom	FRP Composite	Sound	No damage or defect found to the hull bottom, appeared structurally sound throughout.
2.2	Keel	FRP Composite	Sound	
2.3	Bulkheads	FRP Composite	Sound	
2.4	Hull stringers	FRP Composite	Sound	
2.5	Bilge	Flowcoat	Sound	Note: It is important to check all bilges prior and post vessel operation and immediately following vessel launch for water ingress as part of your standard operating procedures.
2.6	Transom	FRP Composite	Sound

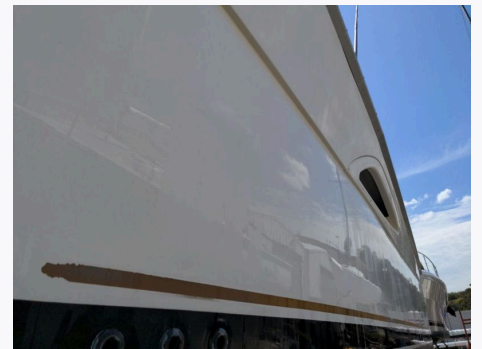
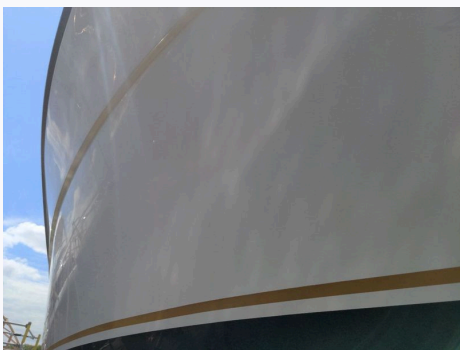
2.7	Hull side / Topsides	Gelcoat / FRP	Sound	
2.8	Gunnel	Aluminium	Sound	
2.9	Bow Stem	Gelcoat / FRP	Sound	
2.10	Skin Fittings	Bronze	Sound	
2.11	Swim platform	FRP Composite	Sound	Some cosmetic wear to edges of platform which is consistent with normal wear tear.
2.12	Antifouling	Black Ablative Application	Good	Being prepared for new antifoul at the time of inspection
2.13	Hull anode	Zinc or Similar	Good	All being replaced with new

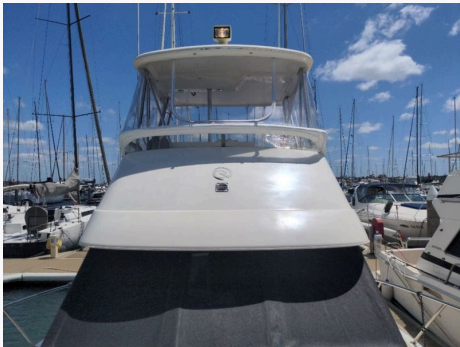
Ref # 4.1

Ref	Item	Material / Construction	Condition	Comments
4.1	Superstructure	FRP Composite	Sound	Flybridge with hardtop and clears, lockable main cabin with open rear cockpit.
4.2	Cockpit Sole	FRP Composite	Sound	Marine carpet overlay
4.3	Combing / Bulwarks	FRP Composite	Sound	
4.4	Seating & Upholstery	Vinyl	Good	Twin Helm seats with flybridge seating. New covers over seating areas.
4.5	Covers & Awnings	Canvas	Good	Rear awning fitted.

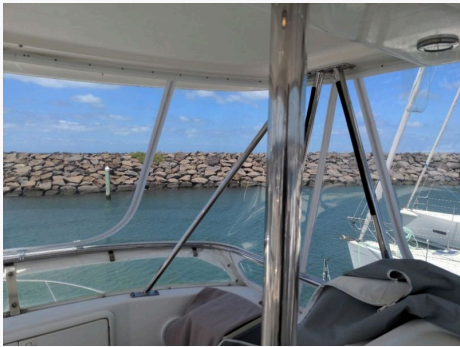
Ref # 4.6

4.6	Clears	Polyvinyl or similar	Good	Fully enclosed flybridge, near new.
4.7	Bimini Frame / Targa	FRP Composite Hardtop	Sound	Found secure, supported by stainless steel frame.
4.8	Cockpit doors	FRP Composite	Sound	
4.9	Cockpit Drainage	Self Draining	Sound

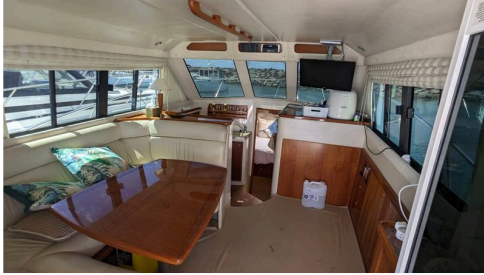
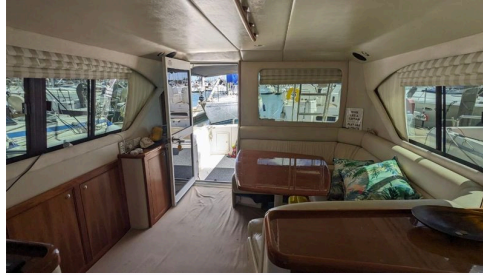
Ref	Item	Material / Construction	Condition	Comments
5.1	Interior Frames	Timber Veneer	Sound	Vessel interior appears original and suitably maintained with only minor wear and tear present to commensurate with age.
5.2	Cabinetry & Fitout	Timber Veneer	Sound	
5.3	Headlining	Material Panels	Sound

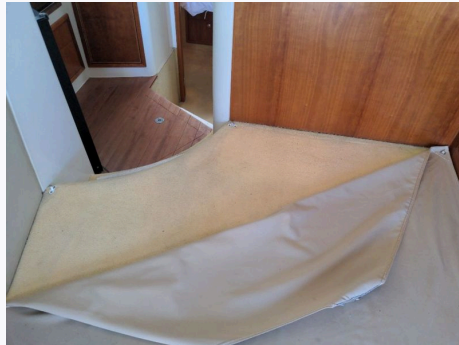
Ref # 5.4

5.4	Cabin Sole	Carpet	Sound	Cream carpet with canvas overlay.
5.5	Galley Fitout	FRP Moulding	Sound	FRP moulded galley with solid timber trim.
5.6	Seating & Upholstery	Leather	Sound

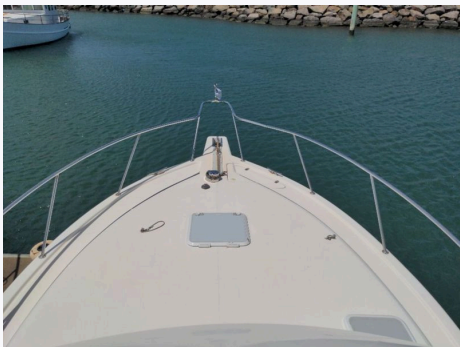
Ref # 6.1

Ref	Item	Material / Construction	Condition	Comments
6.1	Foredeck Structure	FRP Composite	Sound	Deck was found rigid and structurally sound, all hardware appeared to be marine grade quality and secure.
6.2	Deck Finish	Non-skid	Sound	
6.3	Bowrail	Stainless Steel	Sound	
6.4	Stanchions	Stainless Steel	Sound	
6.5	Cleats	Stainless Steel	Sound	
6.6	Hatches	Acrylic or similar	Sound	Appear leak free.
6.7	Windows	Glass or similar	Sound	
6.8	Anchor Winch	12-Volt Electric	Sound	Tested
6.9	Anchor	Plough (Galvanised)	Sound	
6.10	Anchor chain, warp and fittings	Galvanised	Sound	
6.11	Bow roller / Stem head	FRP Composite	Sound

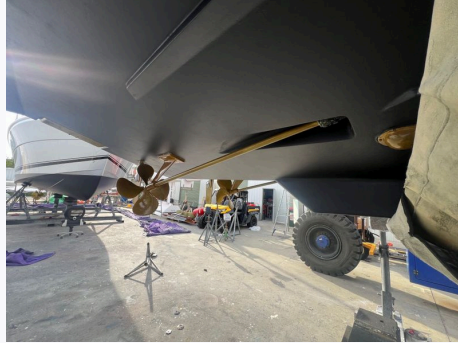
Ref # 8.3

Ref	Item	Type / Make	Condition	Comments
8.1	Type	Shaft Drive	Sound	Twin shaft drives
8.2	Gear Box	ZF	Sound	
8.3	Propellers	Bronze	Sound	Fixed 3 blade
8.4	Shaft	Stainless Steel	Sound	Appears to run true.
8.5	Shaft Seal	Dripless Seal	Sound	<p>PYI PSS type dripless seals, said to have been replaced in 2023.</p> <p>These seals have a limited services life. Please refer to manufacturers maintenance and service guidelines.</p>
8.6	Coupling	Flexible Type	Sound	
8.7	Skegs	Cast Bronze	Sound	Twin bronze skegs, securely mounted.
8.8	Skeg Mount (Internal)	Bronze Plate.	Sound	No signs of stress or damage
8.9	Bonding	Wire	Sound	<p>Appearing to be connected/ bonded where sighted.</p> <p>Bonding strap, continuity test and appears serviceable.</p>
8.10	Drive Anodes	Zinc or Aluminium	Good	Being replaced with new

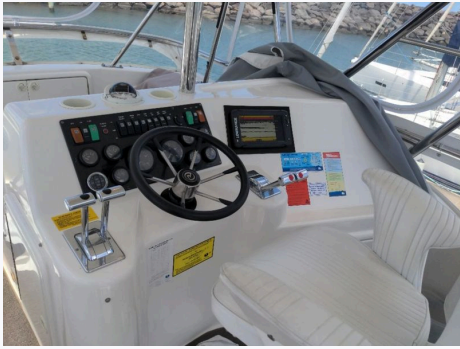
Ref # 9.1

Ref	Item	Type / Make	Condition	Comments
9.1	Helm	Single Helm	Sound	Single flybridge helm
9.2	Type	Hynautic Hydraulic	Sound	
9.3	Connections and Lines	Hose	Sound	Hydraulic lines and fittings appeared serviceable.
9.4	Rudder	Bronze	Sound	Solid bronze rudder blade, no damage.
9.5	Rudder Glands	Packing Type	Sound	No notable leak or deterioration sighted, patina present on glands.
9.6	Rudder Head/Shelf	Timber Veneer	Sound	Rudder head secured to FRP composite rudder shelf.
9.7	Trim Tabs Plate	Stainless Steel	Sound	Anodes fitted, no damage.
9.8	Trim Rams	Bennett Type	Sound	Functional. Low oil in reservoir.

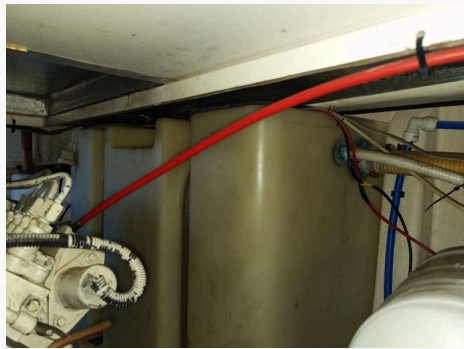
Ref # 11.2

Ref	Item	Type / Make	Condition	Comments
11.1	Fresh Water Pump	12-Volt	Sound	
11.2	Water Tank	Polyethylene or similar	Sound	2 tanks with 342 litre capacity
11.3	Plumbing / Hose	HEP Type	Sound

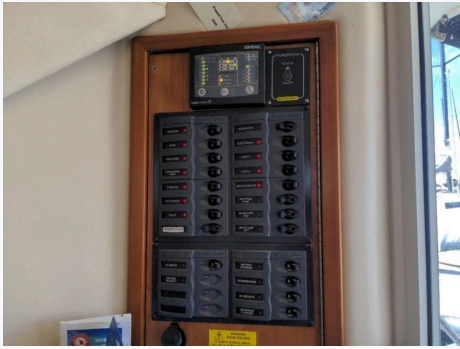
Ref # 12.4

Ref	Item	Type / Make	Condition	Comments
12.1	Shore Power Lead	15-amp Heavy Duty	Sound	
12.2	Shore Power Breaker	Trip Switch / Breaker	Sound	
12.3	Wiring & Cables	Insulated Wire	Sound	
12.4	Switch Panel	AC/DC switch panel	Sound	Switch panel with Xantrex True Charge monitor.
12.5	Power outlets / GPO	Australian Type	Sound	Tested using DETA-240 plug tester, resulting in a PASS.
12.6	Battery Charger	Xantrex	Sound	
12.7	Batteries	12-volt	Sound	House and Start banks.

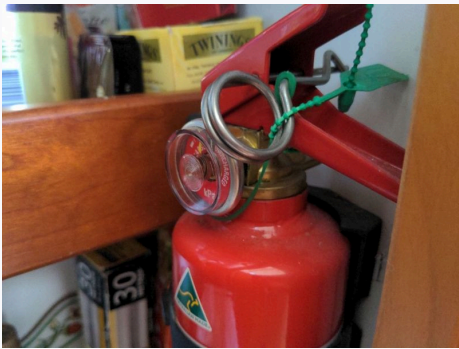
Ref # 16.2

Ref	Safety Gear	Type	Comments
16.1	Life Jackets	Foam PFD type	1 x Inflatable & 8 x Foam sighted. Note: Periodic self inspection of all PFD's and cylinders is essential. Inflatable gas cylinders require replacement, check expiry dates stamped on cylinders.
16.2	Extinguishers	Dry Chemical Type	3 x 1kg Dry Chemical.; State laws may require this vessel to carry a 9kg Dry Chemical cylinder. Check regulations to extinguisher size and number for vessel. Note: Dry powder Fire extinguishers should be serviced as per manufacturers guidelines.
16.3	Fire Suppression	n/a	None
16.4	EPIRB	n/a	None
16.5	Flares	Flare Kit	One set in service.
16.6	Fire Blankets	One Blanket	Found in galley
