**Maritime Solutions**  
*Most Things Nautical*  
**ABN 35 121 707 202**  
**Vessel Survey Inspection Reports**  
**Condition & Insurance Reports, Damage & insurance Claim Survey, Vessel Appraisals, Sea Trails, Vessel Construction Management, Vessel Delivery**  
**P.O.Box 5093**  
**Manly QLD 4179**  
**Ph: 0407 736 331.**

**Surveyor:** Peter Pope **Sea Trial:** Nil  
**Inspection** **Insurance risk,** out of the water only, visual and non invasive report  
**Date:** 11<sup>th</sup> July 2016 **Reference Number:** 11716

**“Antares” 1972 Timber 66ft custom built Ketch**

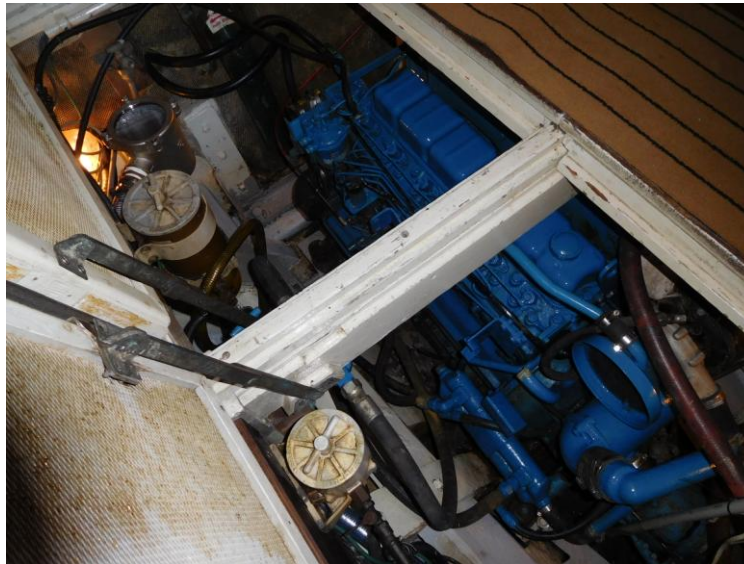
**Machinery**

<b>Main Engines</b>	:	Single shaft driven Perkins 6354, 6 cylinder turbo diesel motor rated @ 160 HP.
<b>Age</b>	:	1972 and has been reconditioned in 1996
<b>Recorded Hours</b>	:	233 Hours
<b>Serial No(s)</b>	:	TE20696U570531F
<b>Auxiliary Motor</b>	:	OnanOMKD 3R IB, 3 cylinder diesel generator rated @ 8 KVA with no sound shield
<b>Age</b>	:	Rebuilt in 2014 by Viking Marine, Mona Vale NSW
<b>Recorded Hours</b>	:	2181 hours
<b>Serial No</b>	:	L860860038

<b>Status</b>	<b>Notes</b>
<b>External Condition</b>	:	Both motor and generator are in clean condition with no oil leaks sighted
<b>Engine mounts</b>	:	Flexible engine mounts on both and in reasonable condition
<b>Cooling</b>	:	Fresh water cooled motor and generator
<b>Controls</b>	:	Morse cable control unit.
<b>Instruments</b>	:	Full Perkins instrumentation
<b>Transmission</b>	:	Single Borg Warner 2:1 gearbox
<b>Stern gland</b>	:	PSS Dripless shaft propeller gland
<b>Rudder gland</b>	:	Single Bronze rudder traditional stuffing gland in good condition
<b>Covers</b>	:	Spray dodger covers and sail covers plus a full set of storage covers
