Survey Report for Insurance Purposes

Vessel: Halvorsen 40, "Lewana" (circa 1946)

Builder: Lars Halvorsen Sons, Ryde NSW

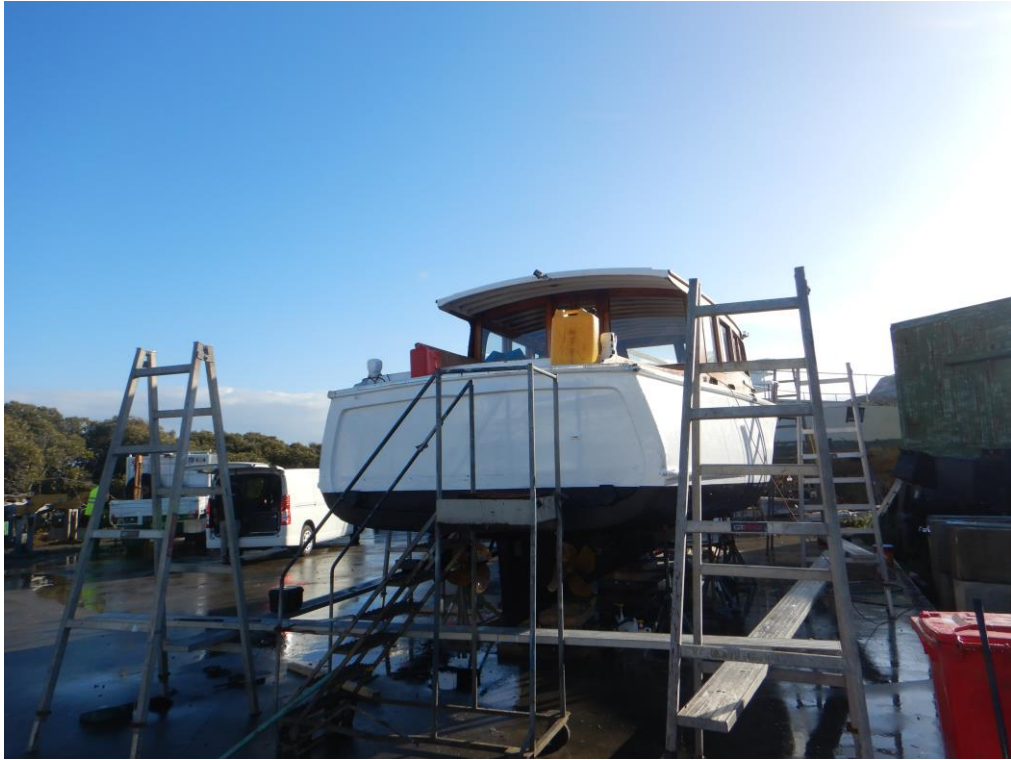
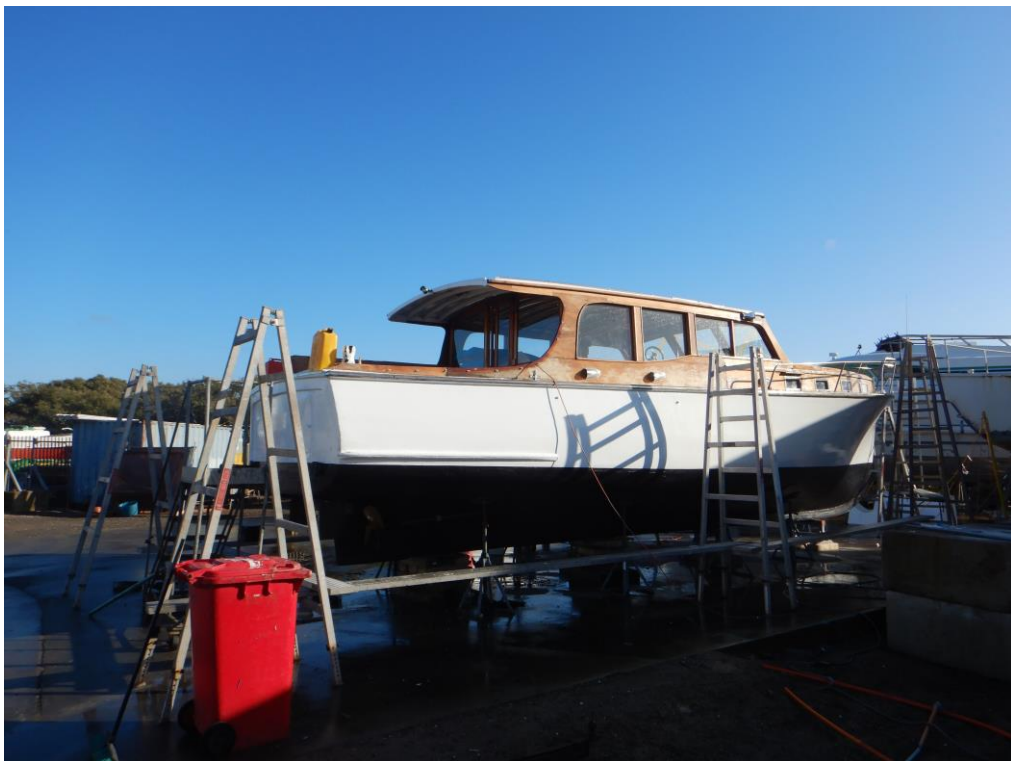
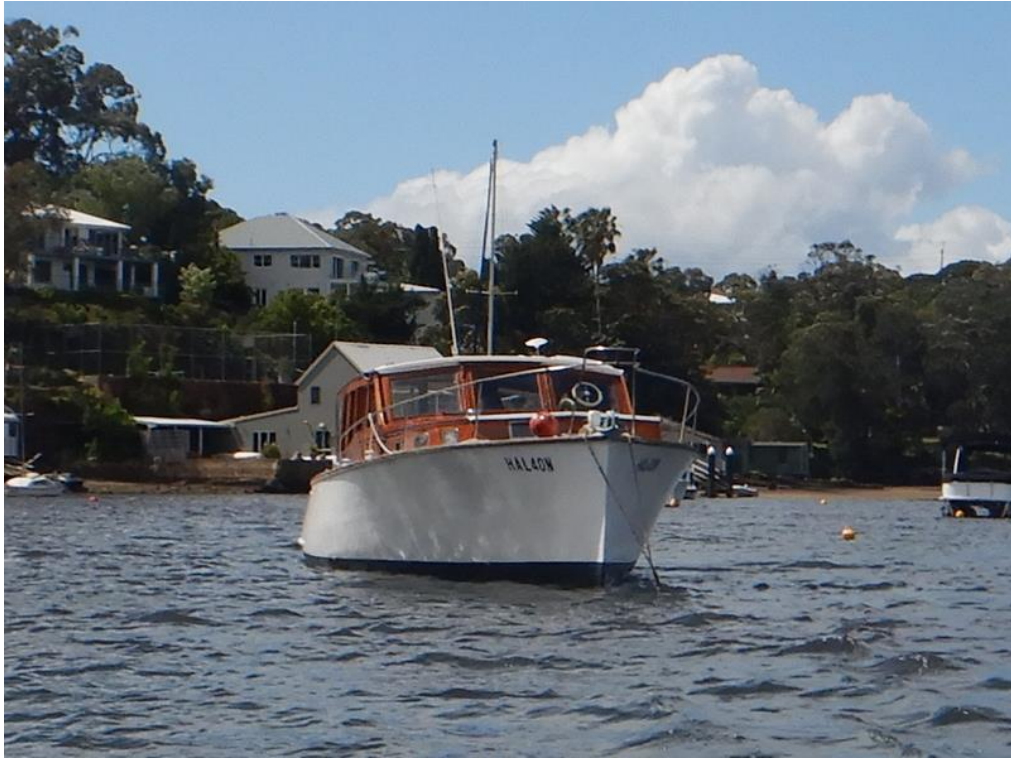
**Comments:****Underwater Section:**

The antifouling was completed at first inspection.
 The skin fittings are metal.
 Caulking and refastening were carried out prior to first inspection.
 Multiple sister “ribs” have been fitted.

Topsides: The topsides are generally in good condition; they were painted just prior to first inspection.
