Oref : 17002/AZ(mi0515xr)

## CONDITION SURVEY REPORT

### S/Y MIYAGI MOON

At Aegina May/17

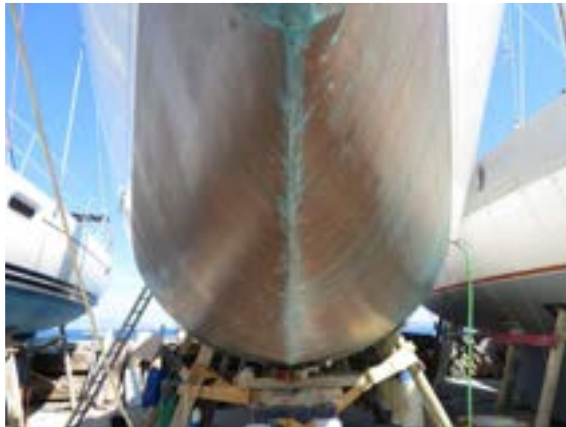
Hull below waterline was recently coppercoated. The hull surfaces were fair. Hammer sounding did not find any delamination or voids. There were no osmosis blisters.

Hull surfaces fair

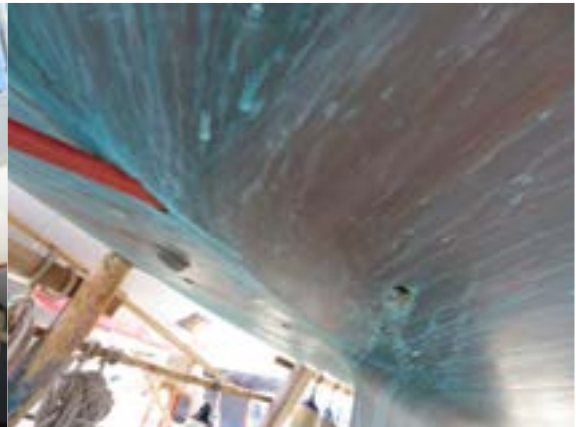
Another view

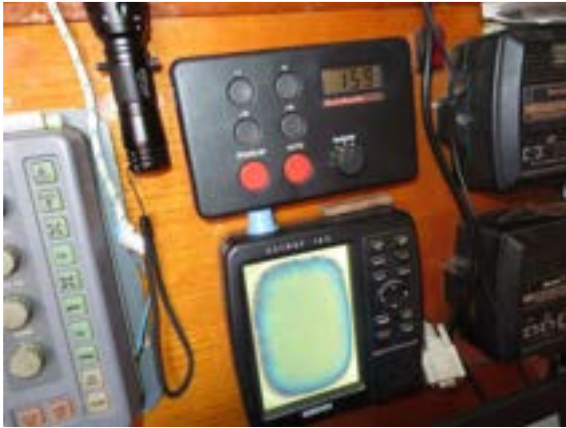
Electric autopilot checked working. Access to steering is poor without removals therefore not possible to inspect linear drive.

Checking autopilot

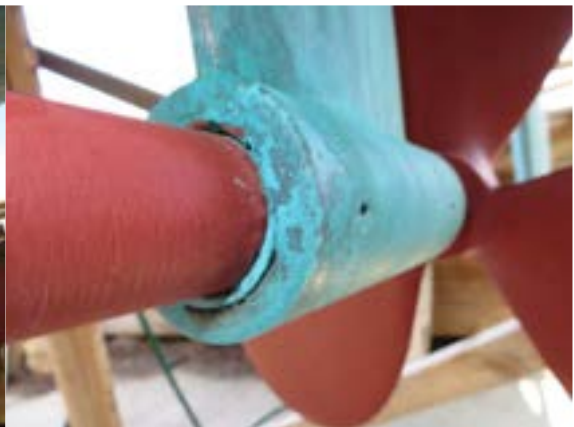
P-bracket without wastage

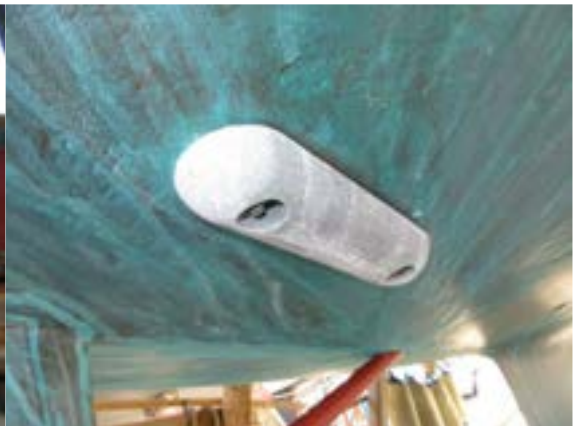
Hull anode new

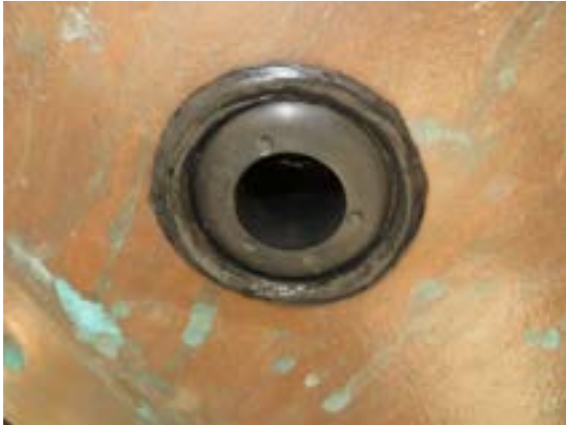
New depth sounder fitting

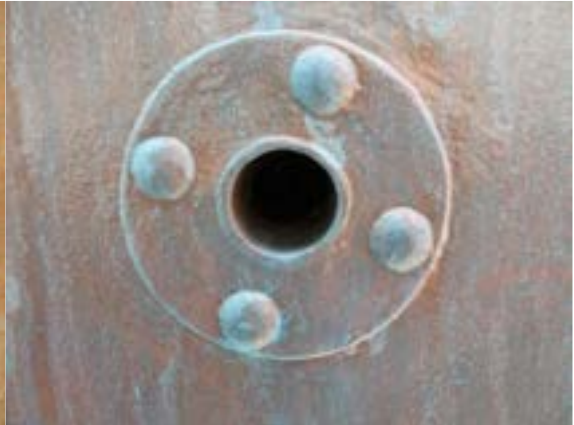
Through hull necks without wastage

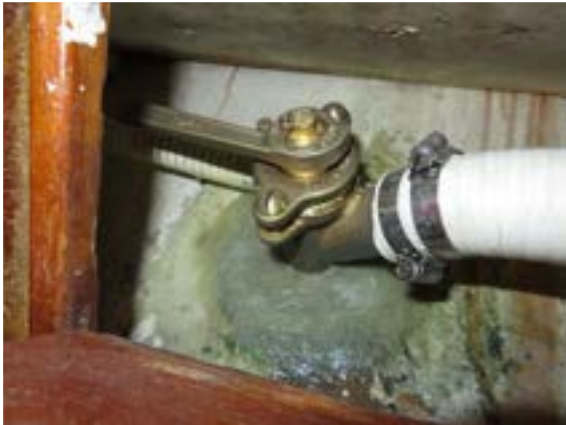
New blakes seacock

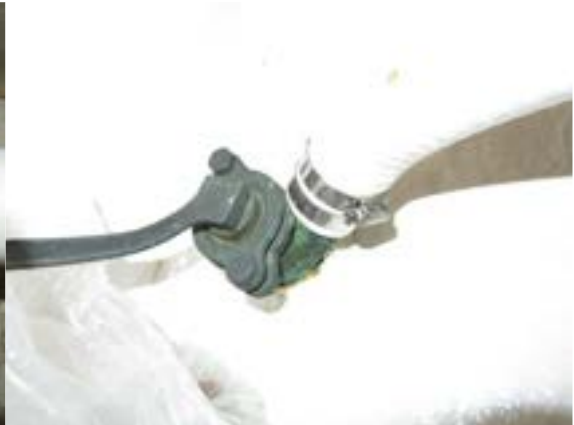
Hoses double clipped

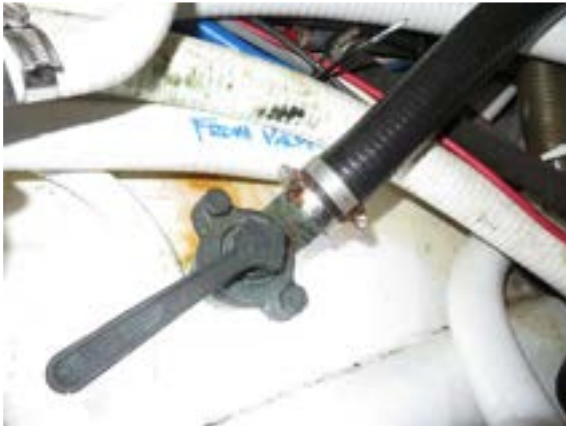
Valve without wastage

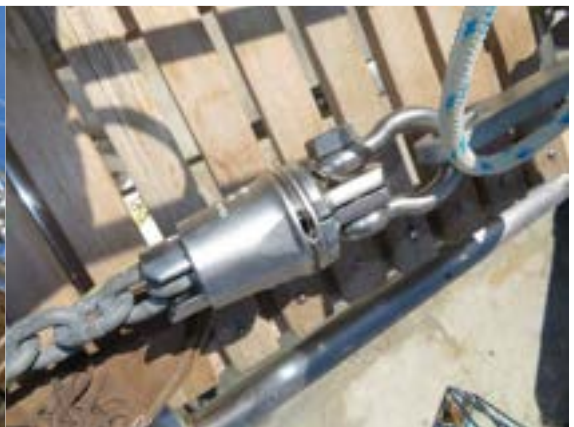
New anchor swivel

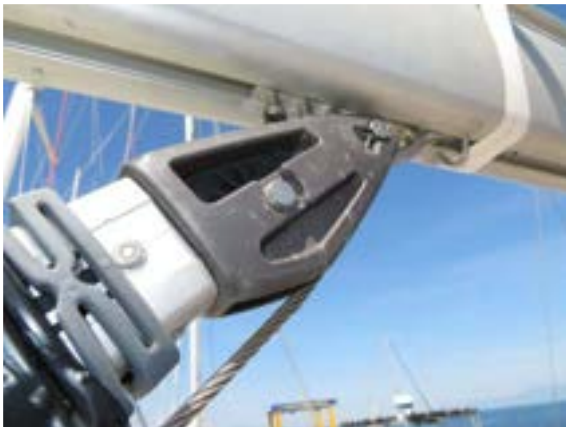
Other side also good

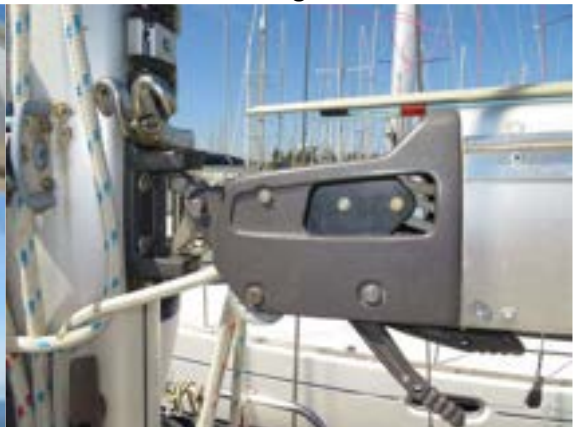
Boom gooseneck secure

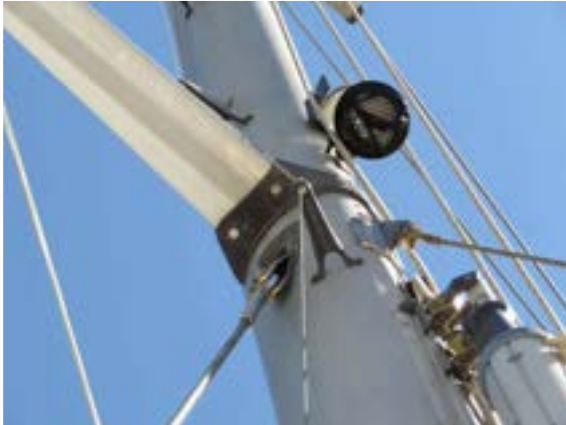
Spreaders secure

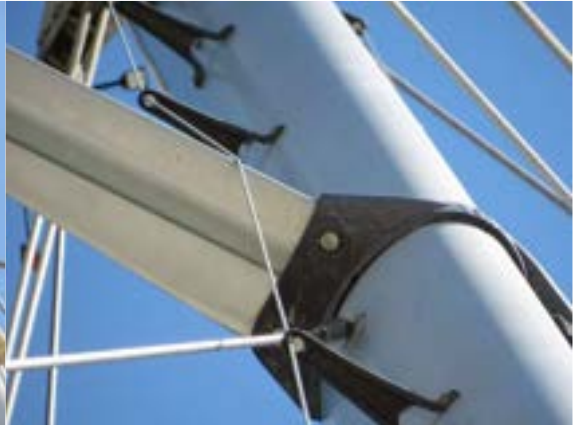
Spreaders secure

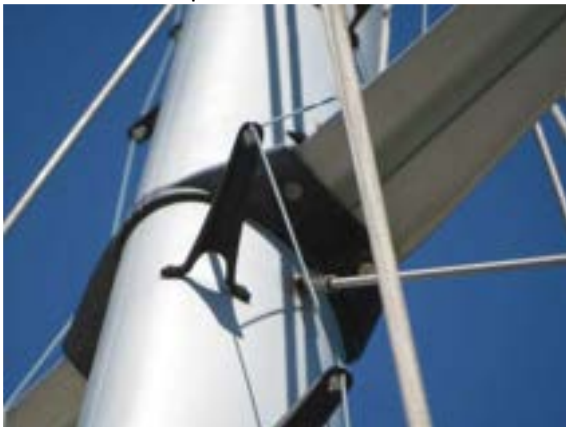
Spreaders secure

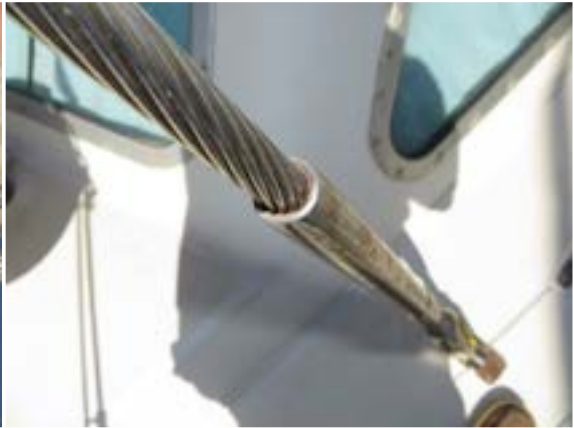
Another view

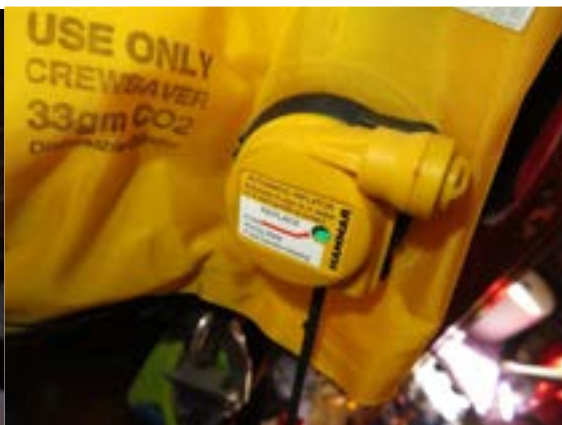
Gas inflated lifejackets to service by 2008

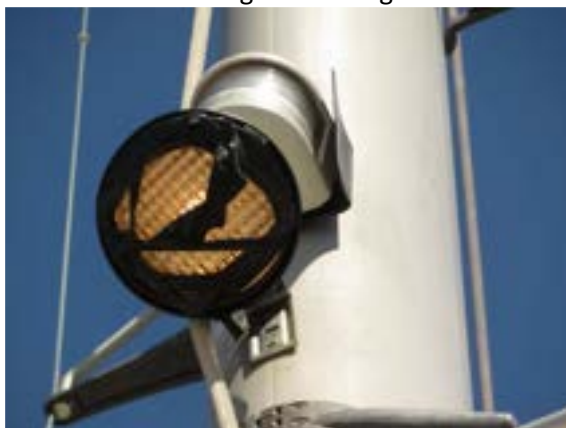
Deck and Steaming light working

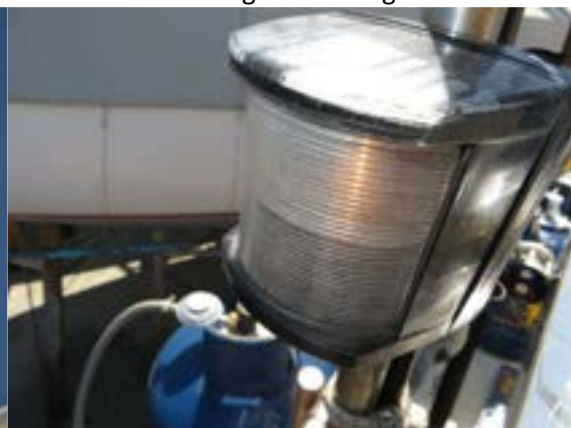
Stern light working

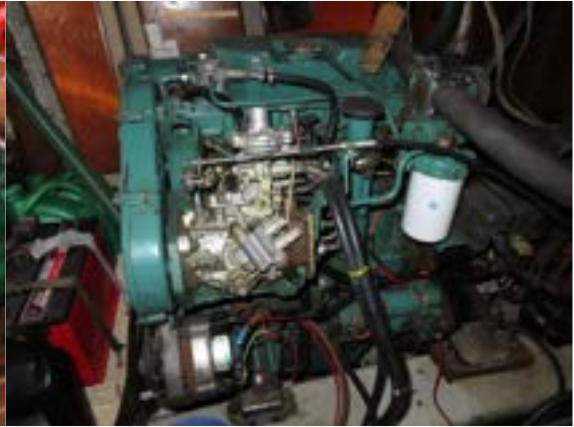
Another view

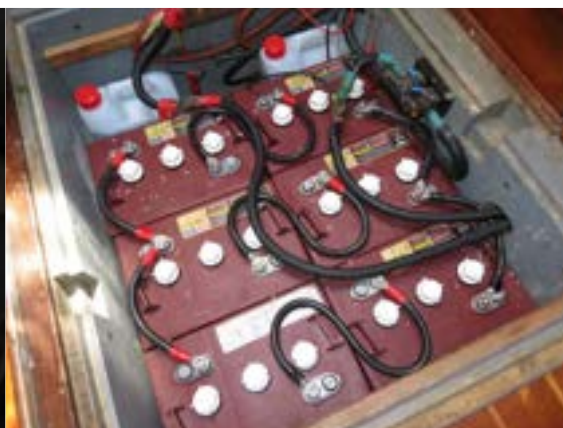
Batteries secure

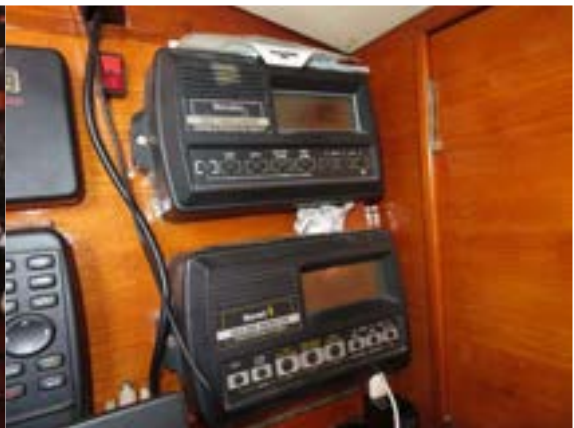
Speed and Depth working

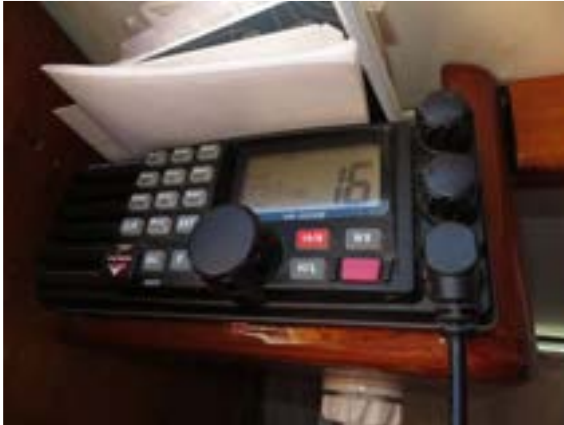
DSC VHF working

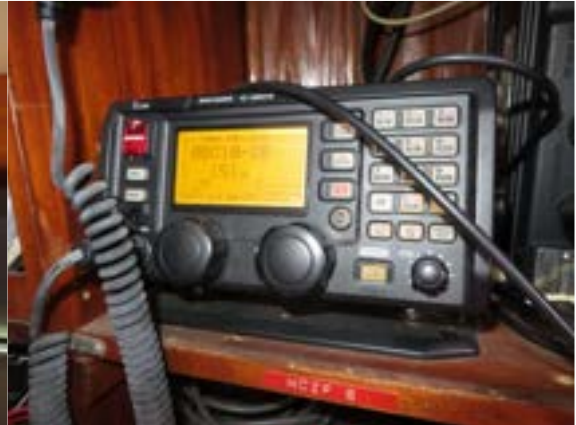
MF / HF working

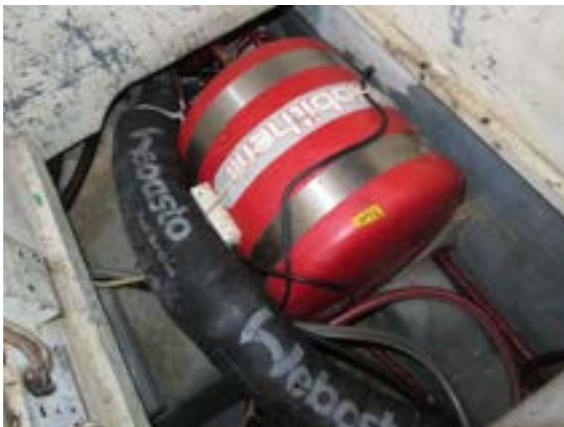
Water heater externally intact and secure.

Water heater
